# Photo Exhibits Album

by Dunn Owen R - EA-CU

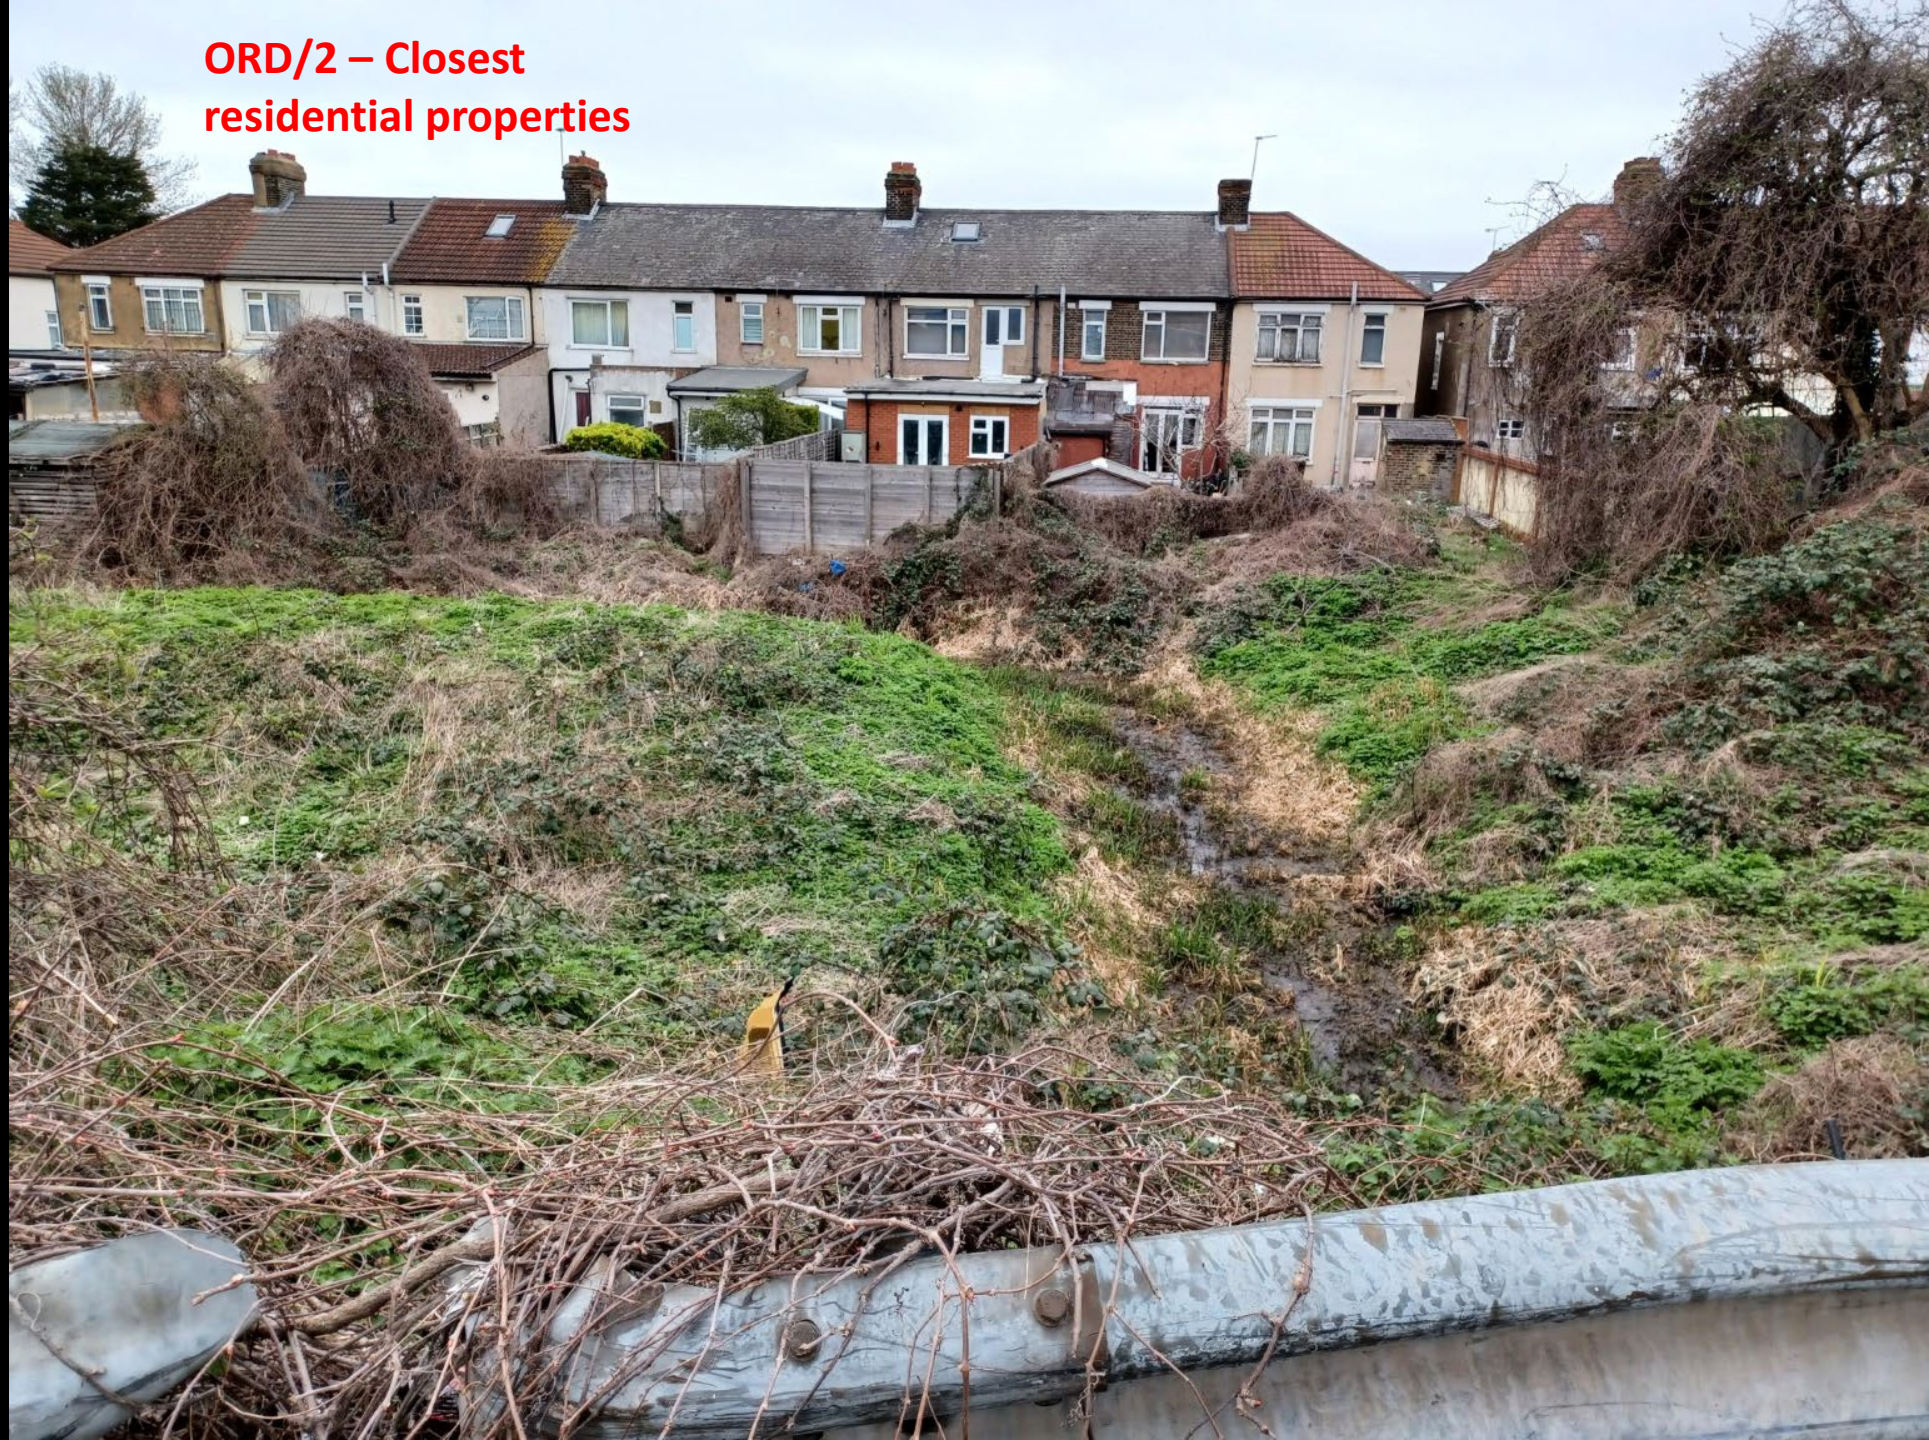
**ORD/2 – Closest  
residential properties**

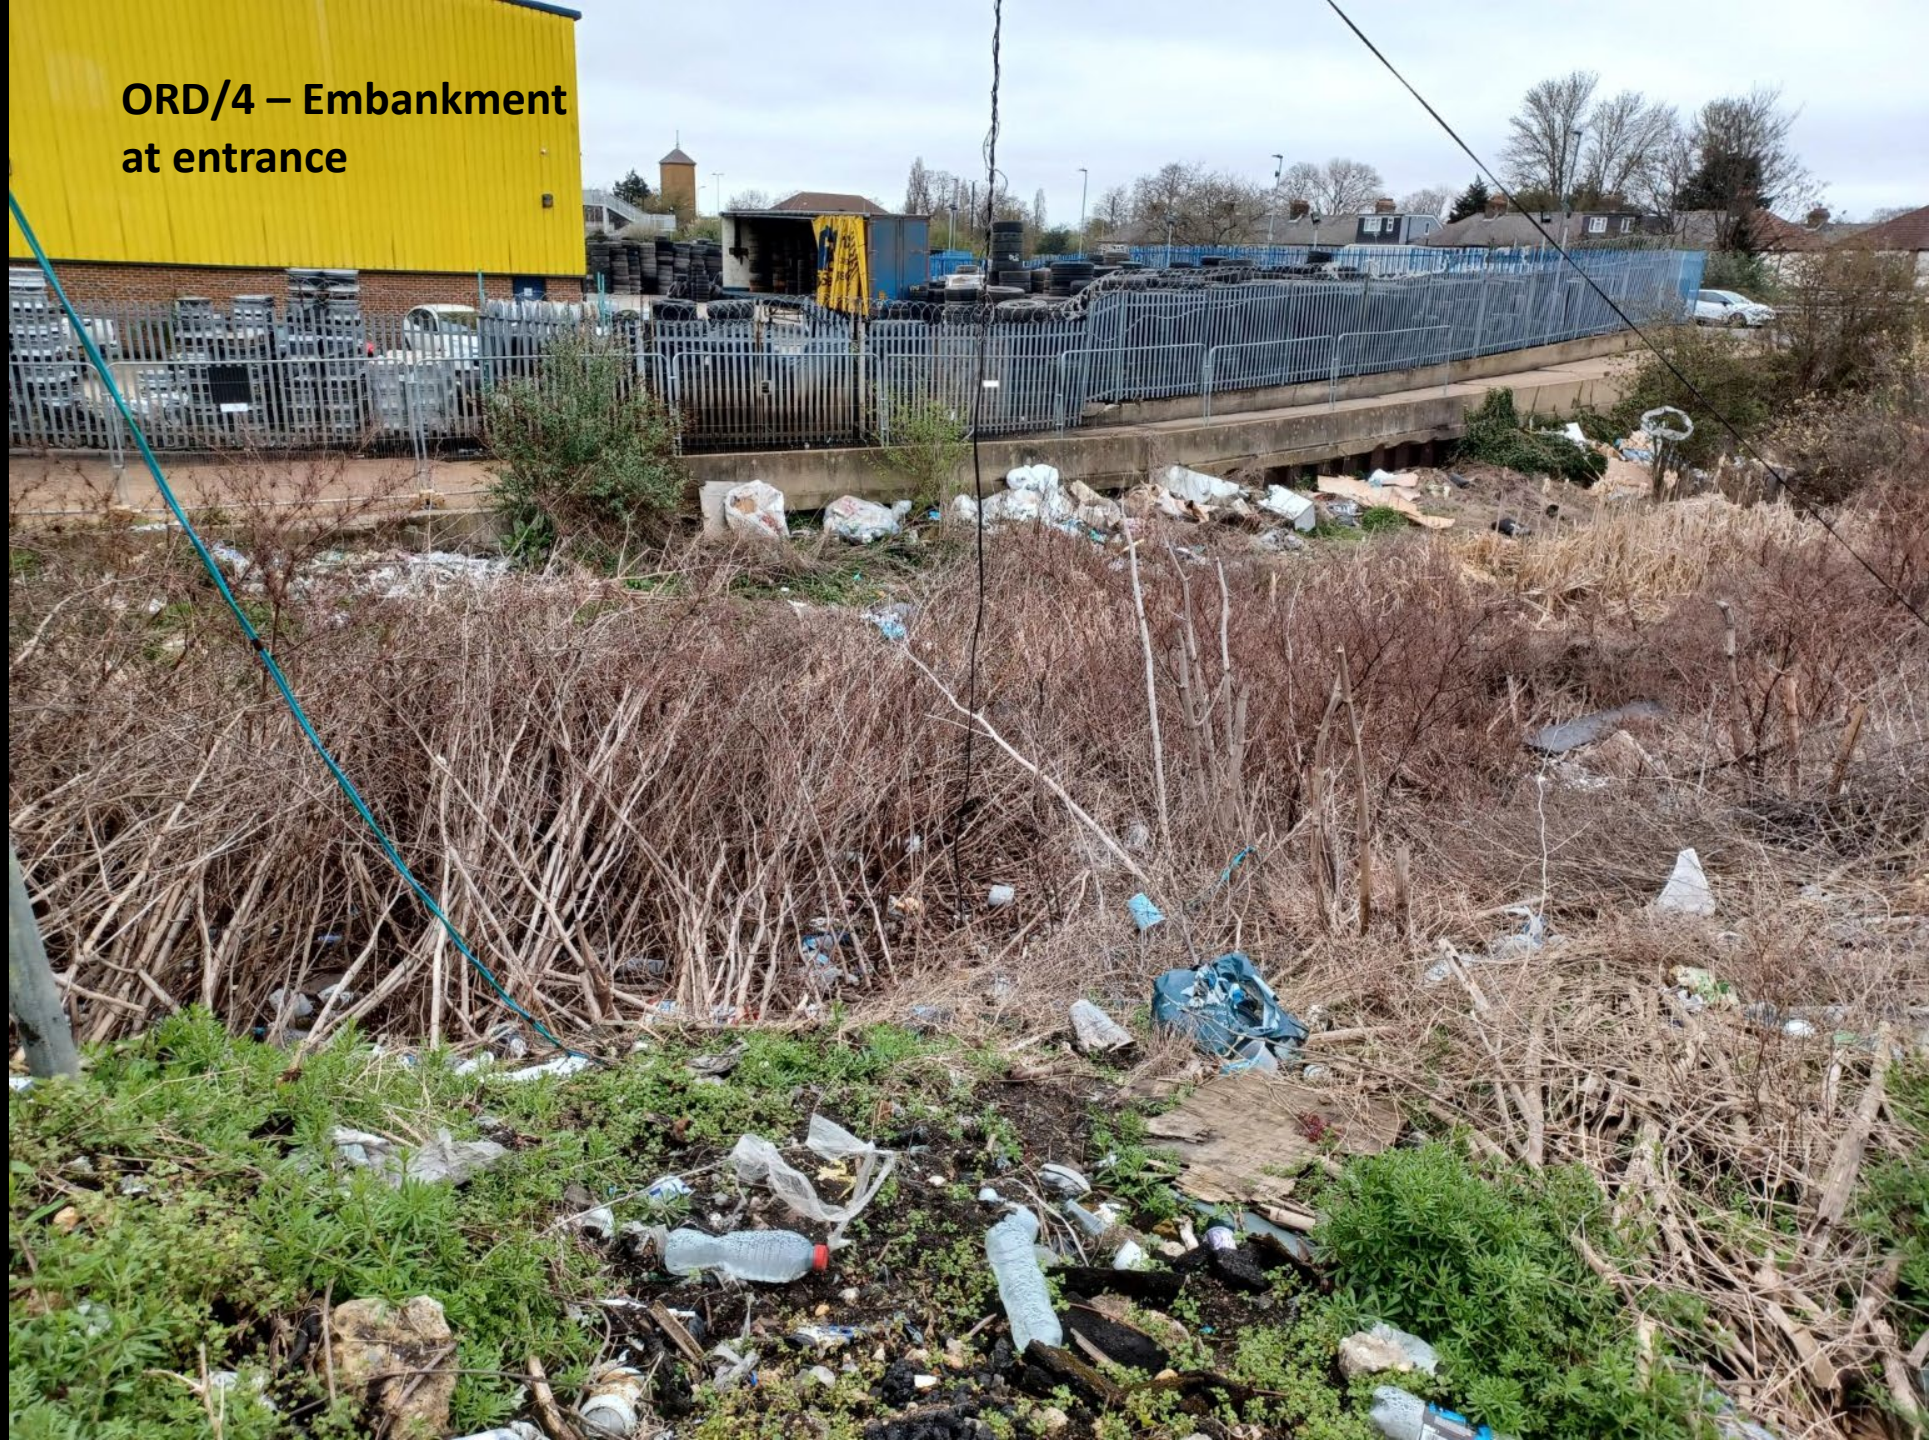
**ORD/4 – Embankment  
at entrance**

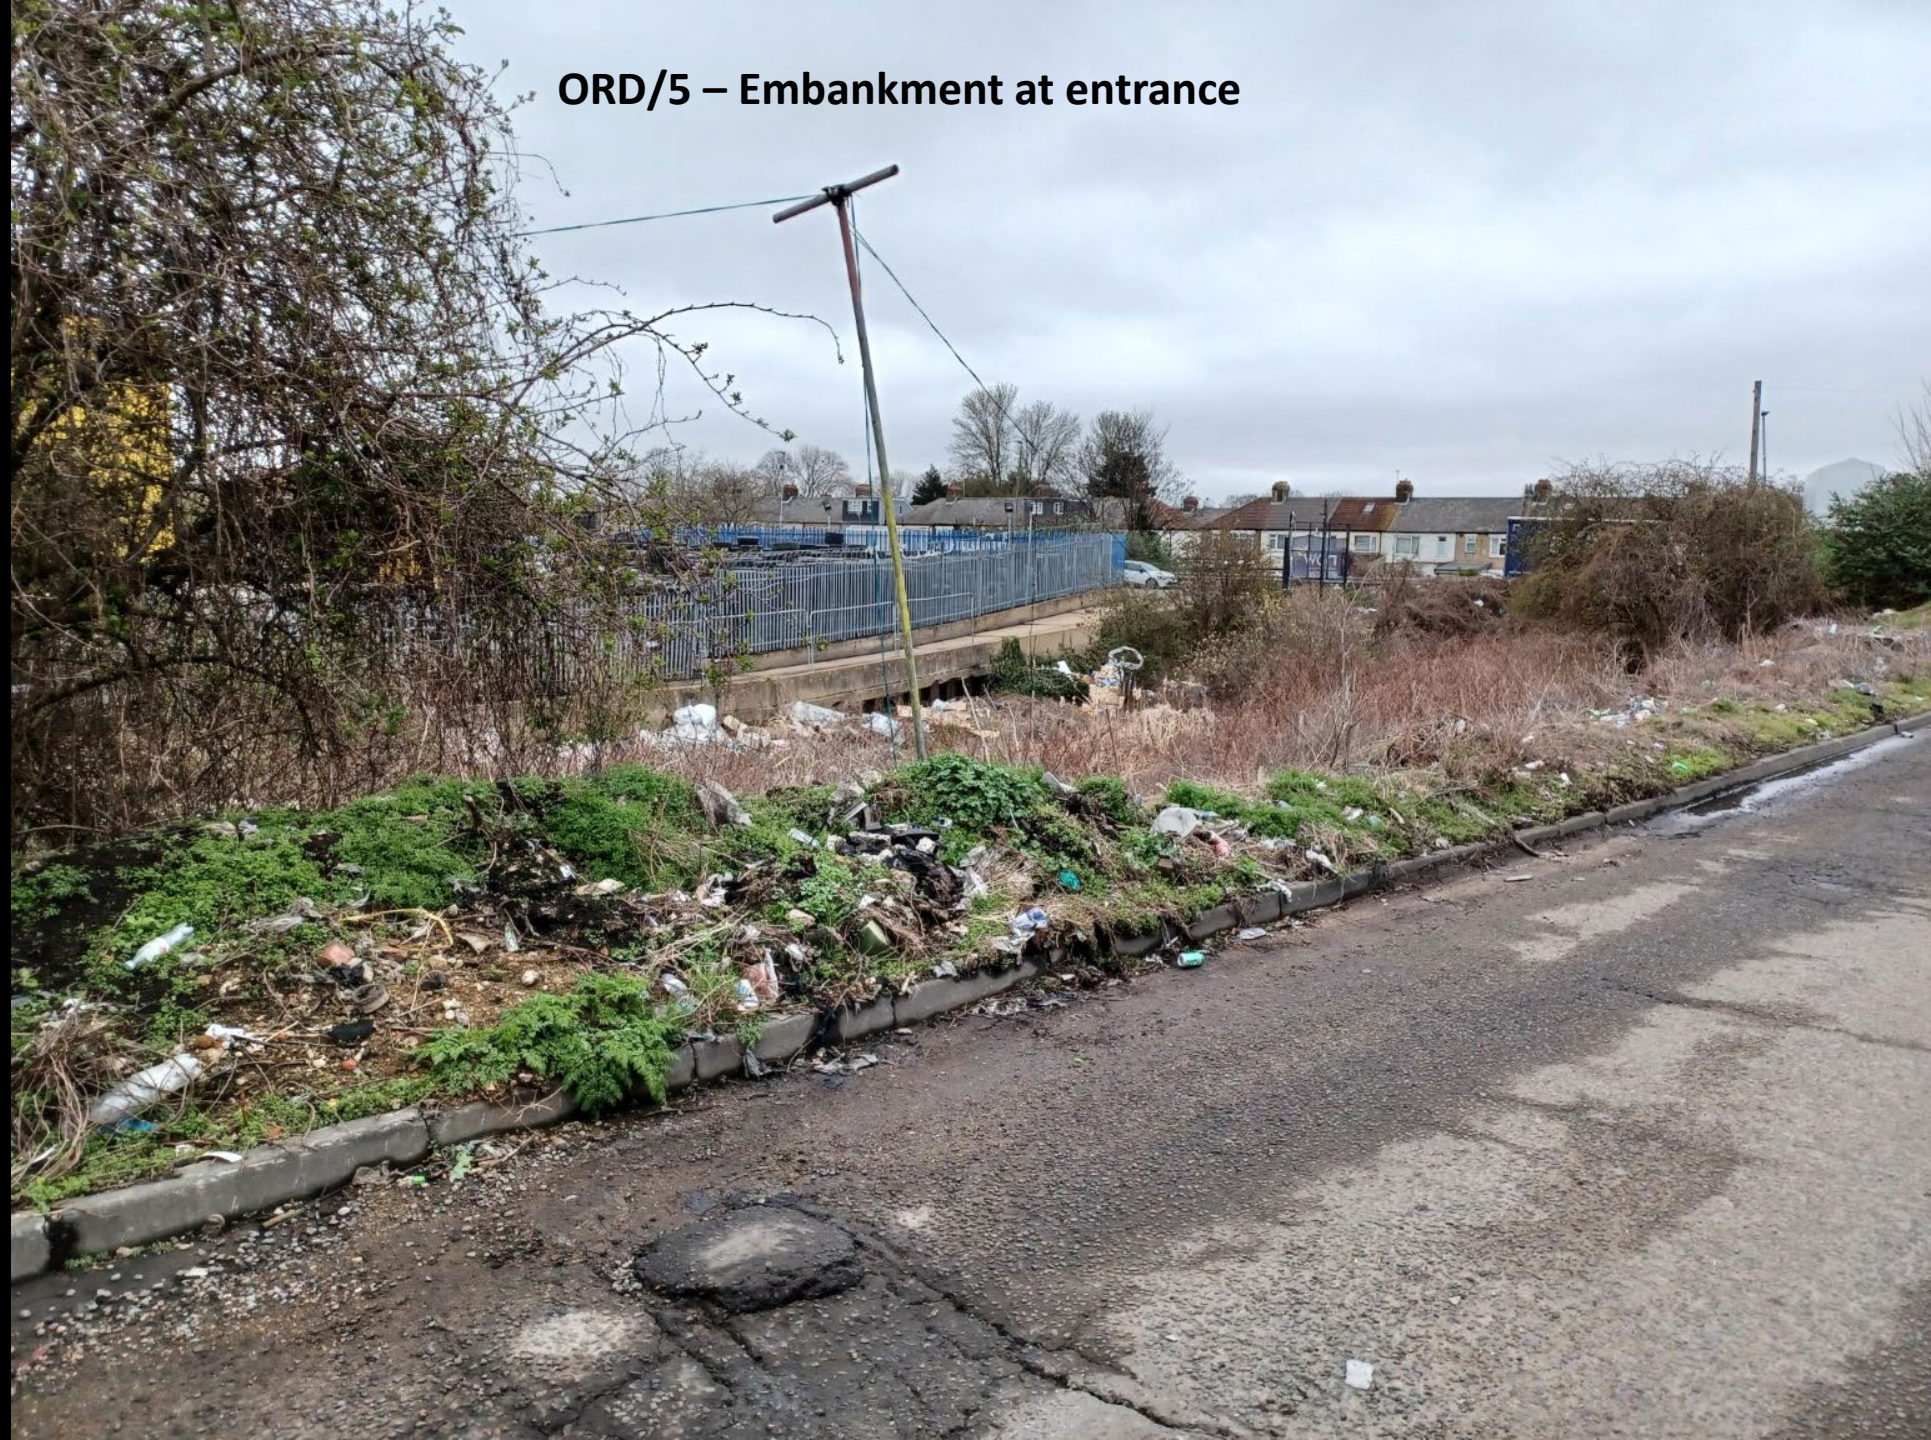
ORD/5 – Embankment at entrance

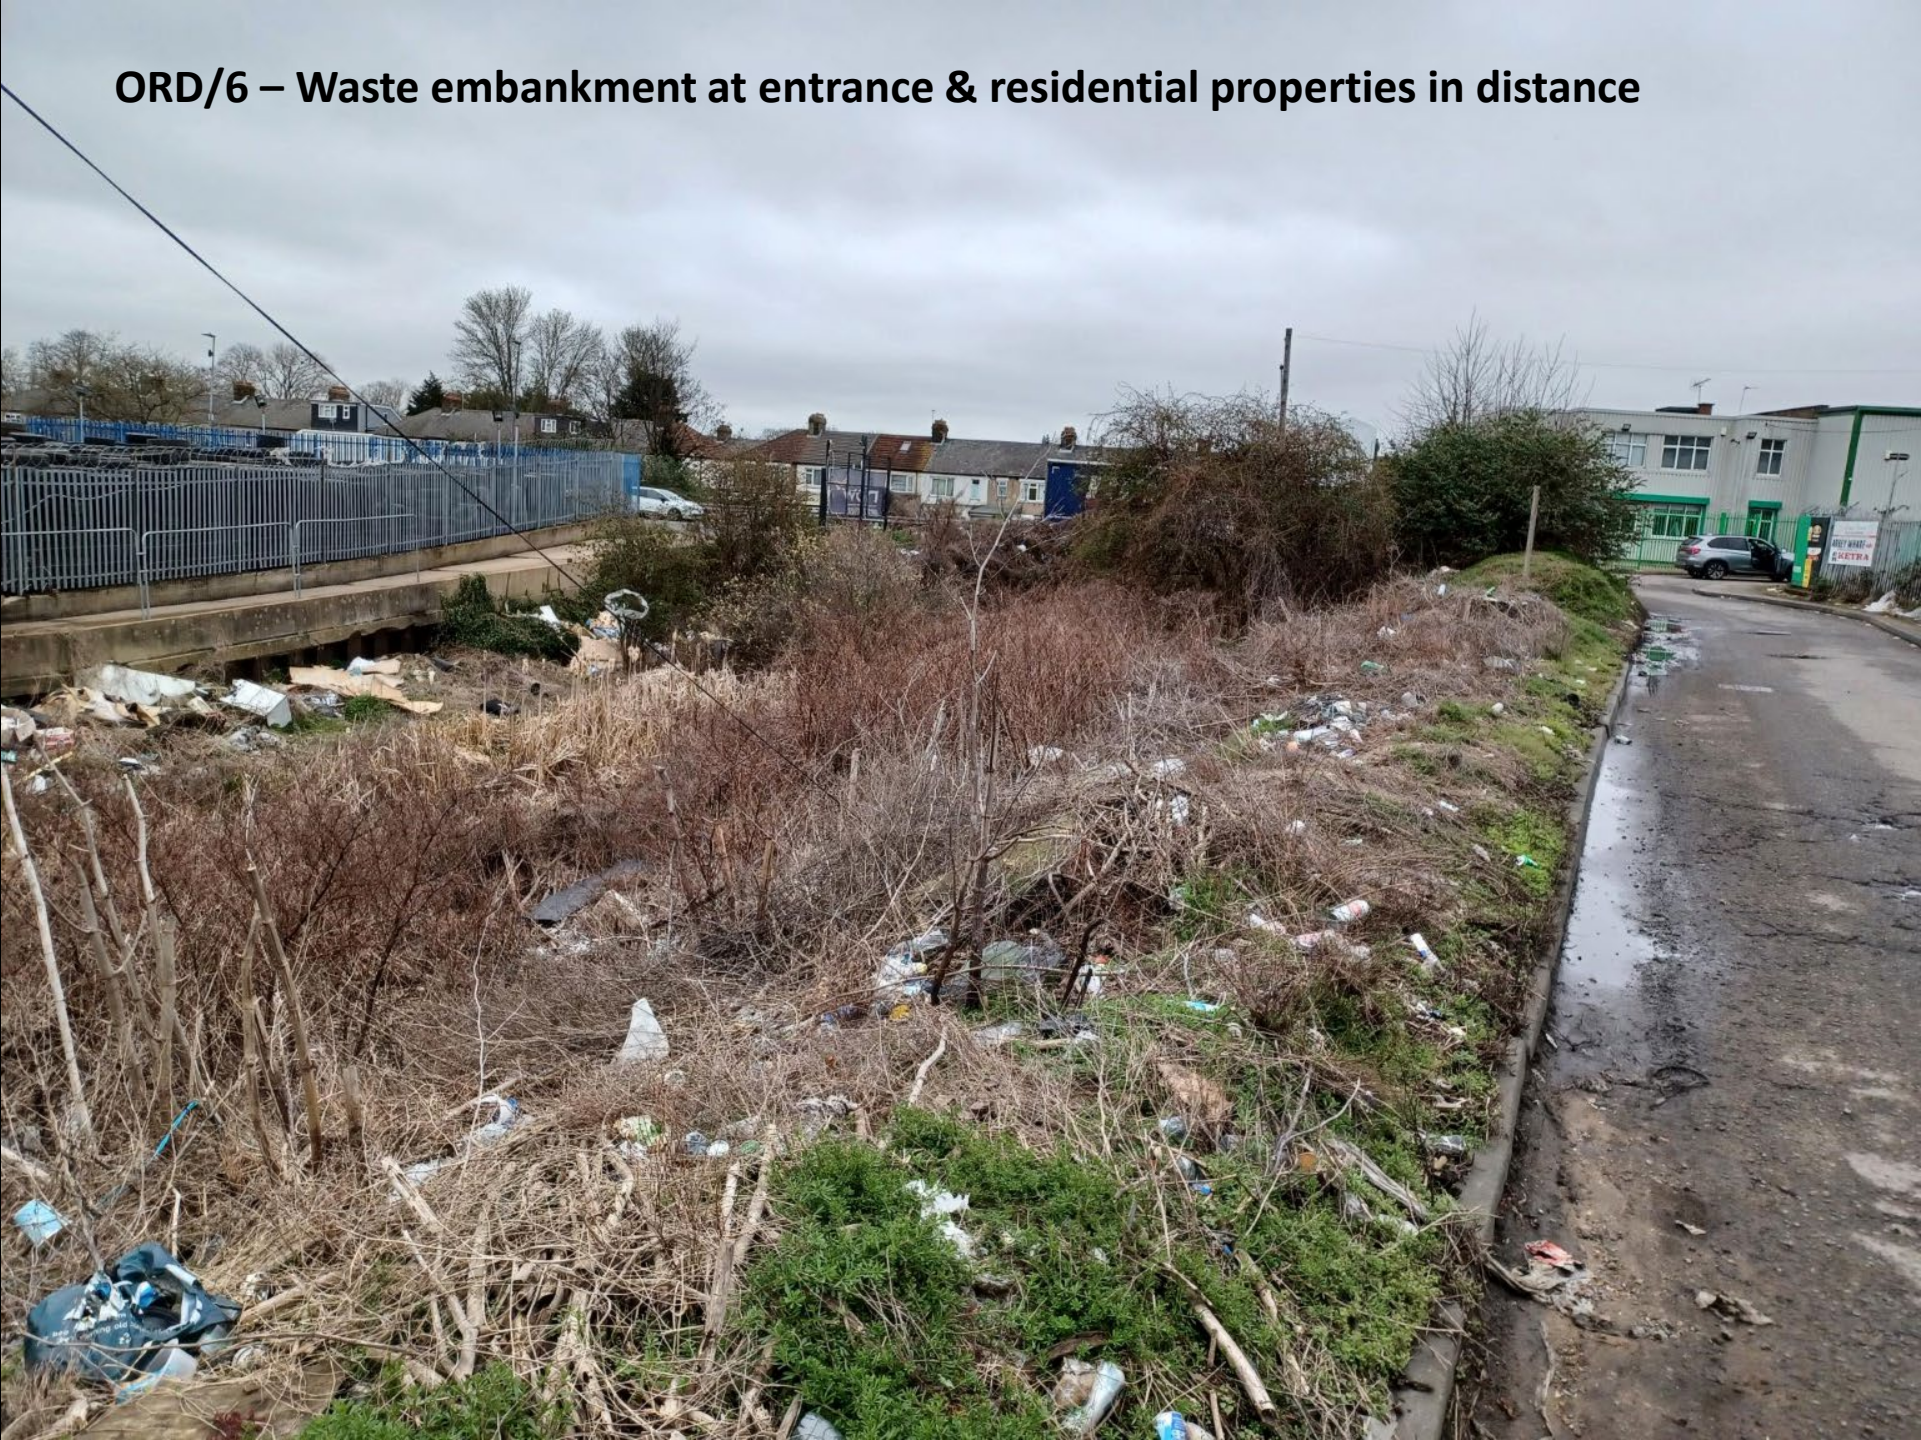
**ORD/6 – Waste embankment at entrance & residential properties in distance**

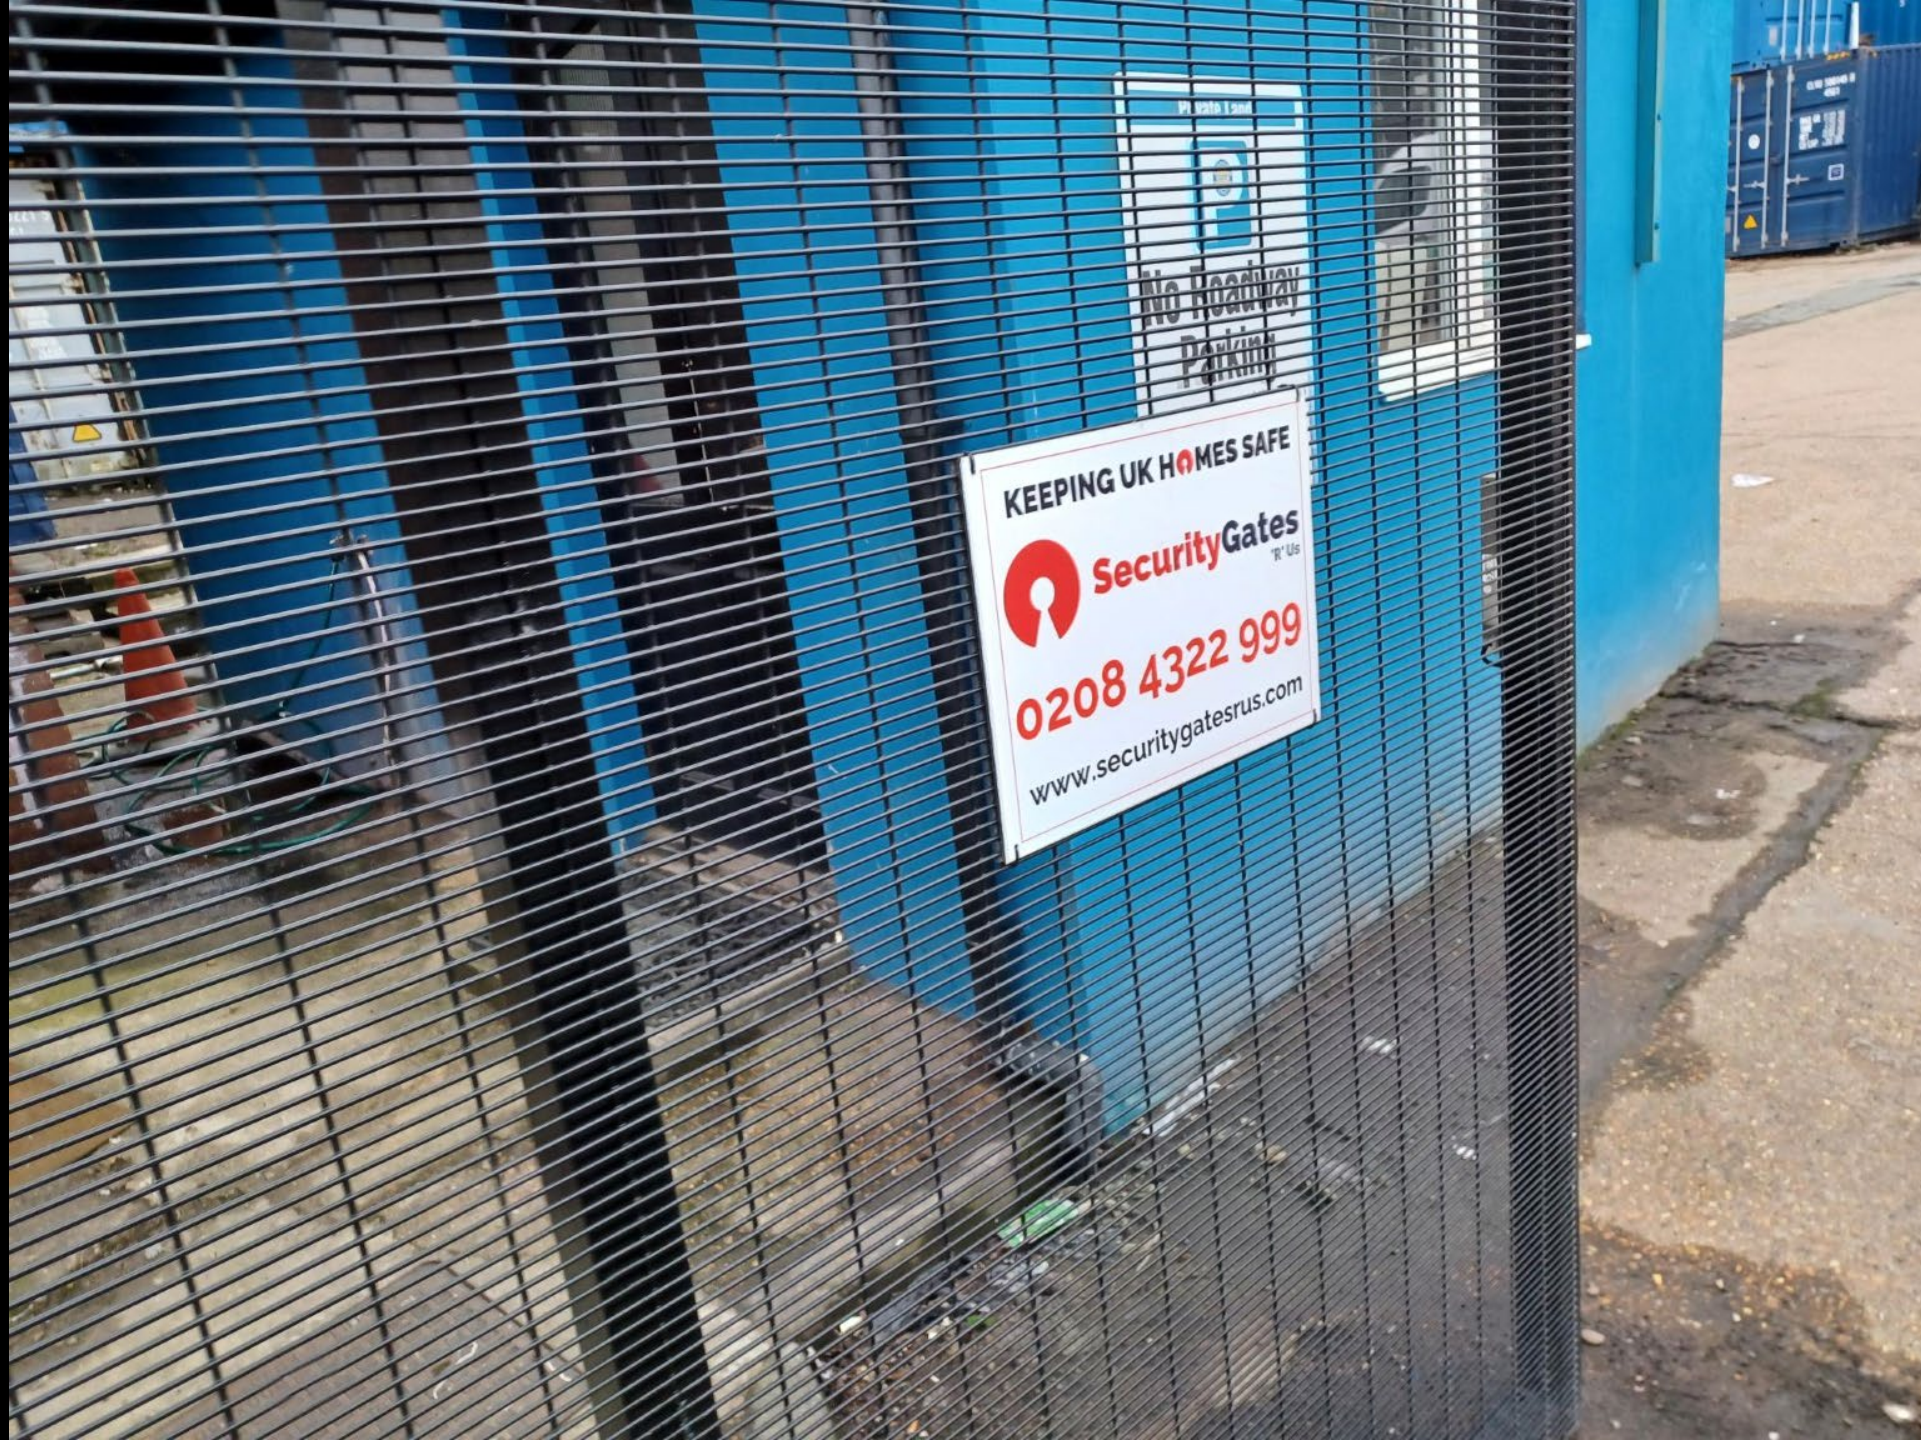
ORD/7 – Security gates which get locked

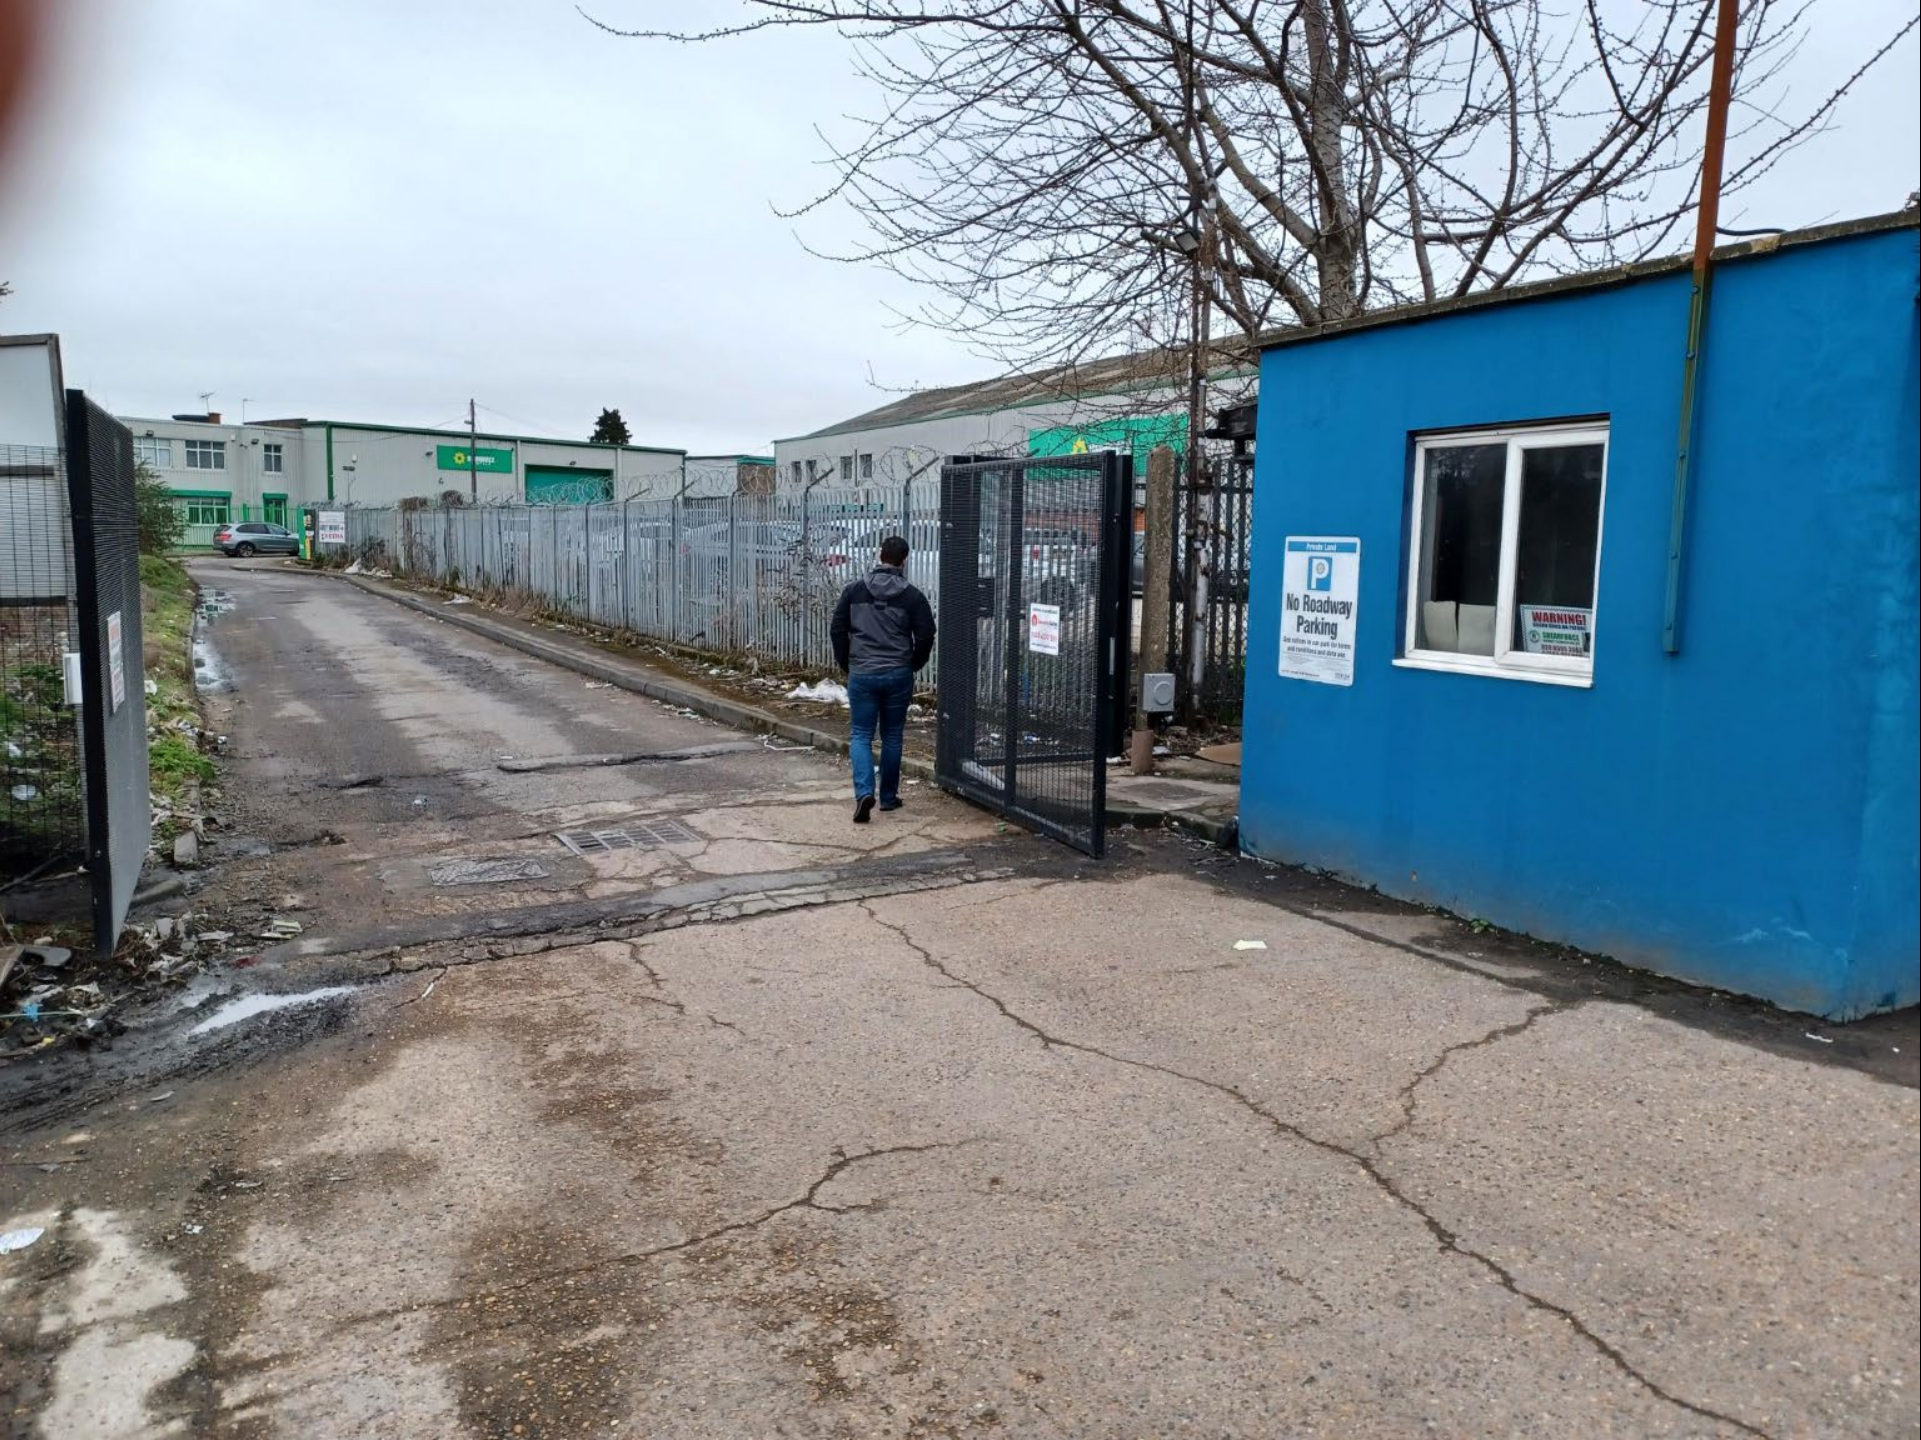
**ORD/8 – Security gates which were unstaffed and apparently get locked.**

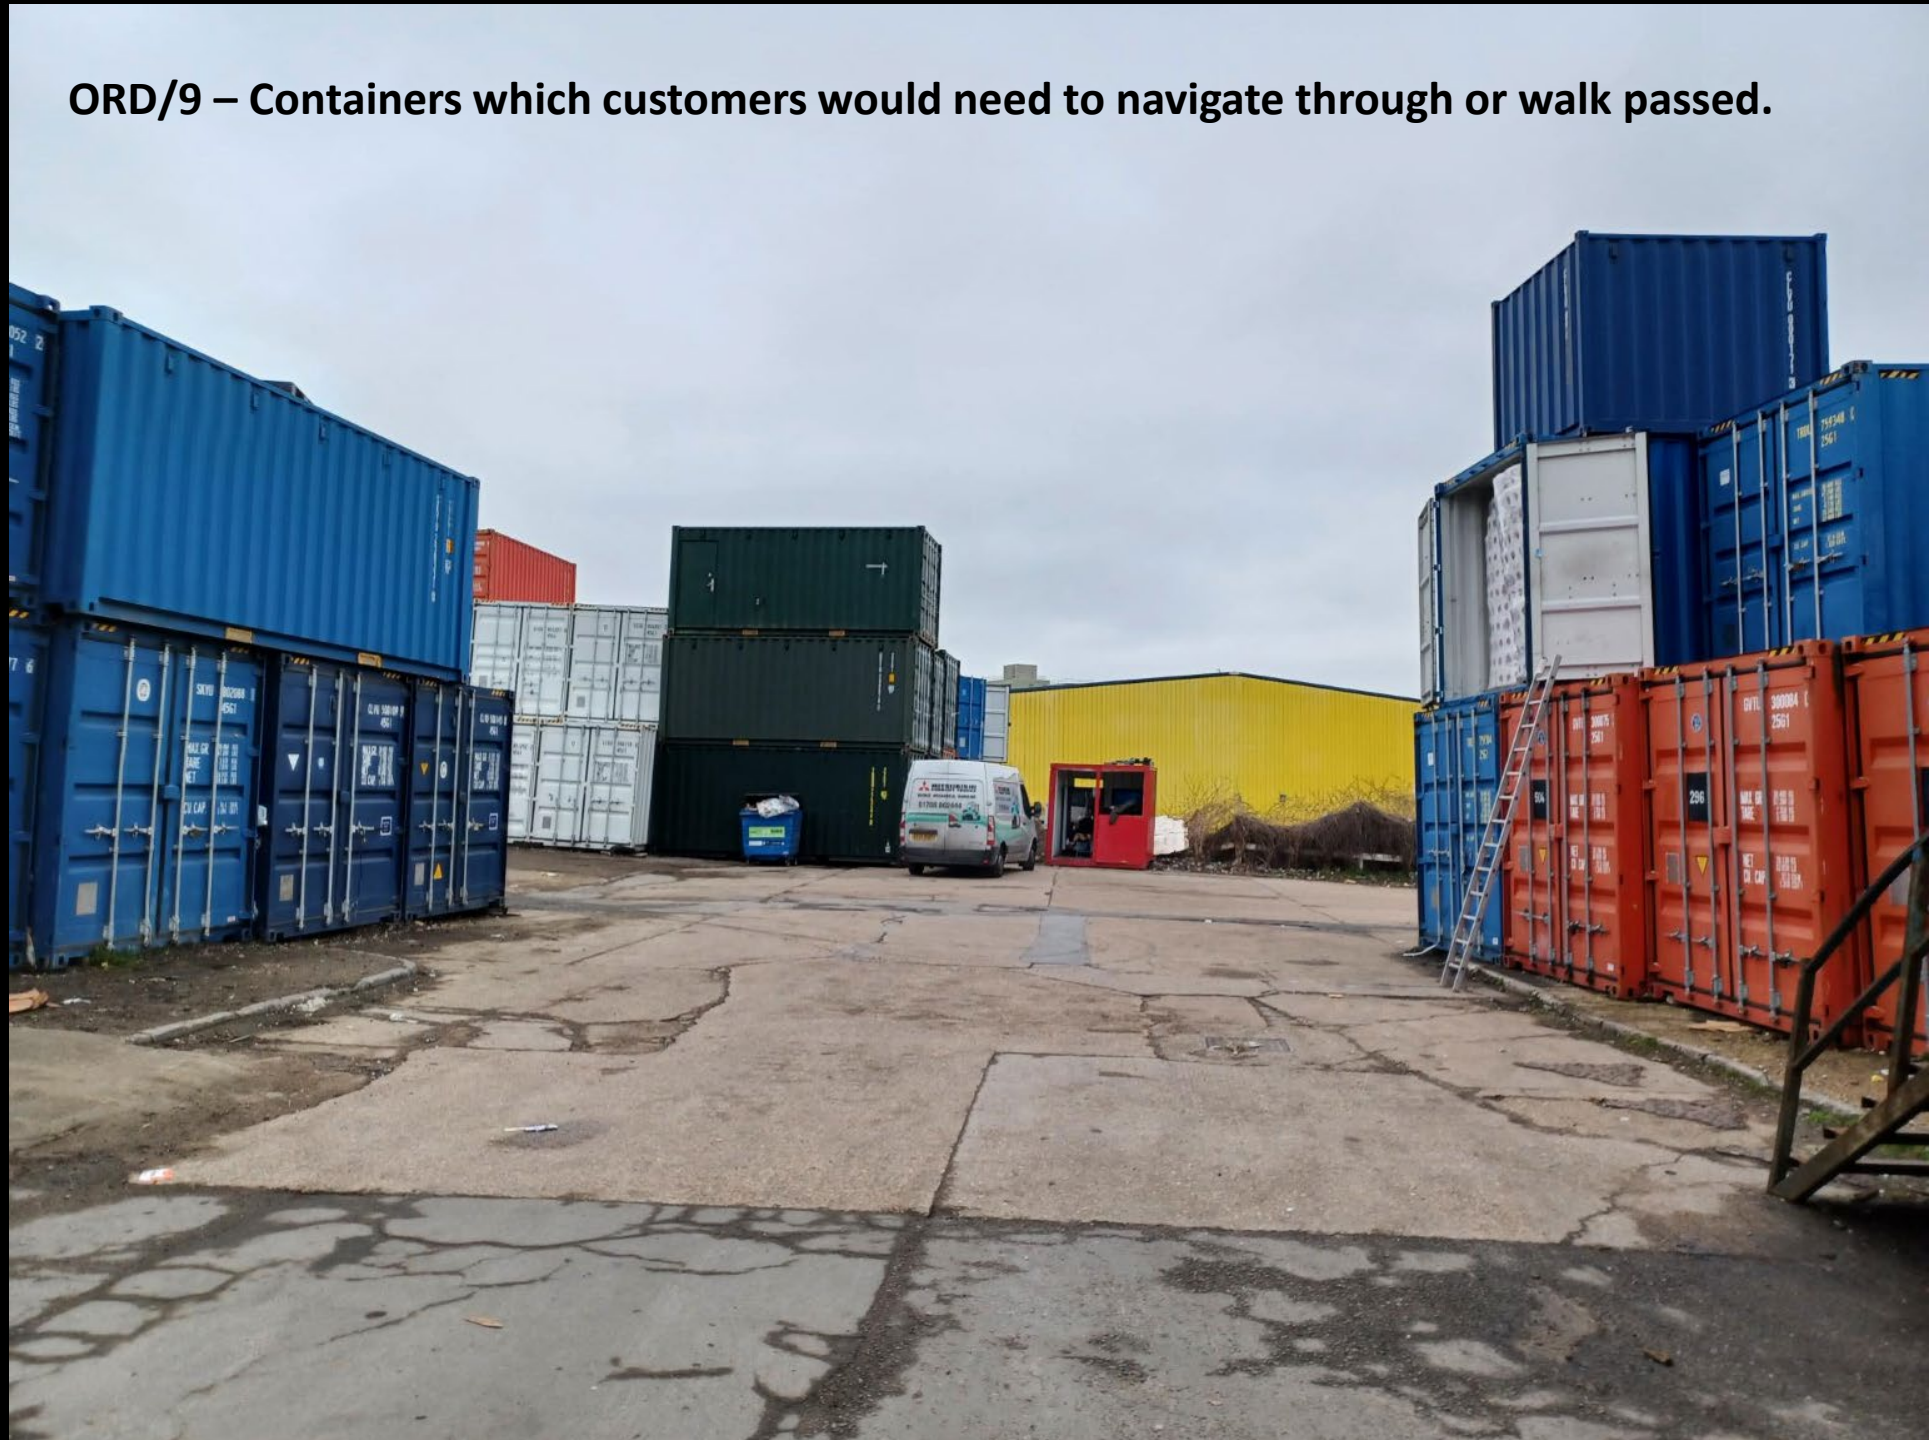
**ORD/9 – Containers which customers would need to navigate through or walk passed.**

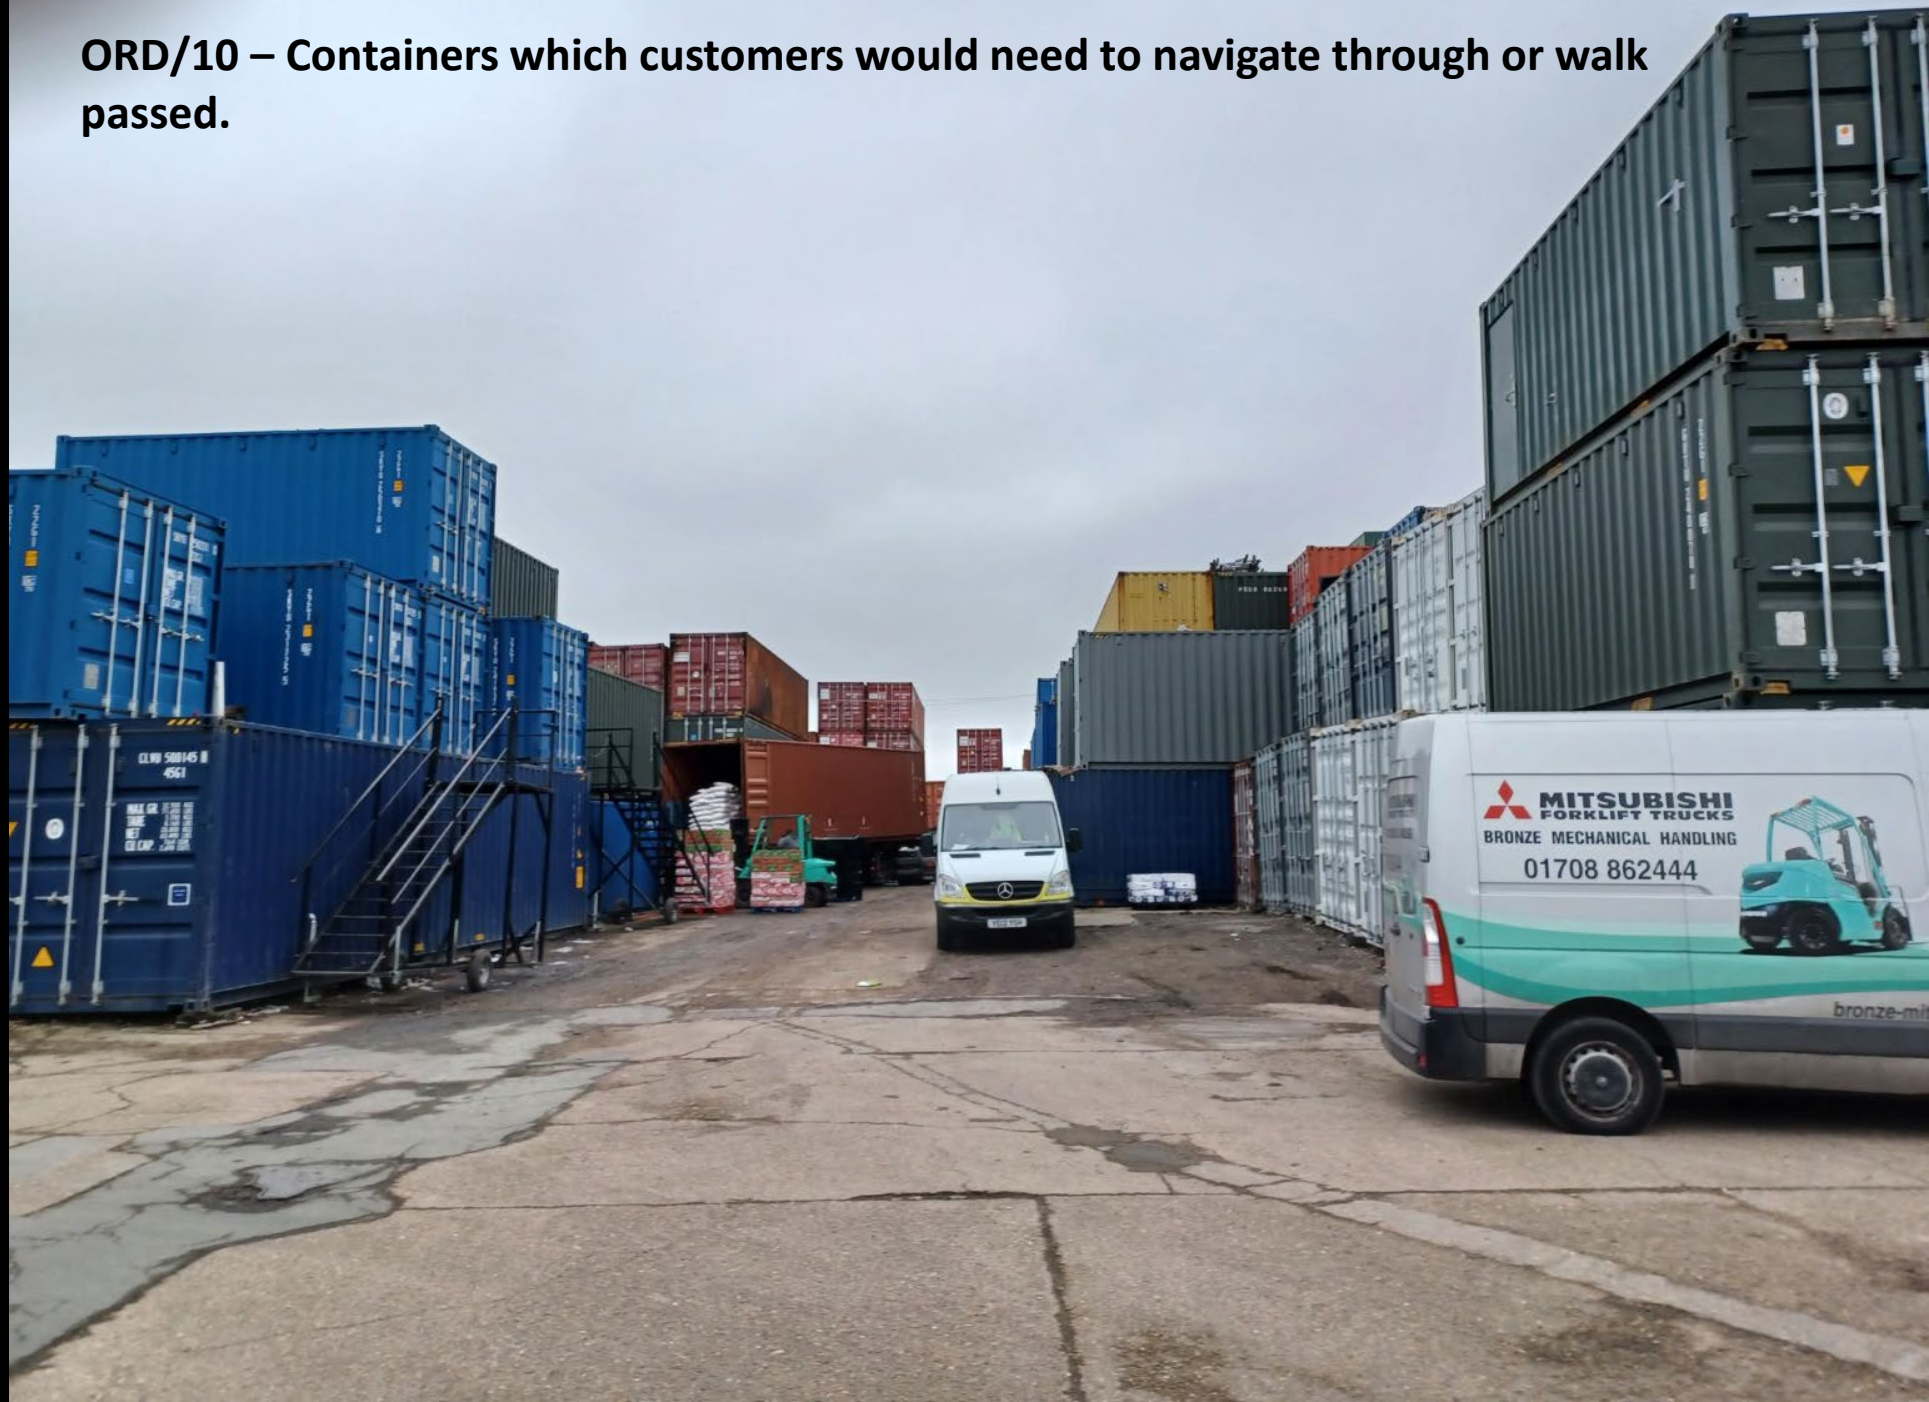
ORD/10 – Containers which customers would need to navigate through or walk passed.
