# Photo Exhibits Album

by Dunn Owen R - EA-CU

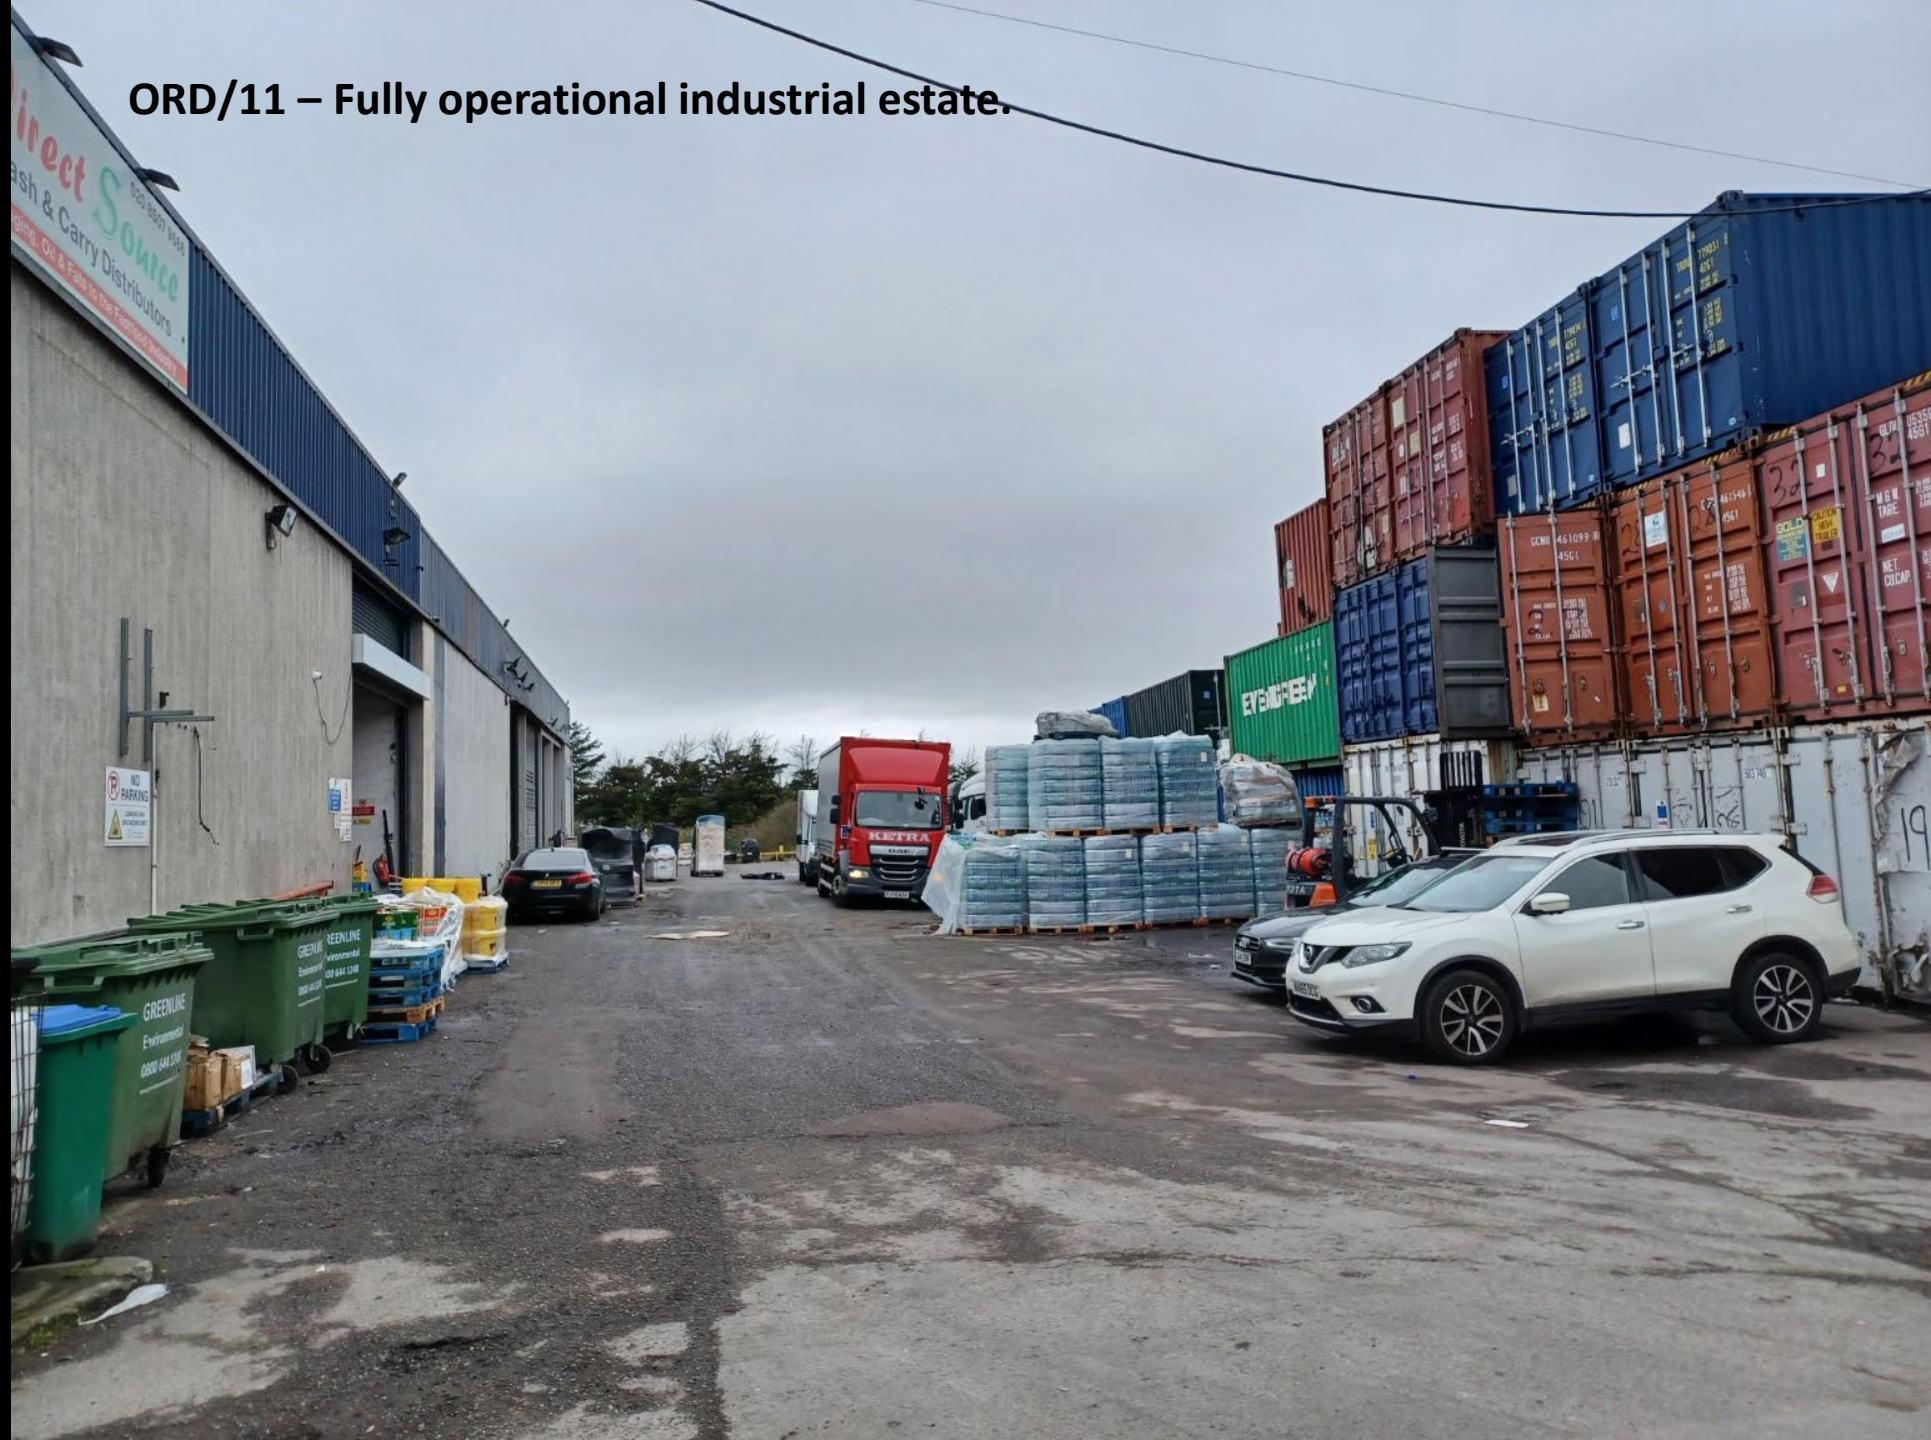
ORD/11 – Fully operational industrial estate.

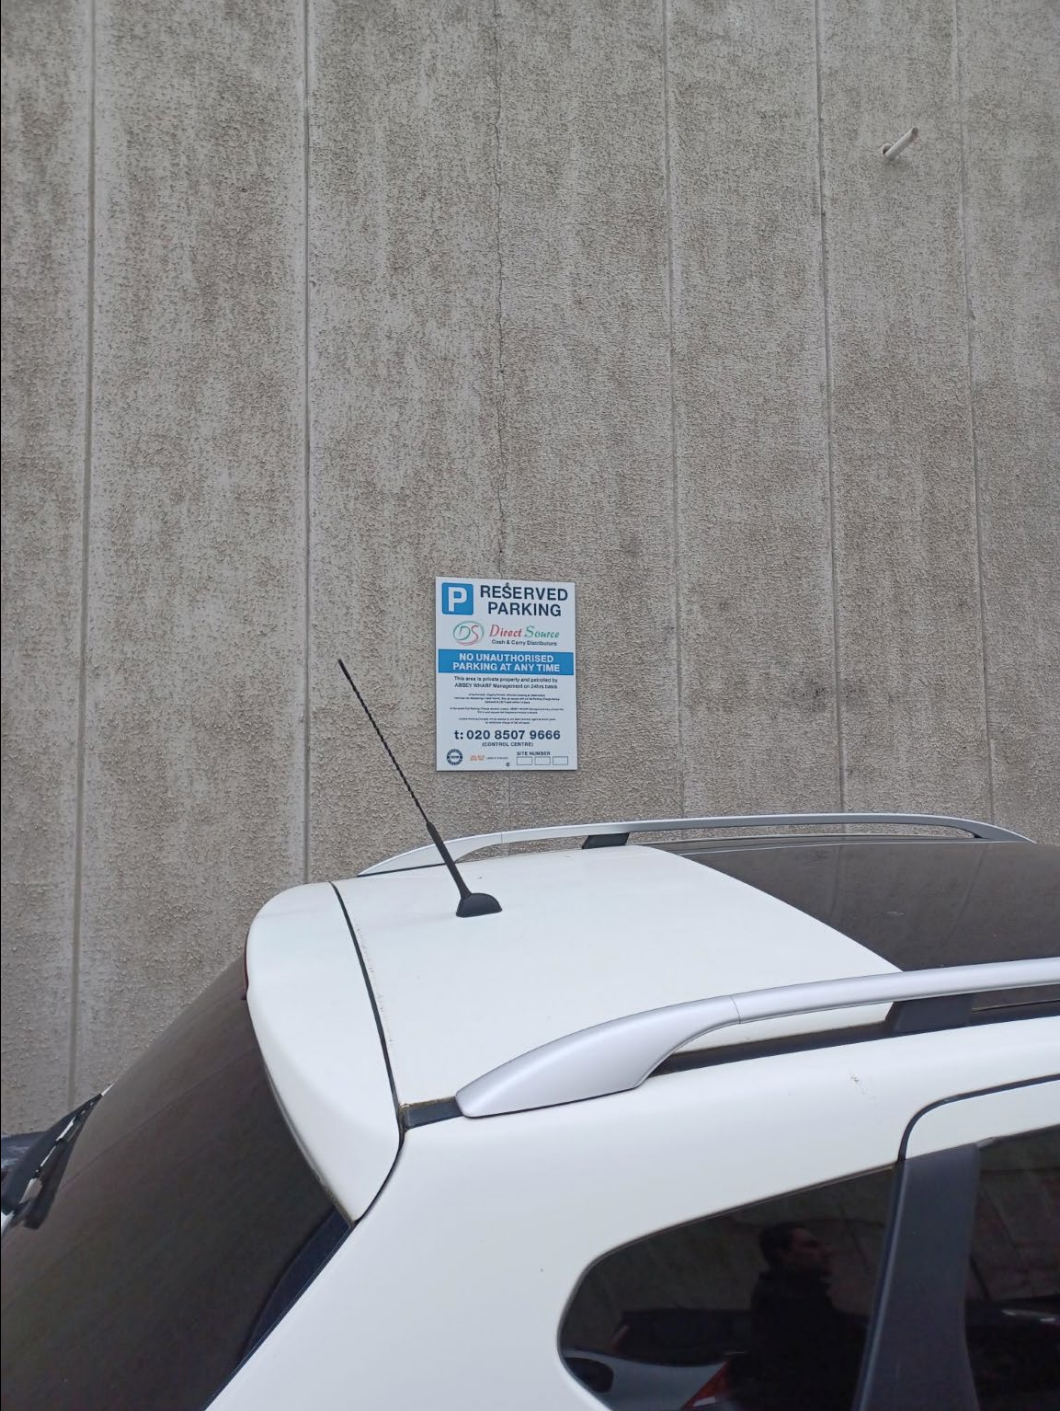
**ORD/12 – Reserved parking for the Active companies, which could Become effected.**

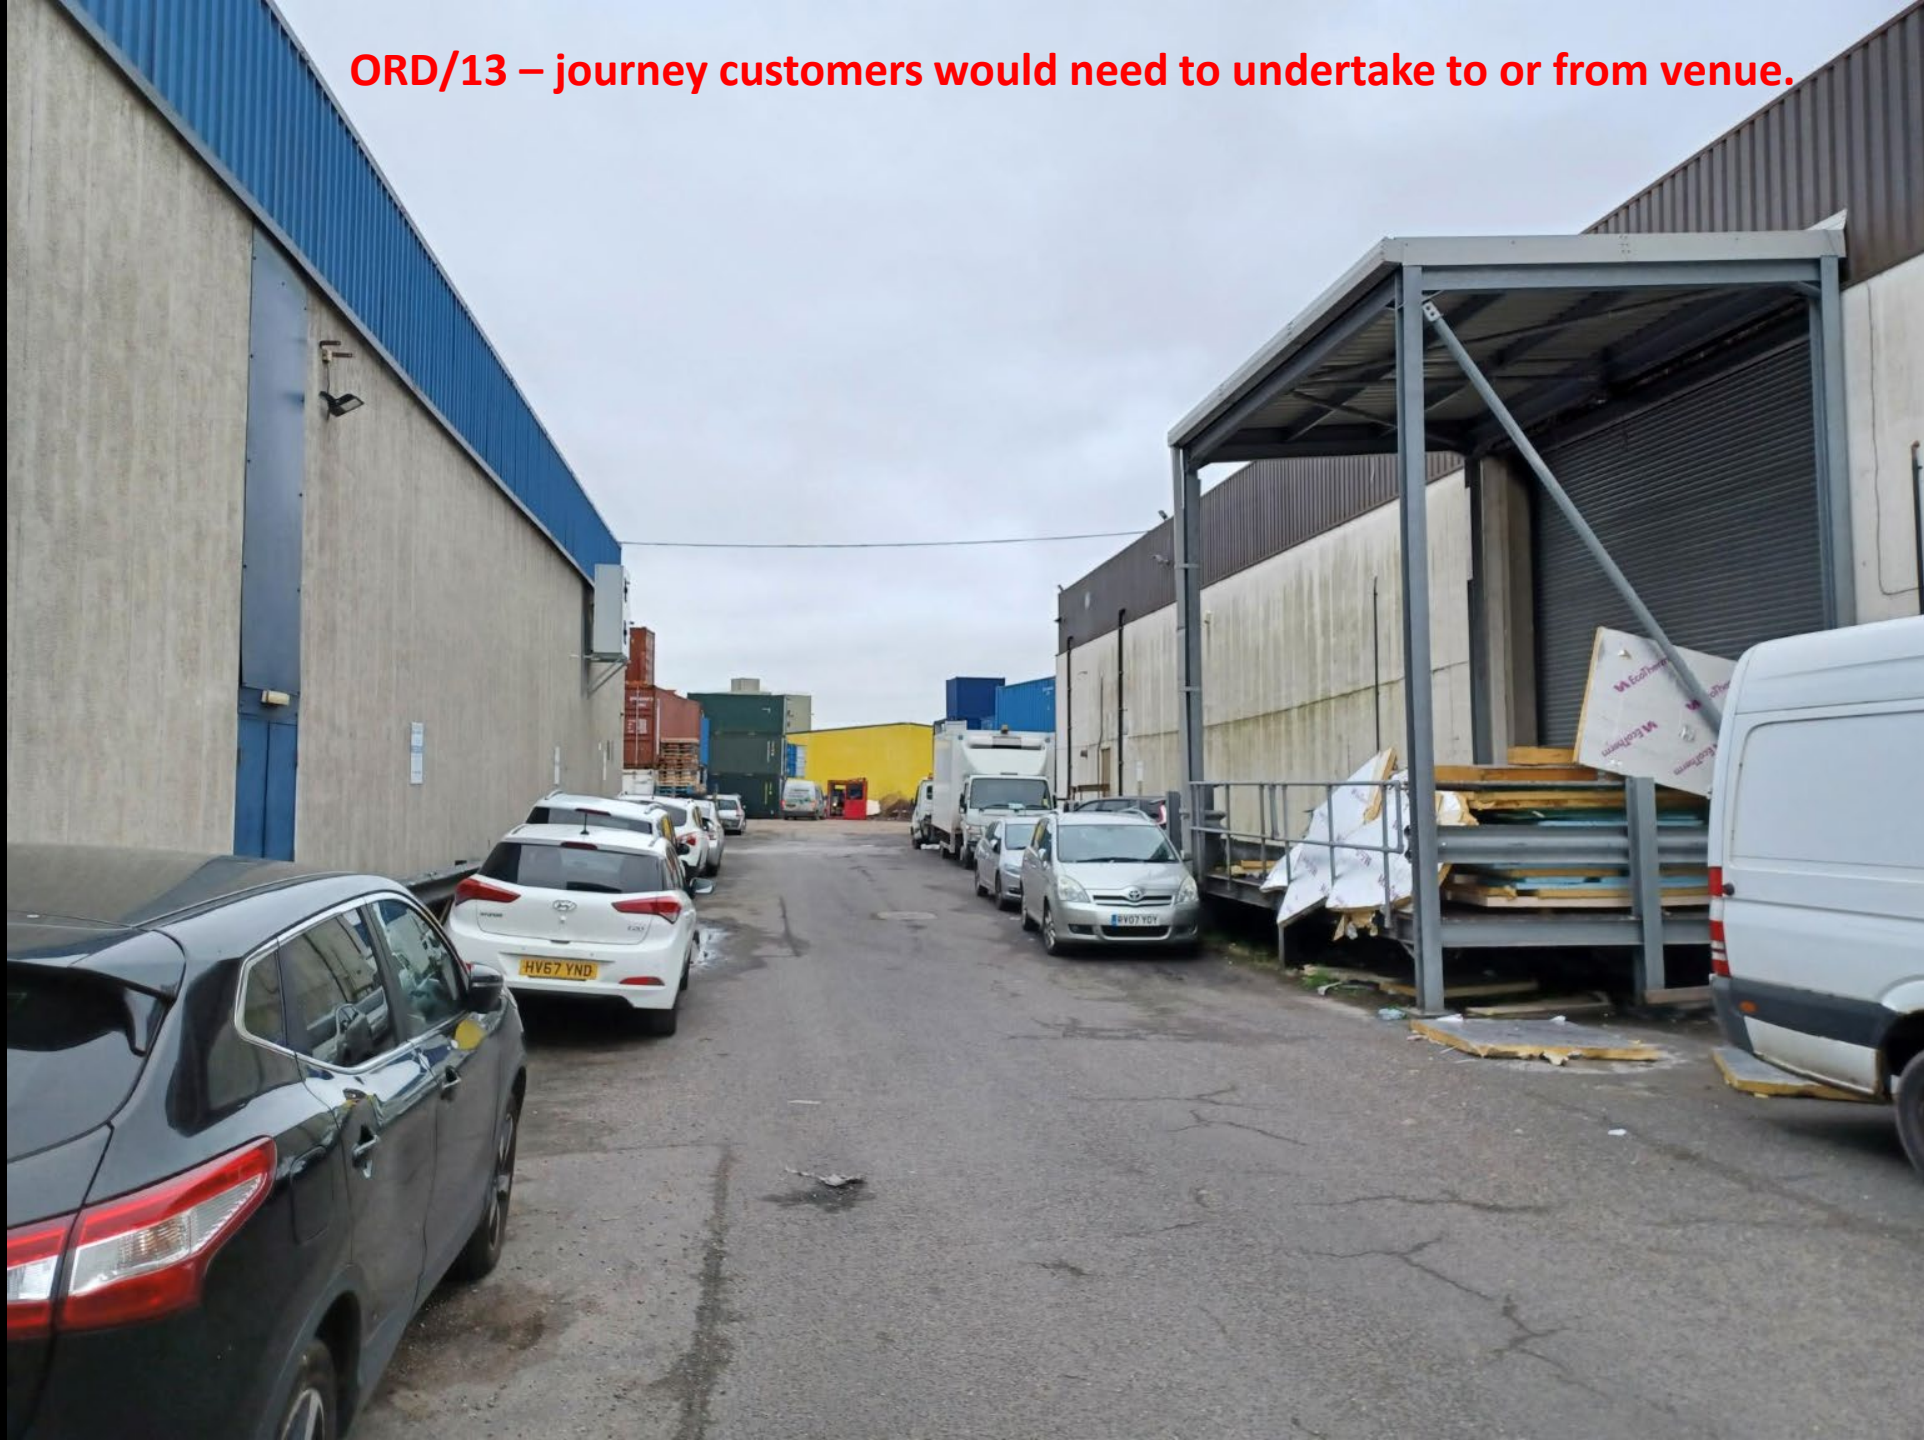
**ORD/13 – journey customers would need to undertake to or from venue.**

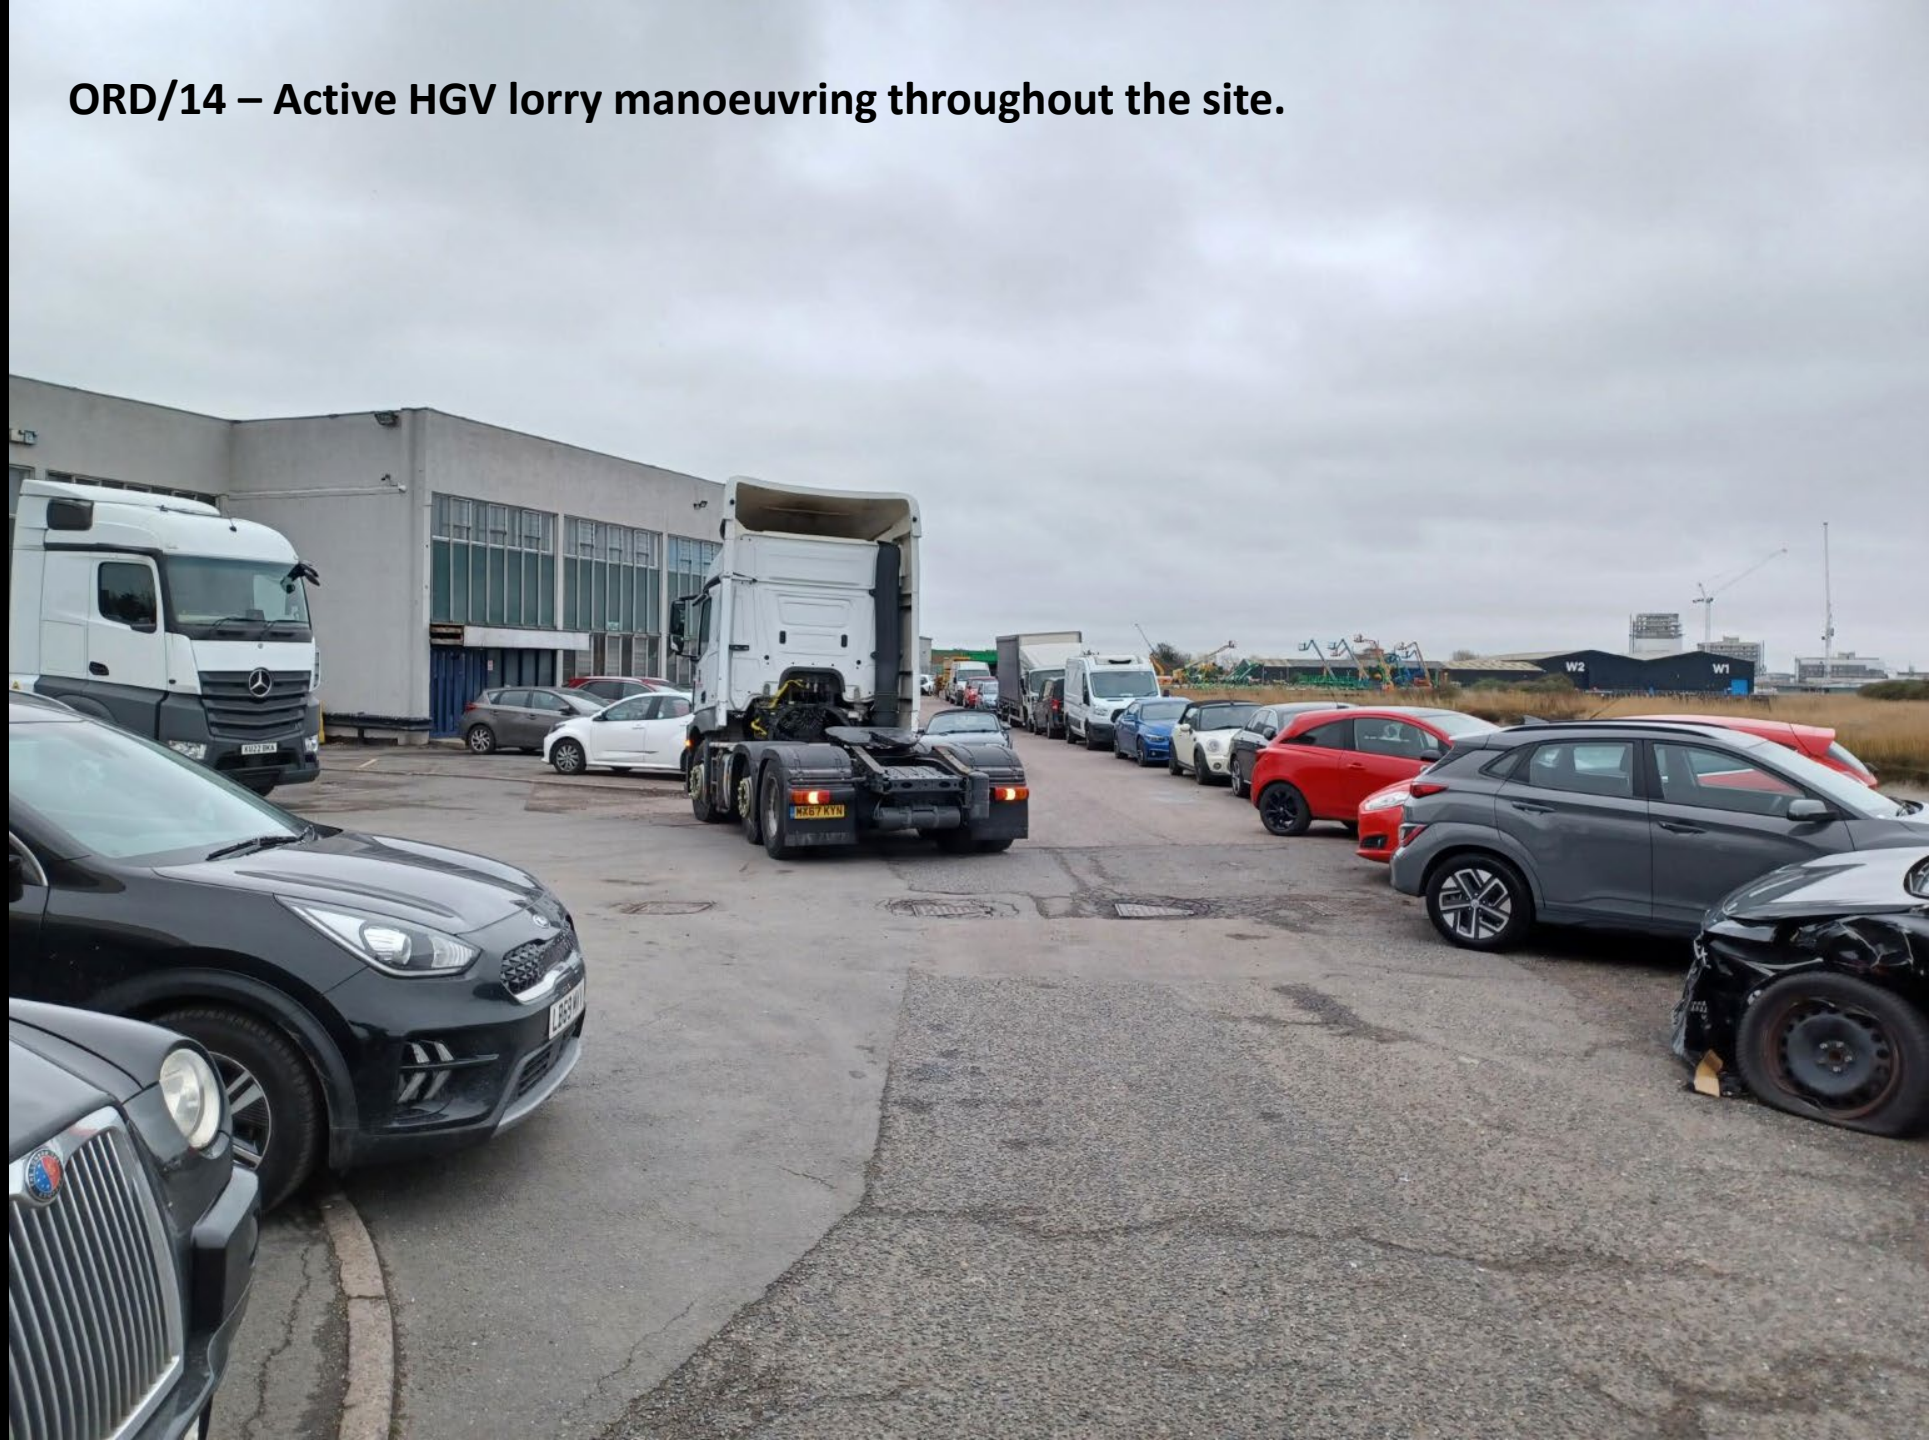
**ORD/14 – Active HGV lorry manoeuvring throughout the site.**

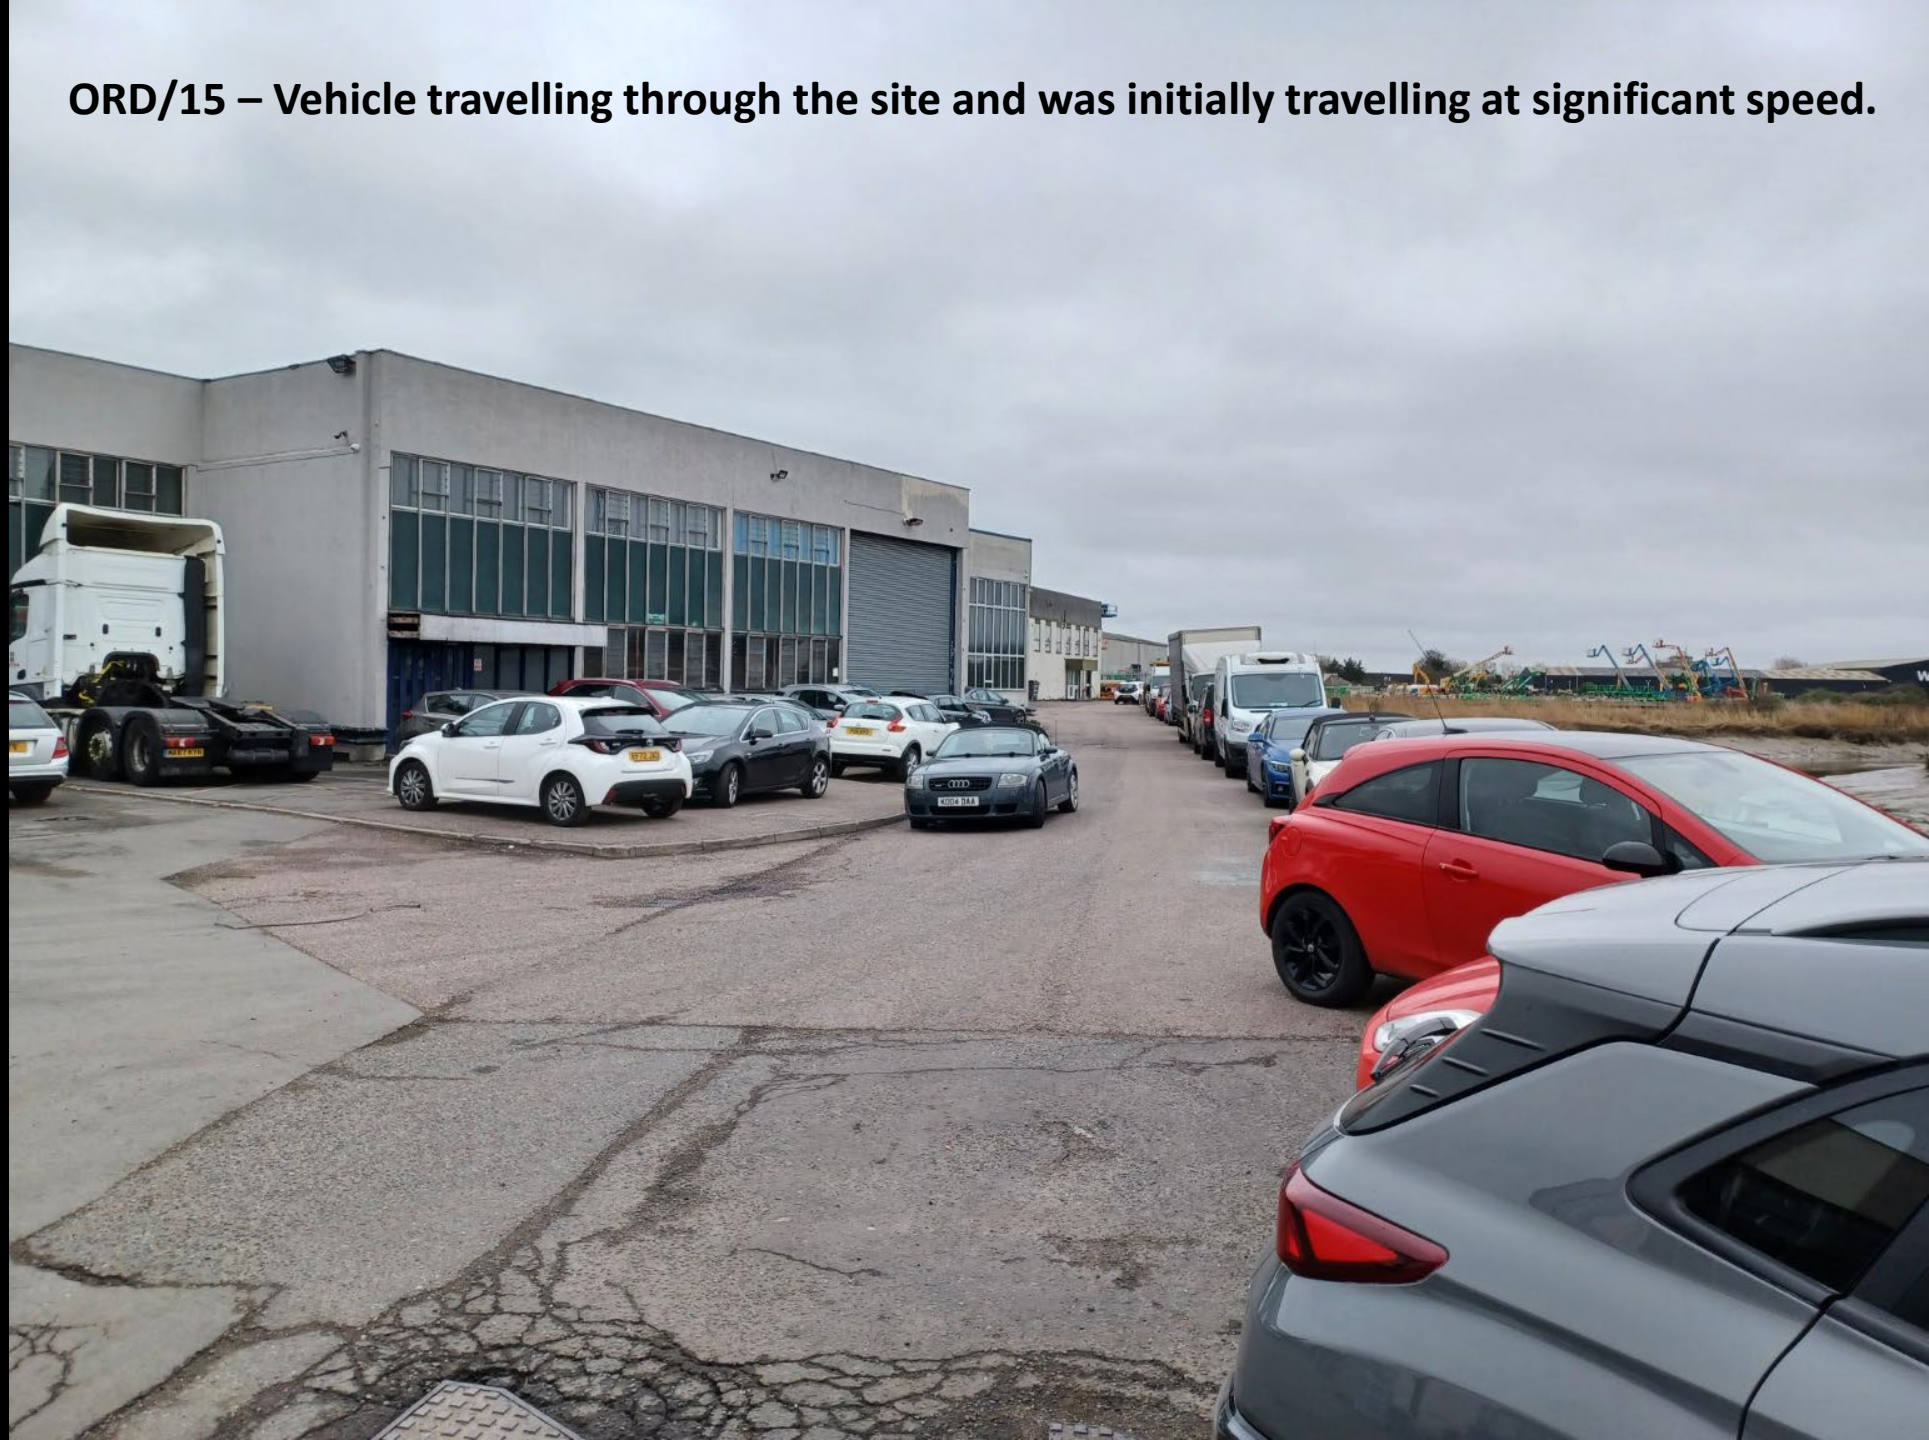
**ORD/15 – Vehicle travelling through the site and was initially travelling at significant speed.**

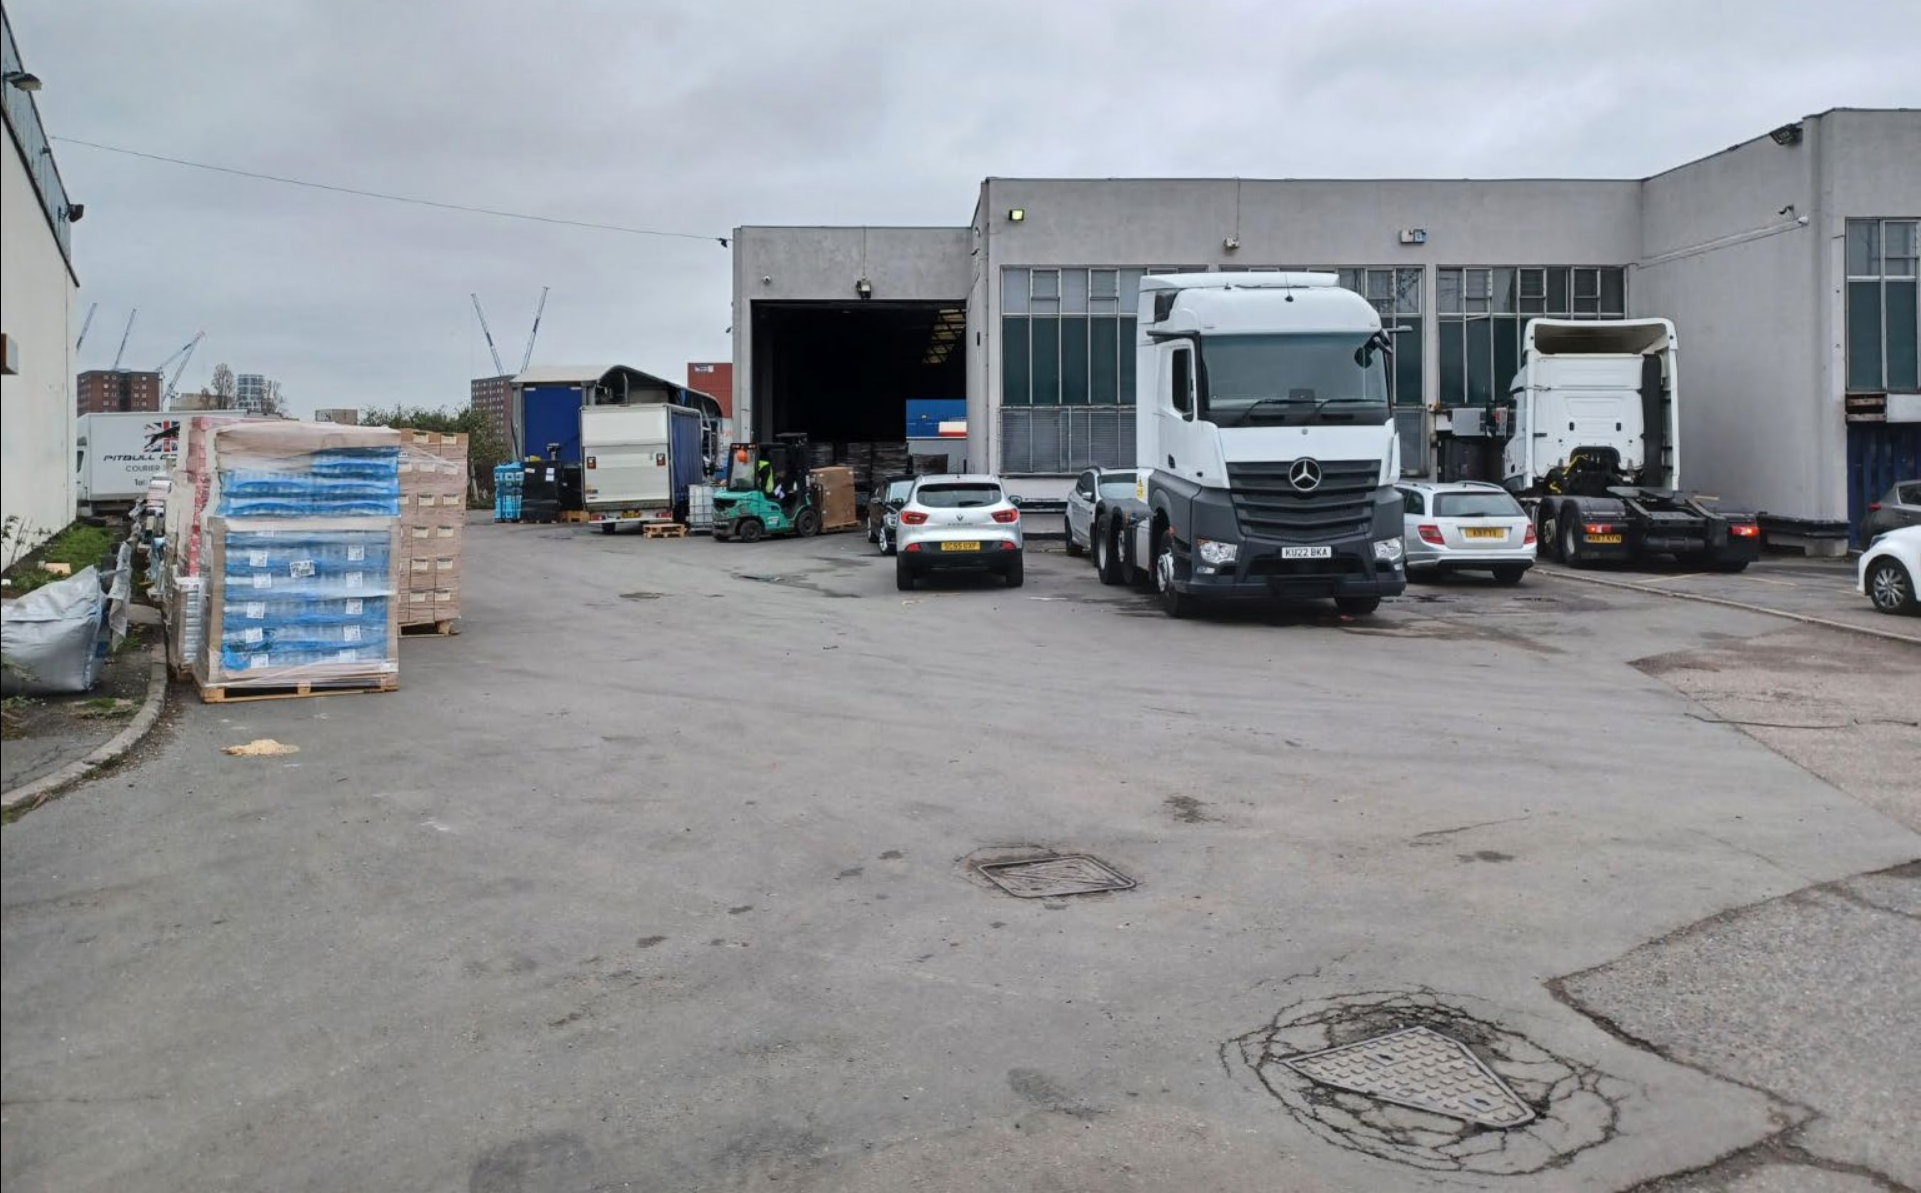
**ORD/16 – Active businesses in operation next to applicants unit with various HGVs and Fork lift vehicles.**

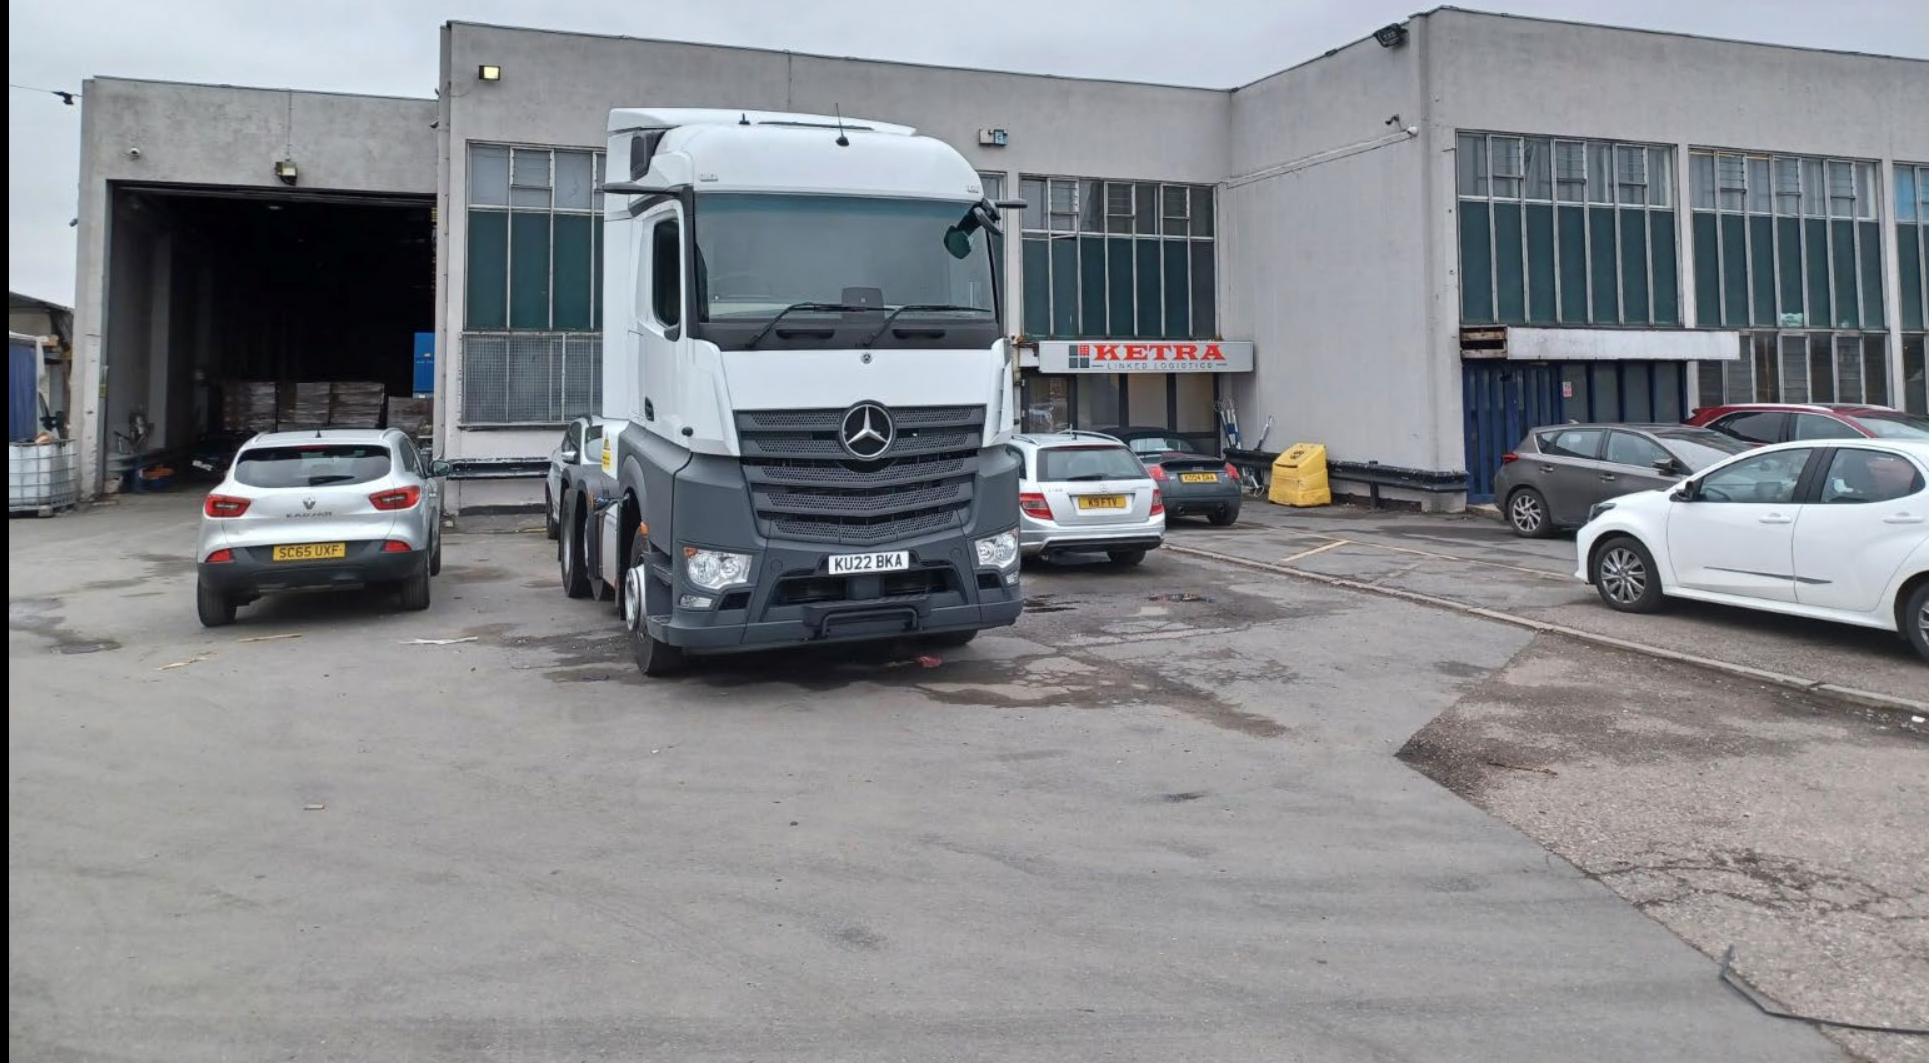
ORD/17 – Business which runs a 24 hour operation.

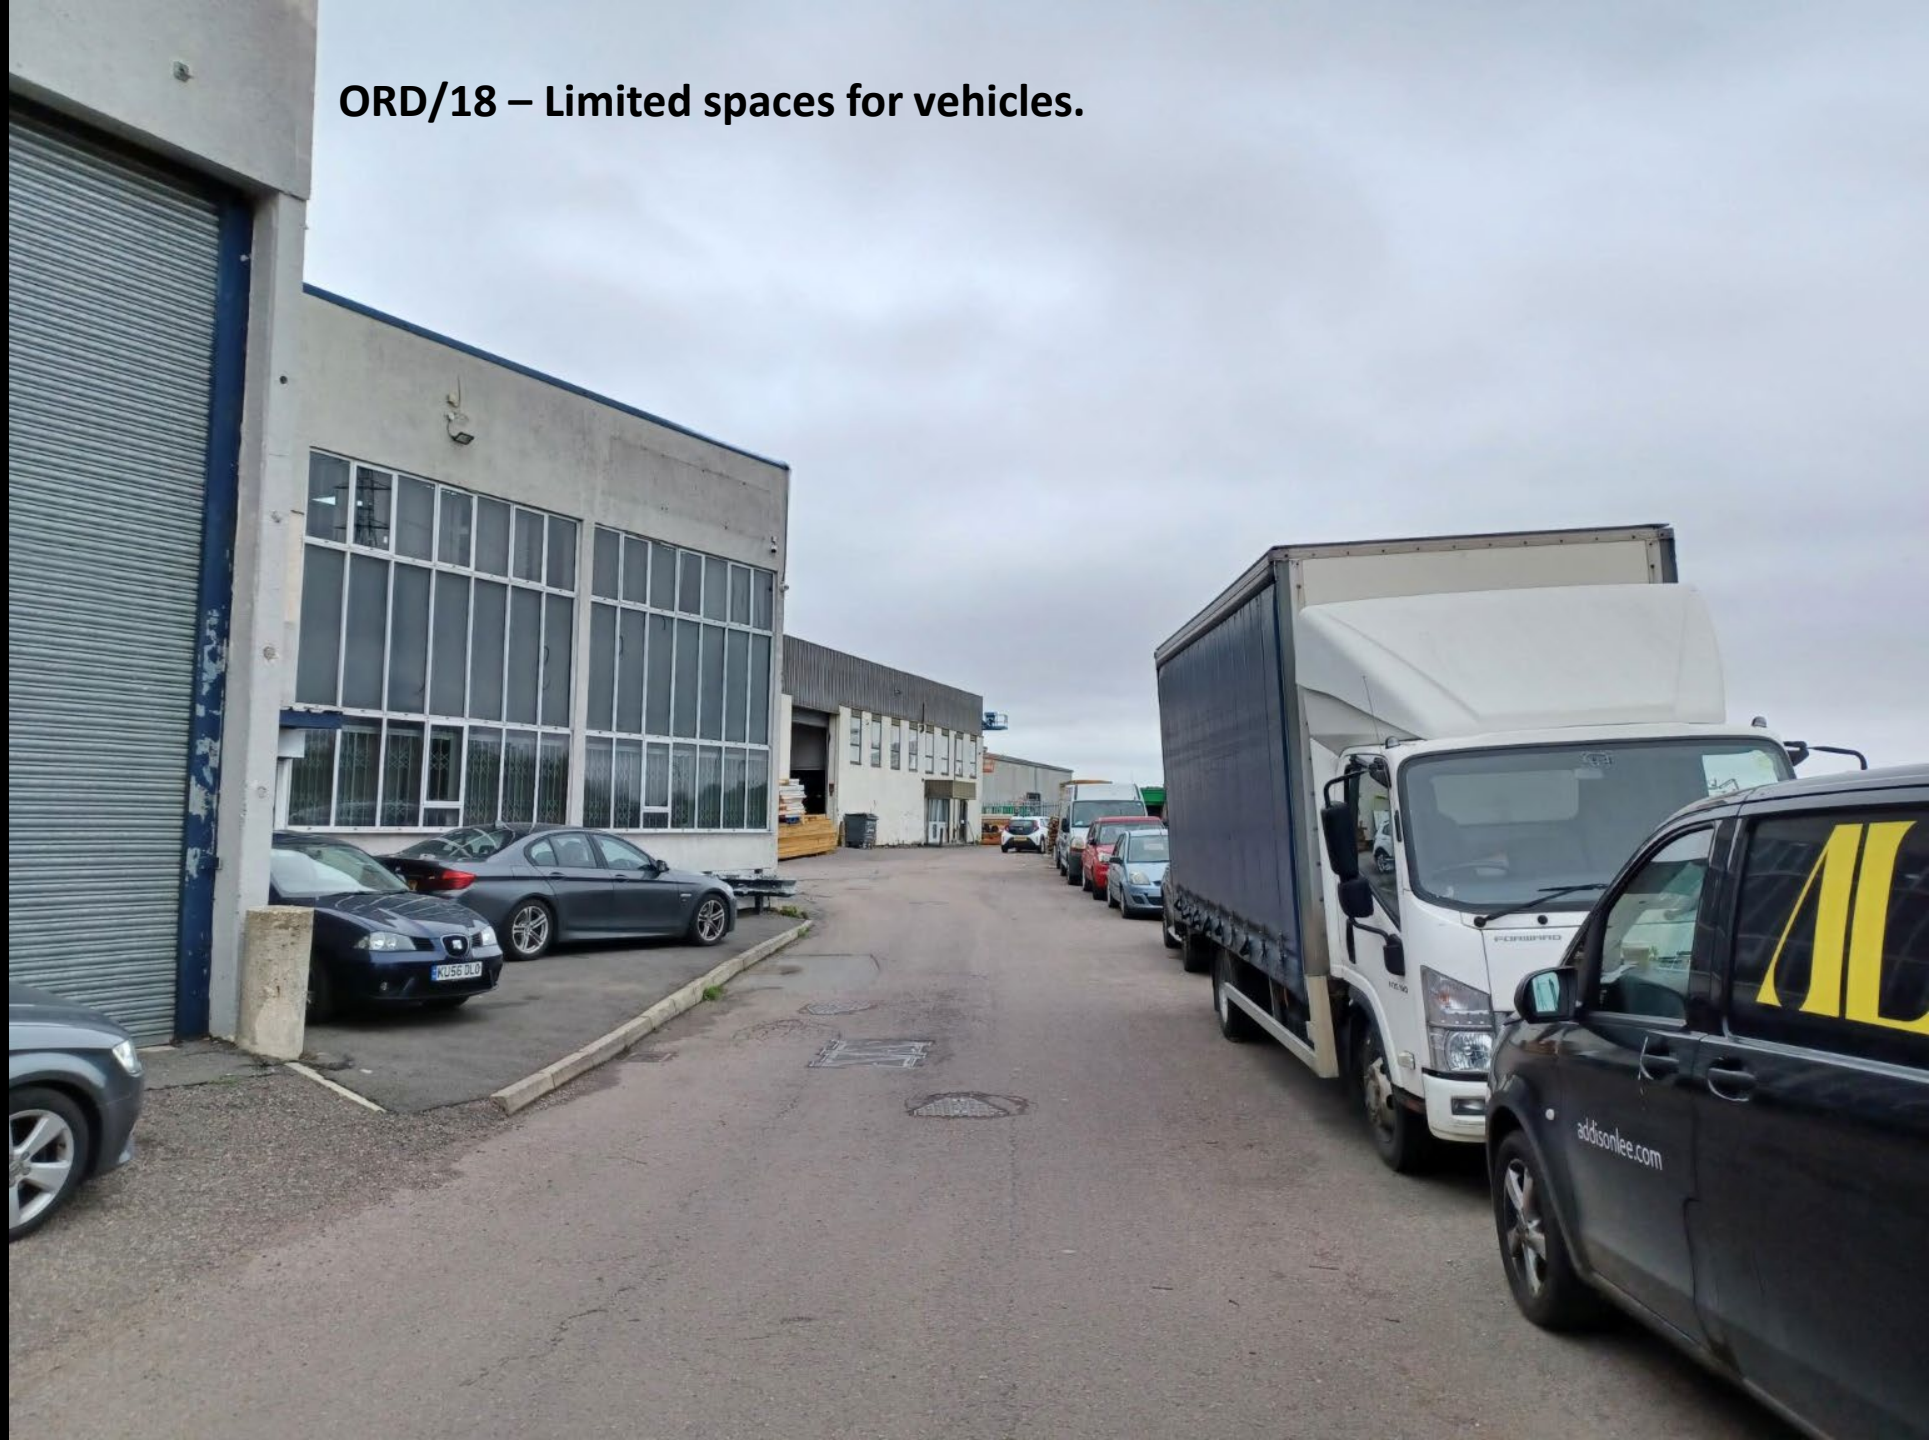
ORD/18 – Limited spaces for vehicles.

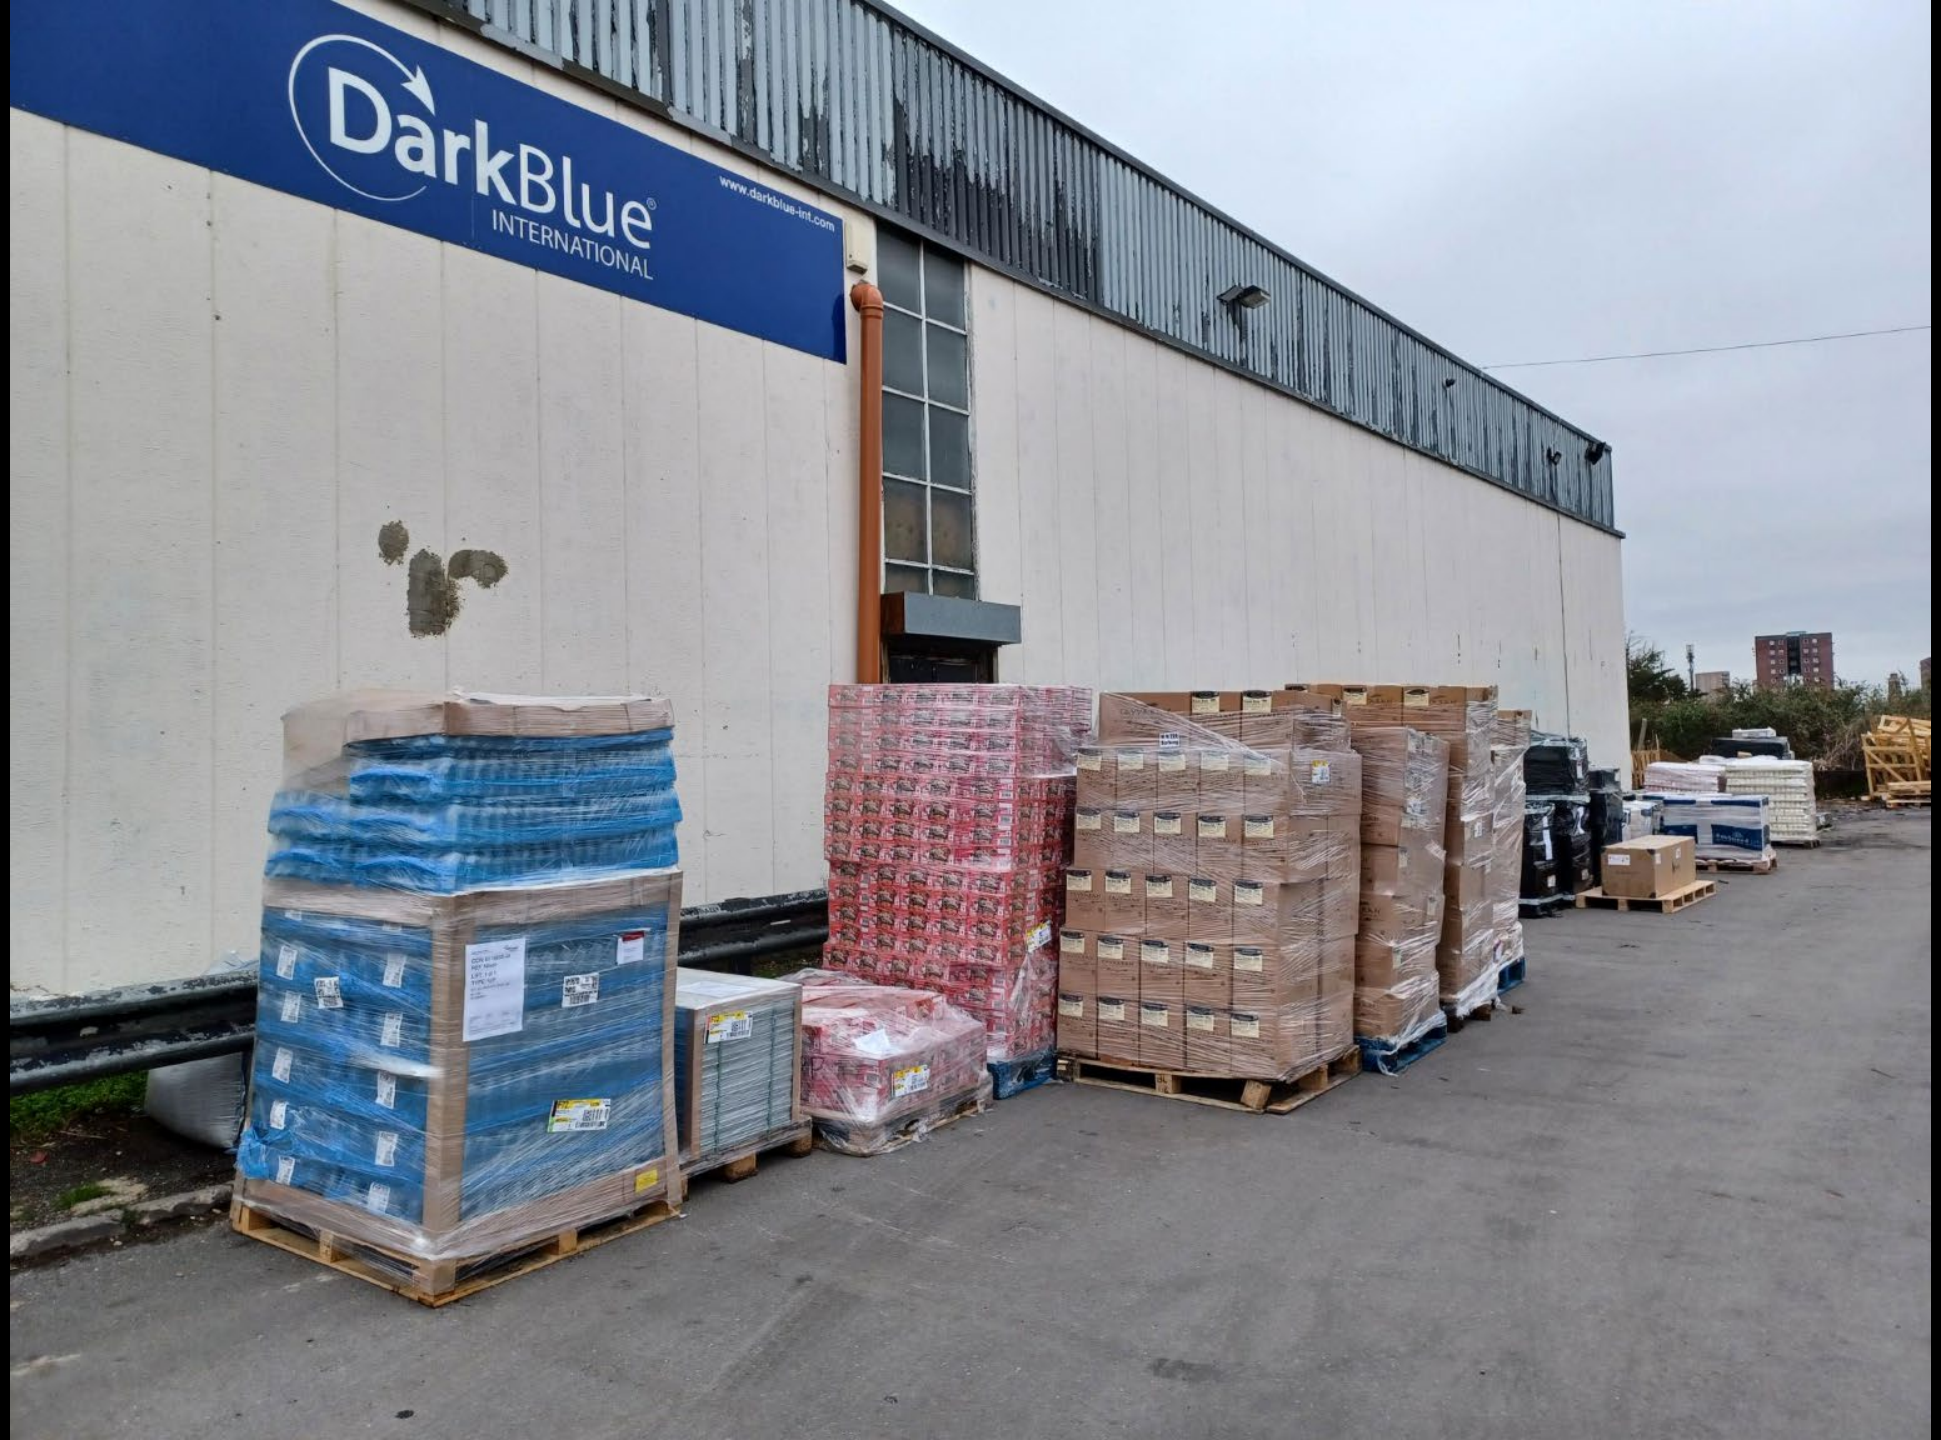
**ORD/19 – Apparent  
entrance / exit blocked  
by pallets from  
businesses (possible  
fire exit)**
