# Photo Exhibits Album

by Dunn Owen R - EA-CU

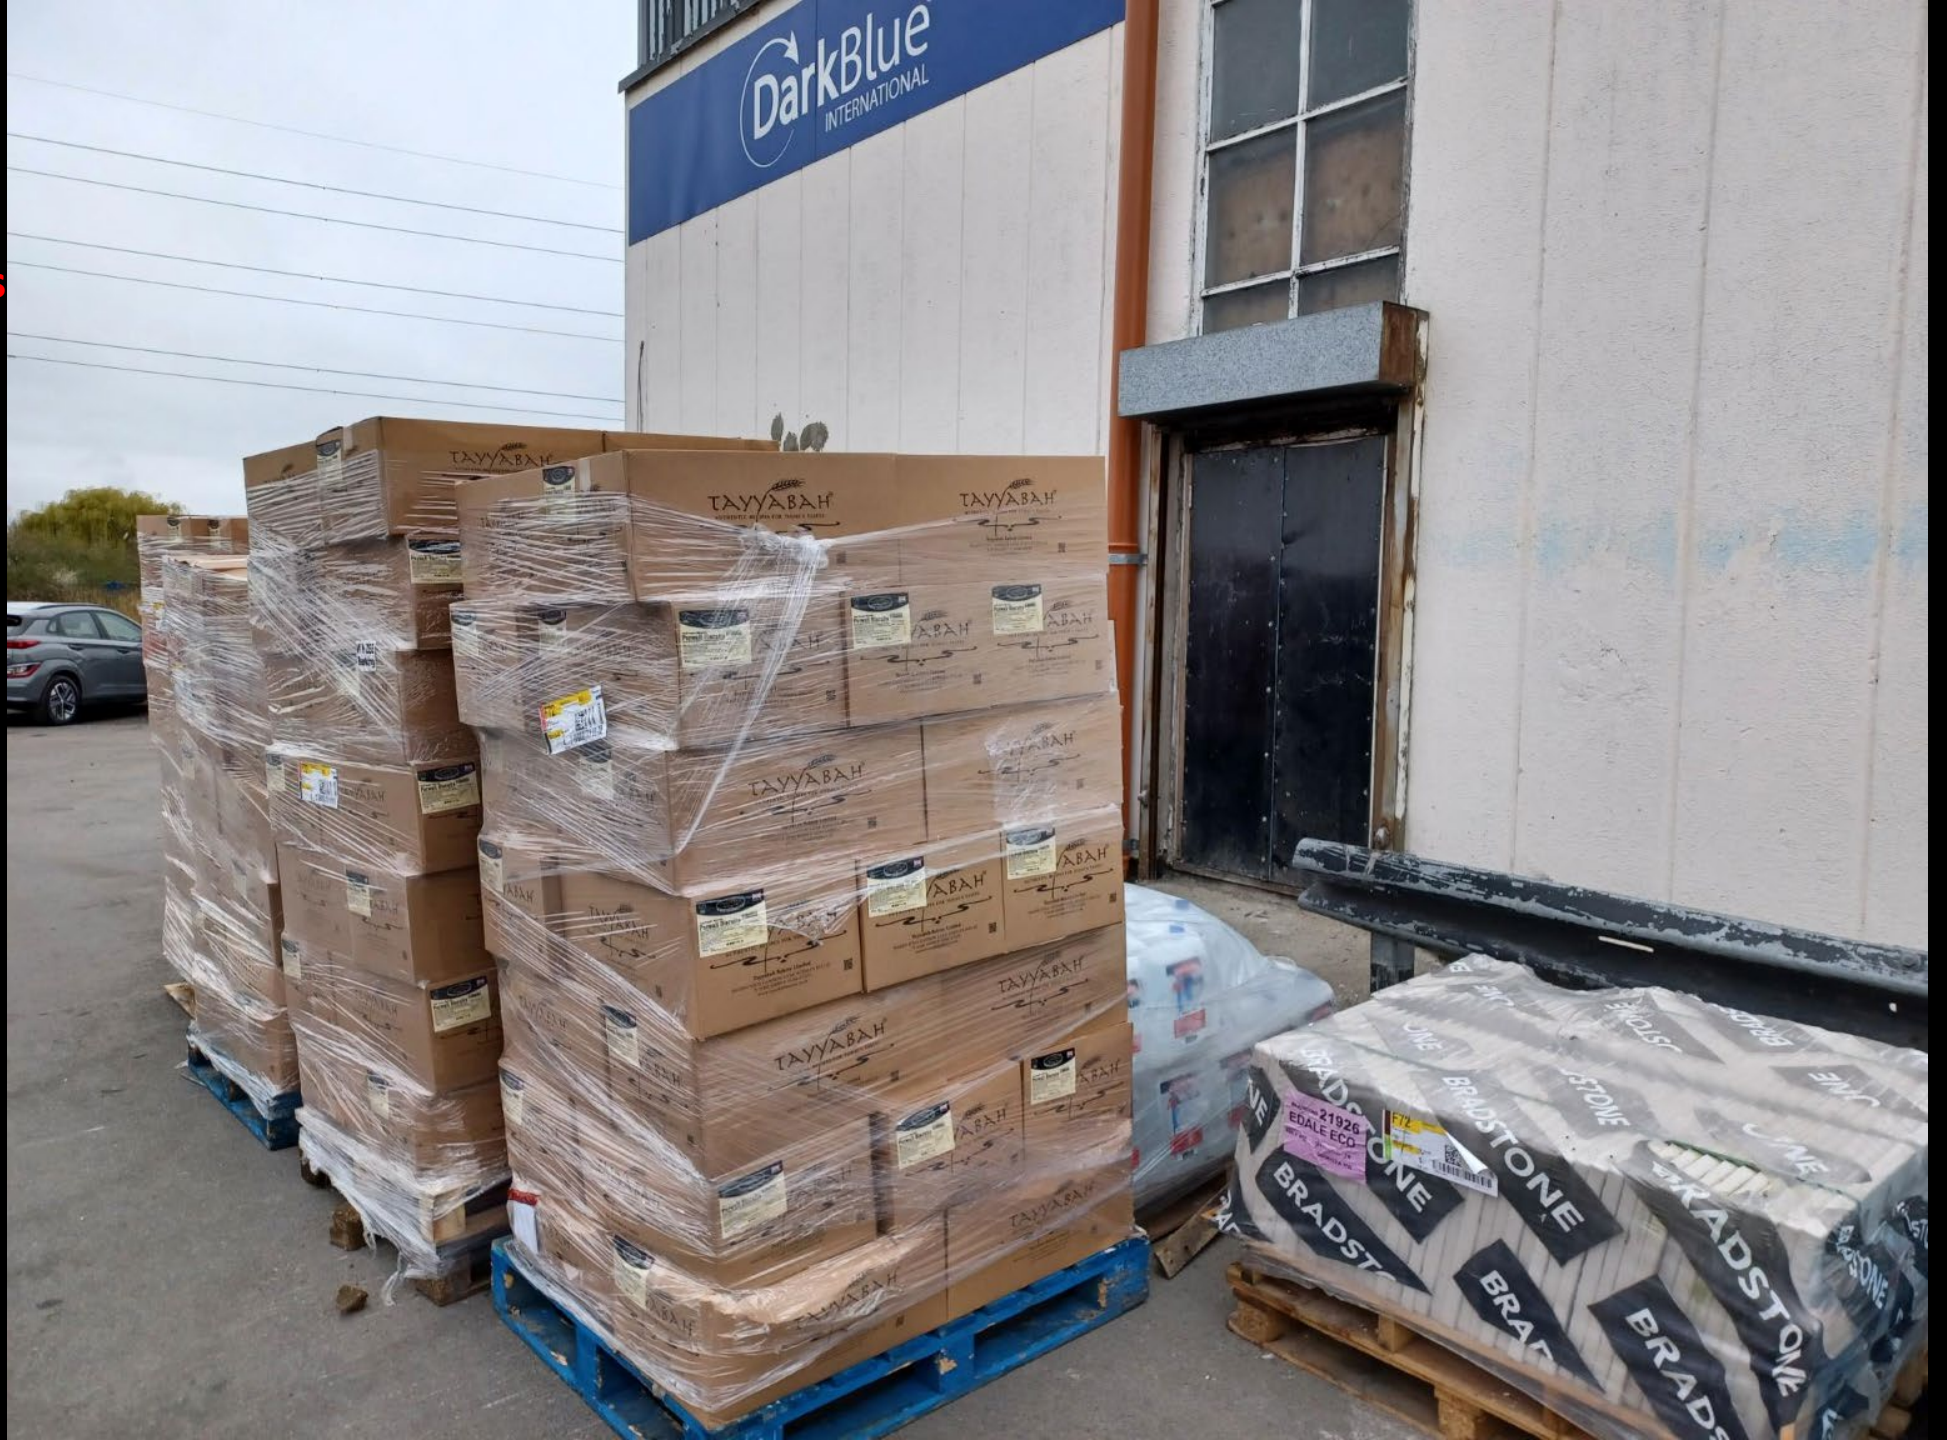
**ORD/20 - Apparent  
entrance /  
exit blocked by pallets  
from businesses  
(possible fire exit).**

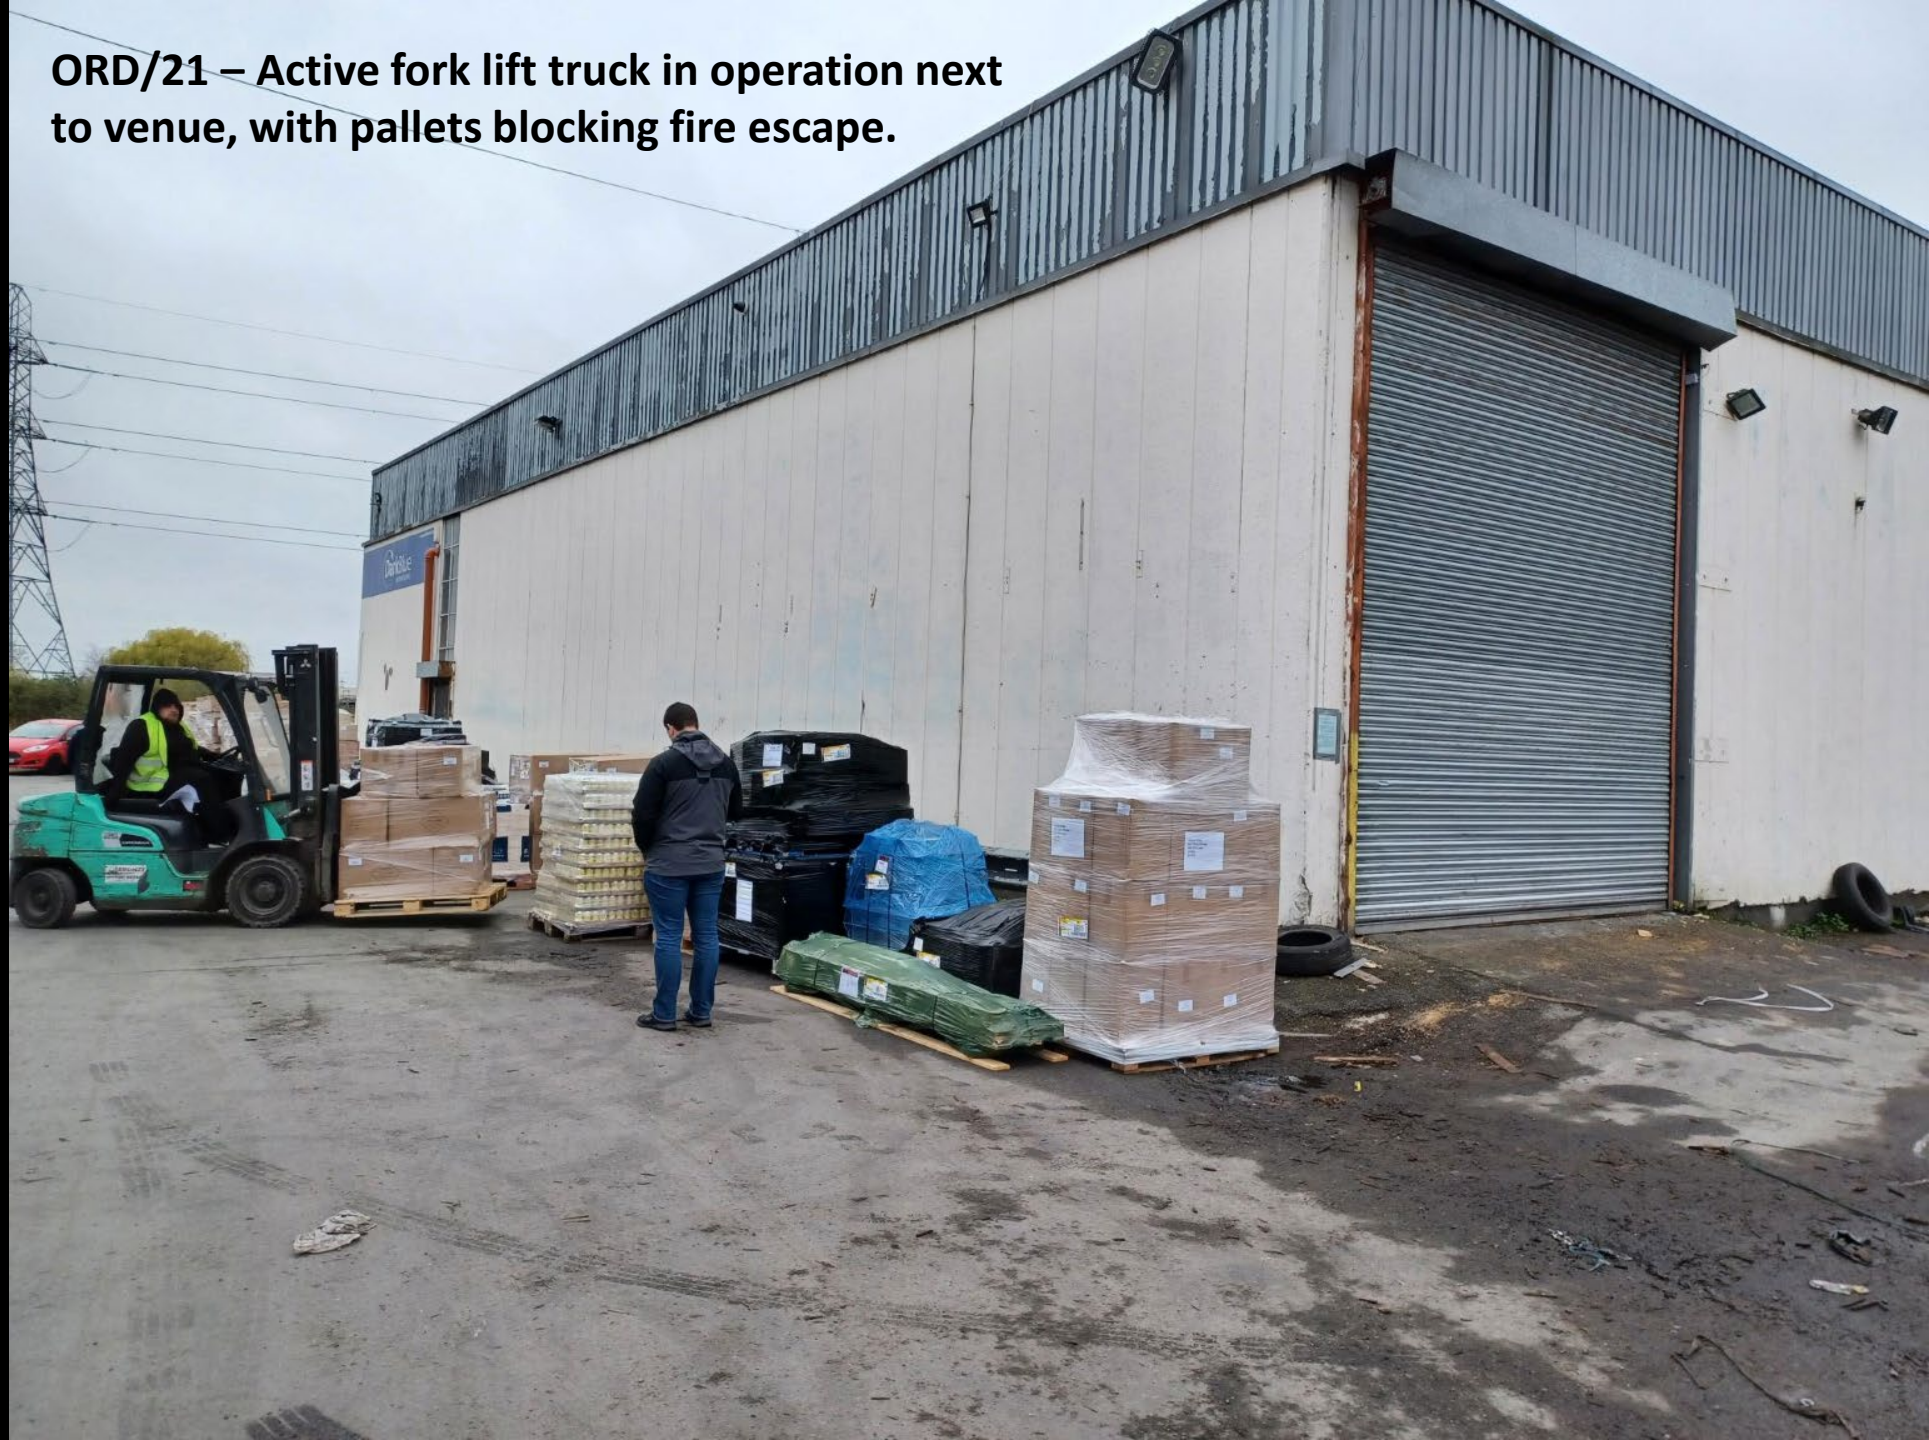
**ORD/21 – Active fork lift truck in operation next to venue, with pallets blocking fire escape.**

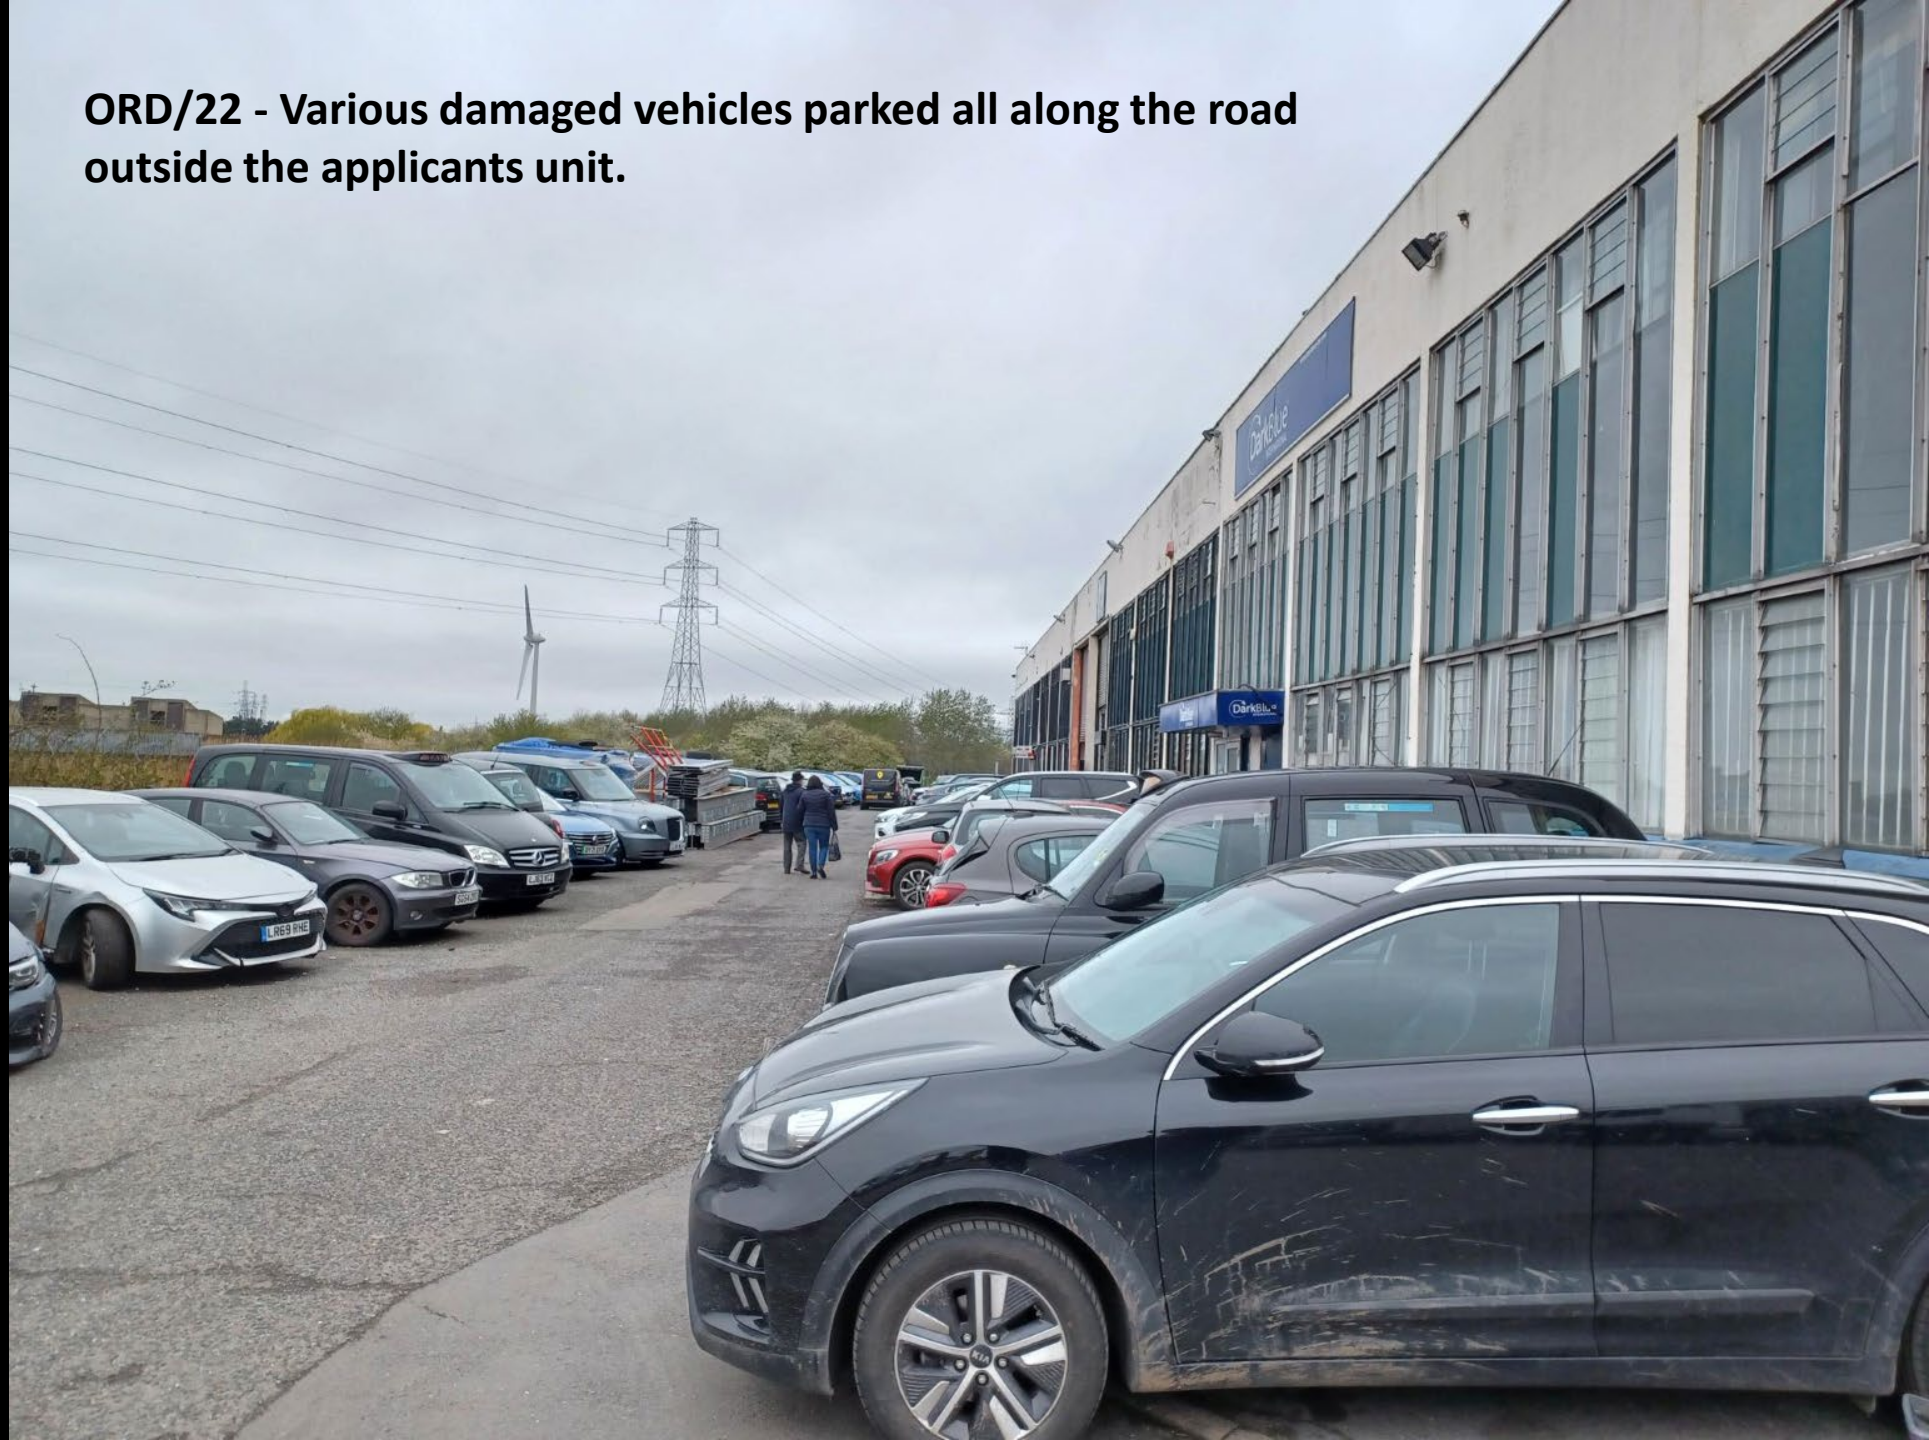
**ORD/22 - Various damaged vehicles parked all along the road outside the applicants unit.**

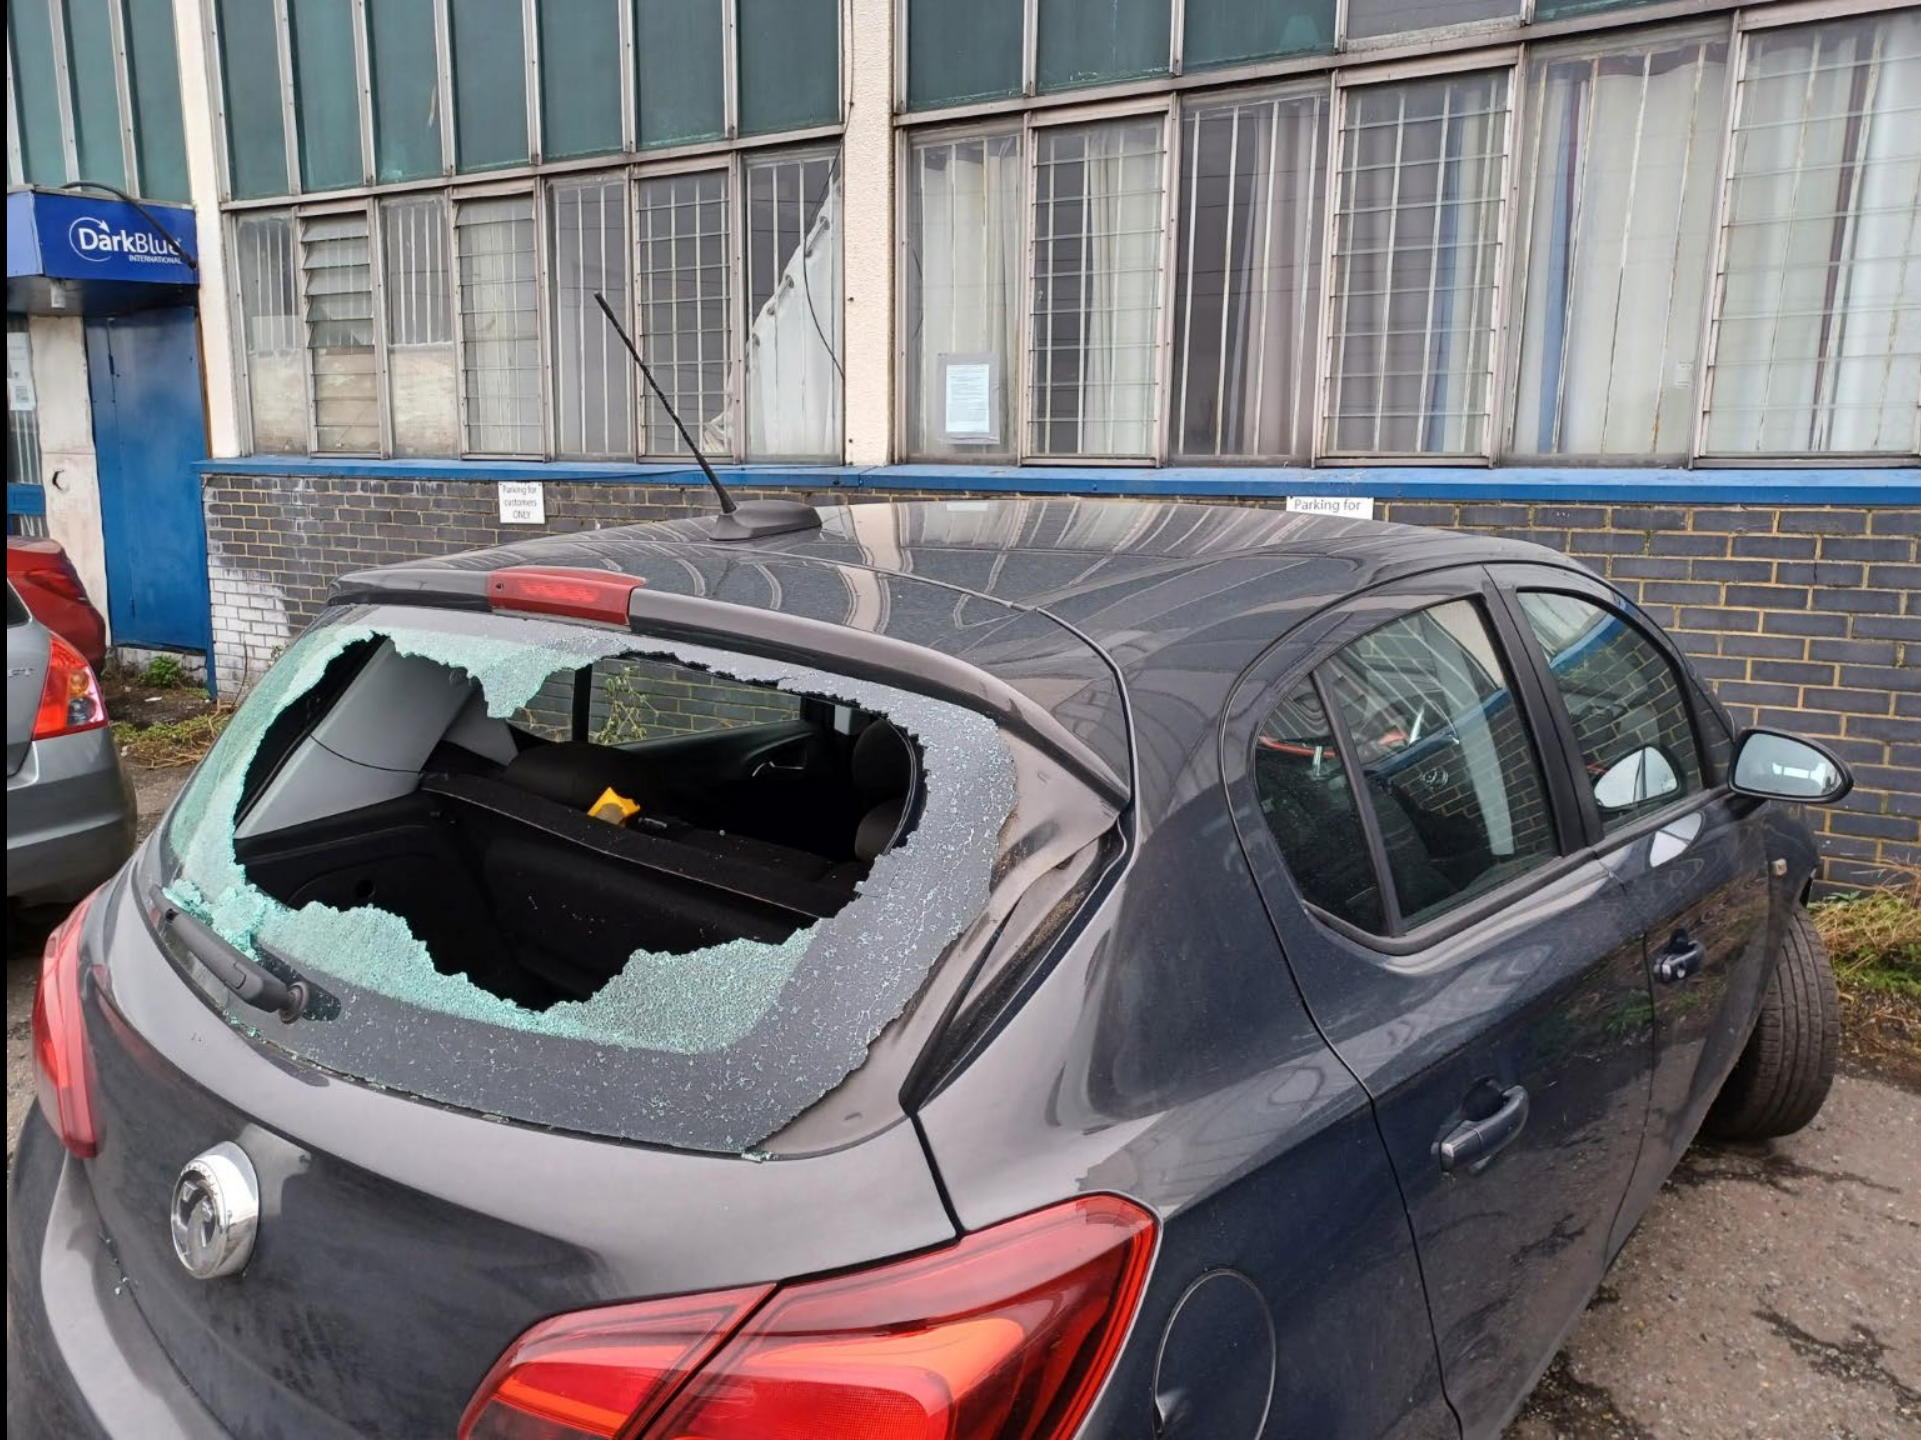
**ORD/24 – Damaged vehicle awaiting repair with broken glass.**

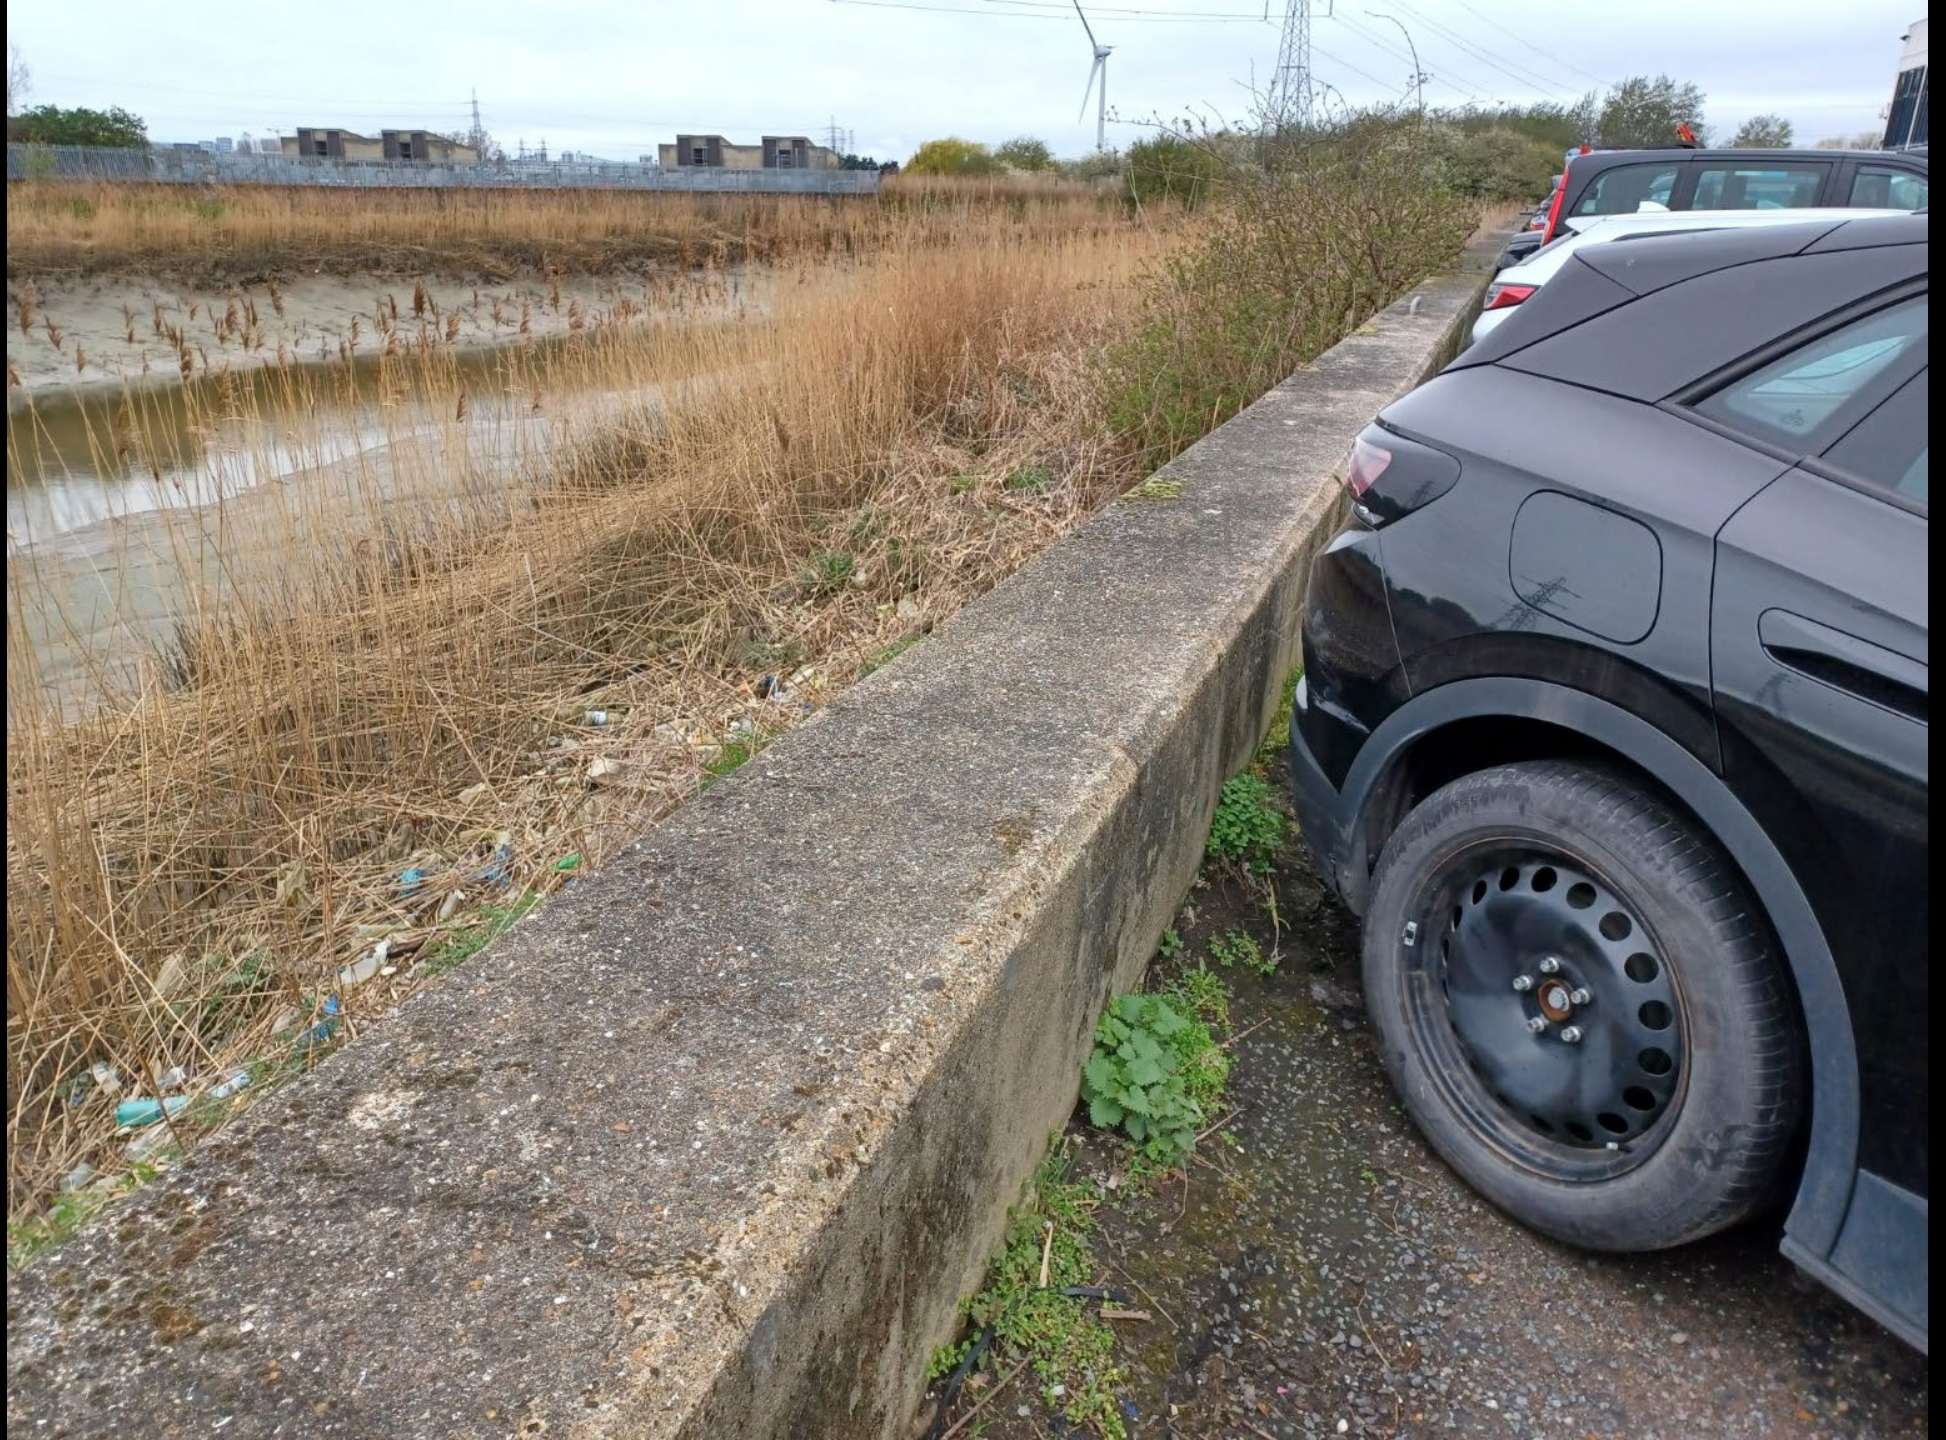
**ORD/25 – Small wall is only safety barrier between Road and drop down to the river.**

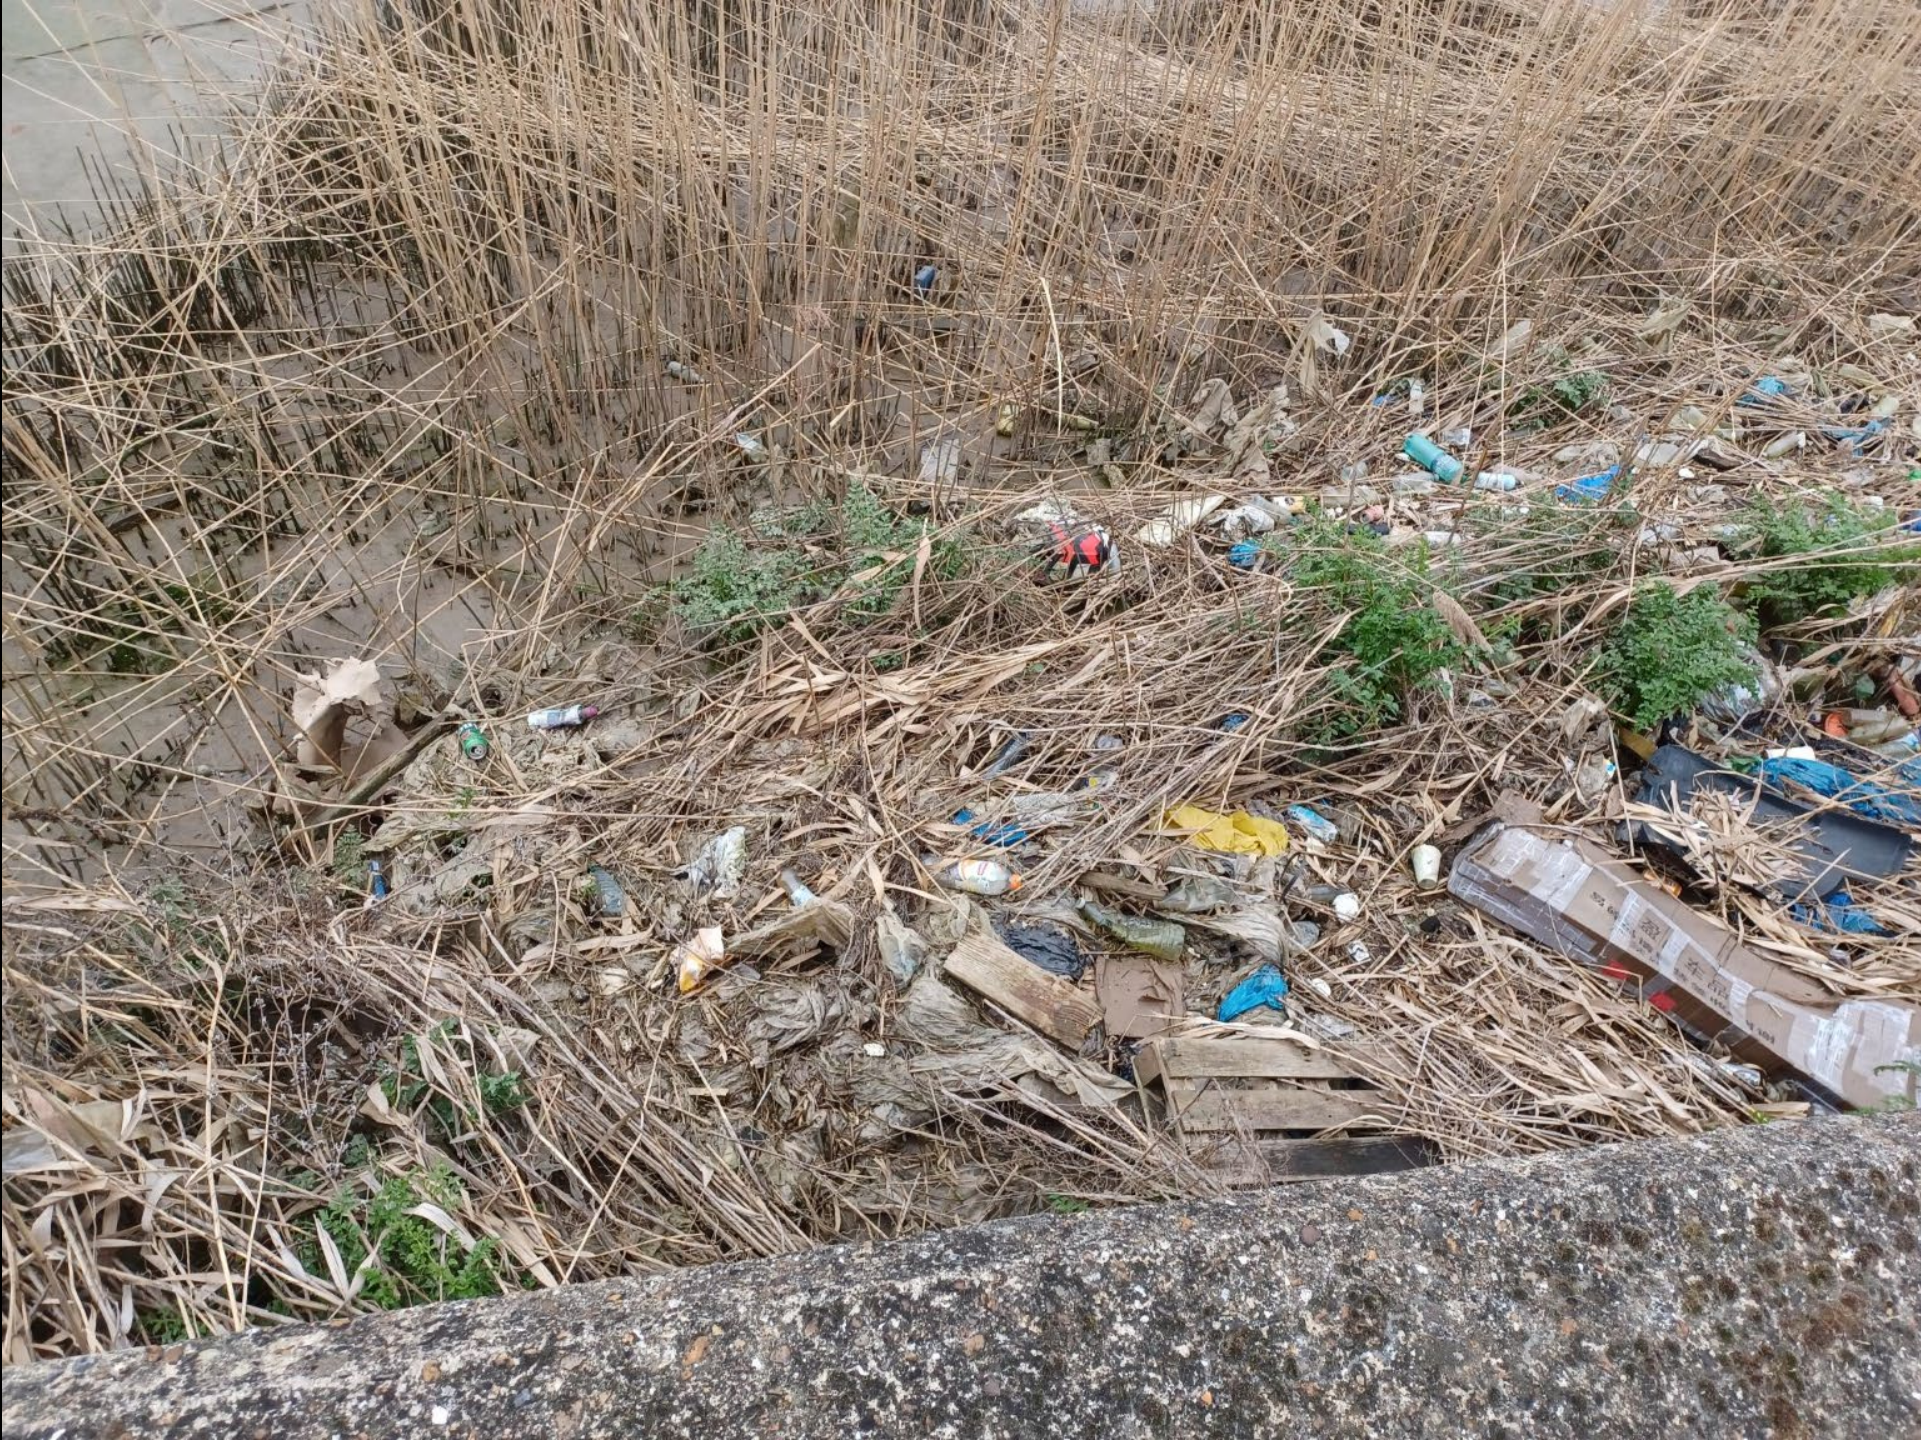
**ORD/26 – waste at  
bottom of drop before  
water from river.**

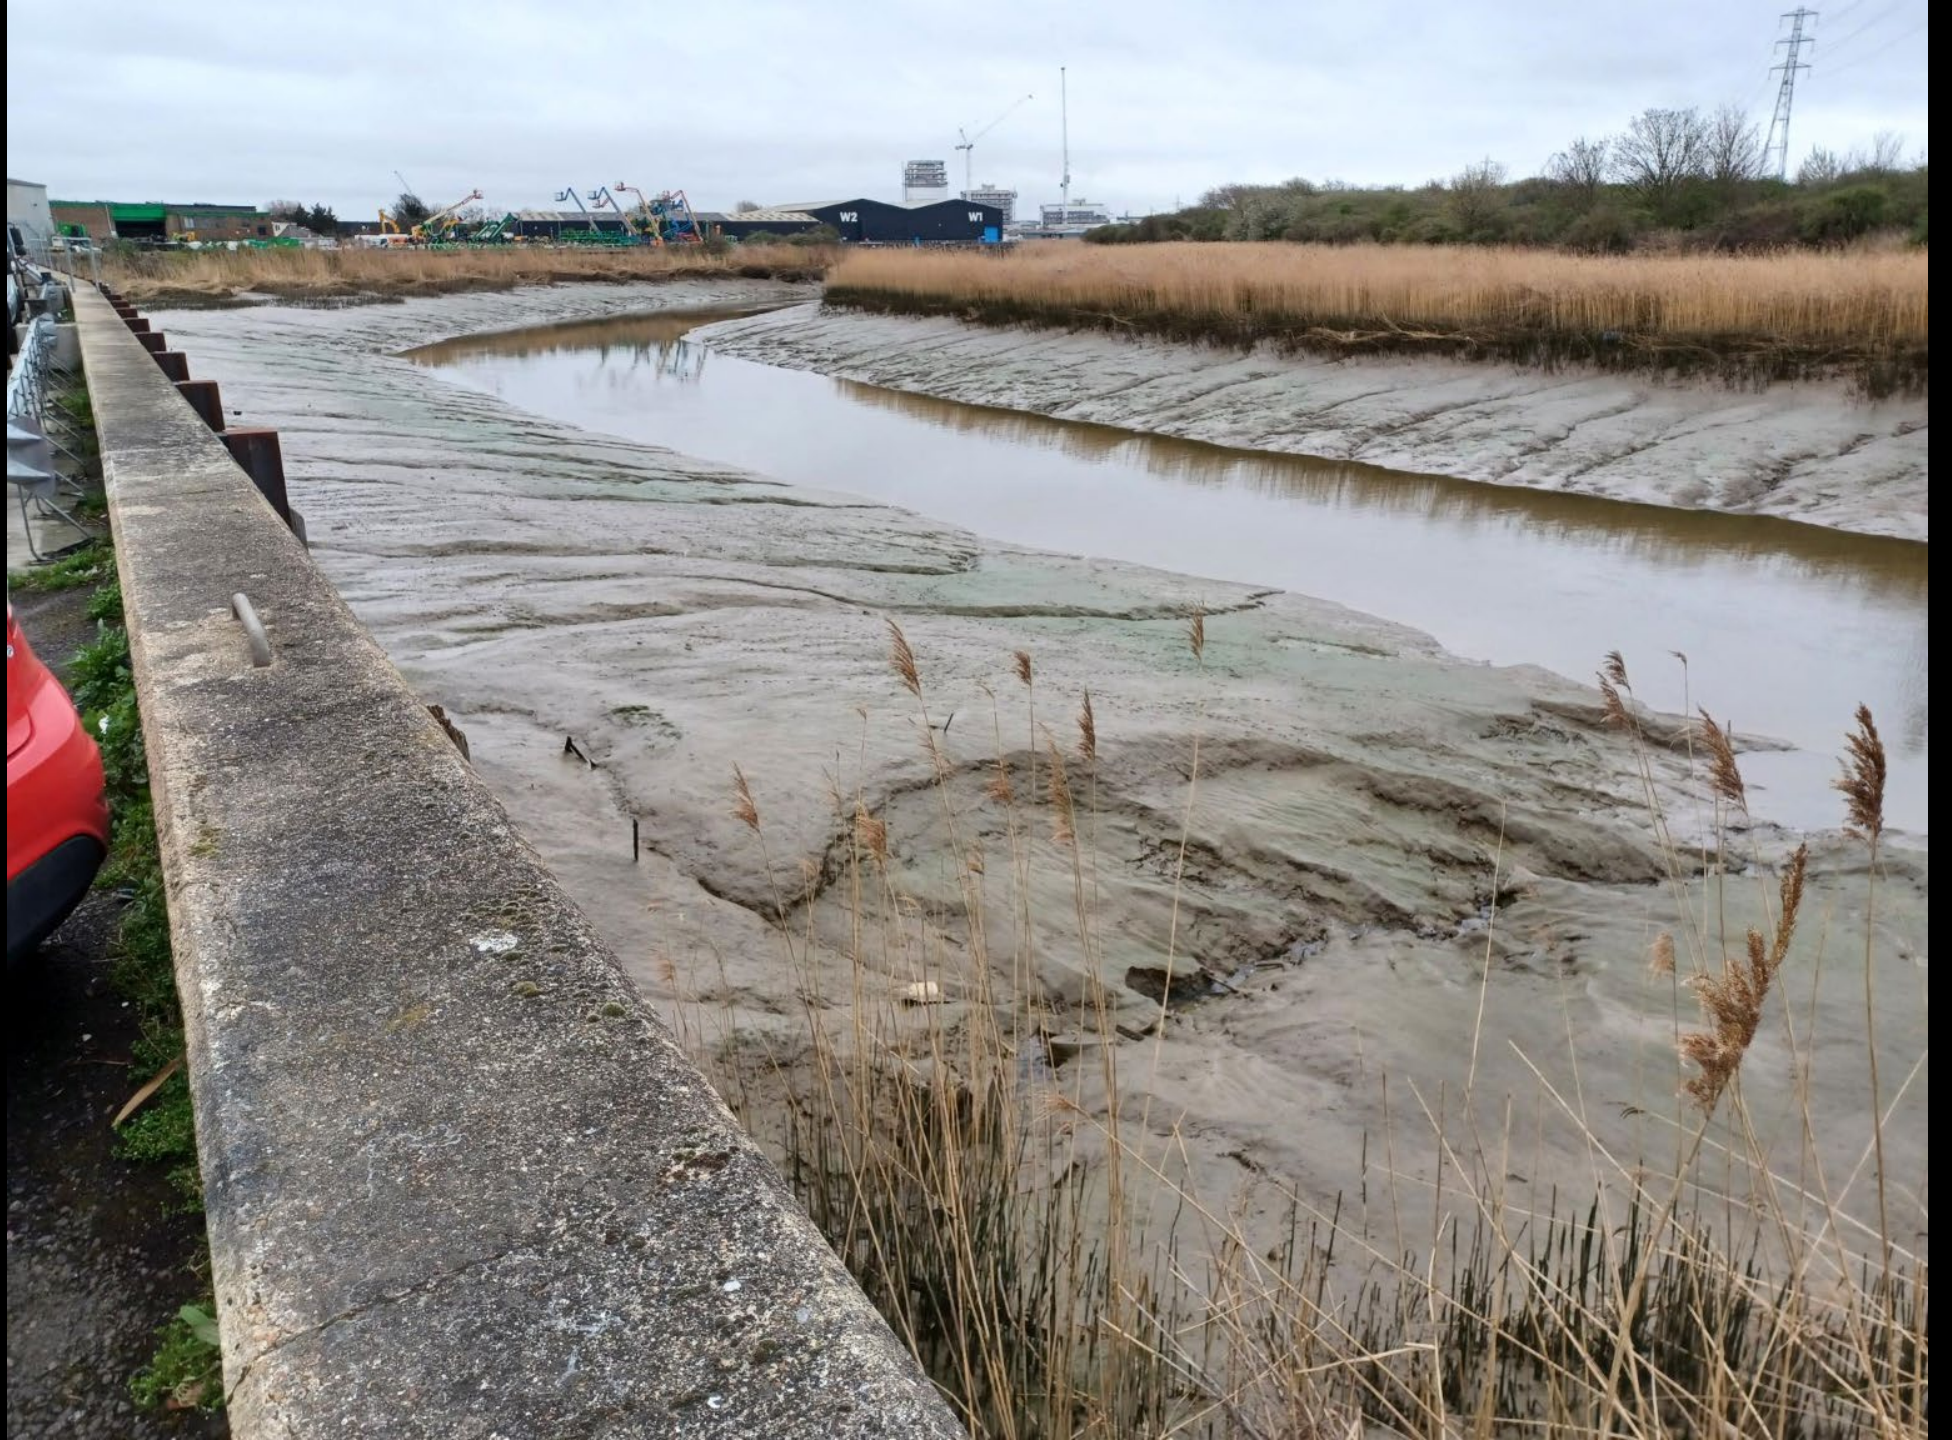
**ORD/27 – Drop  
down  
To the riverbed  
Outside the entrance  
To the venue.**

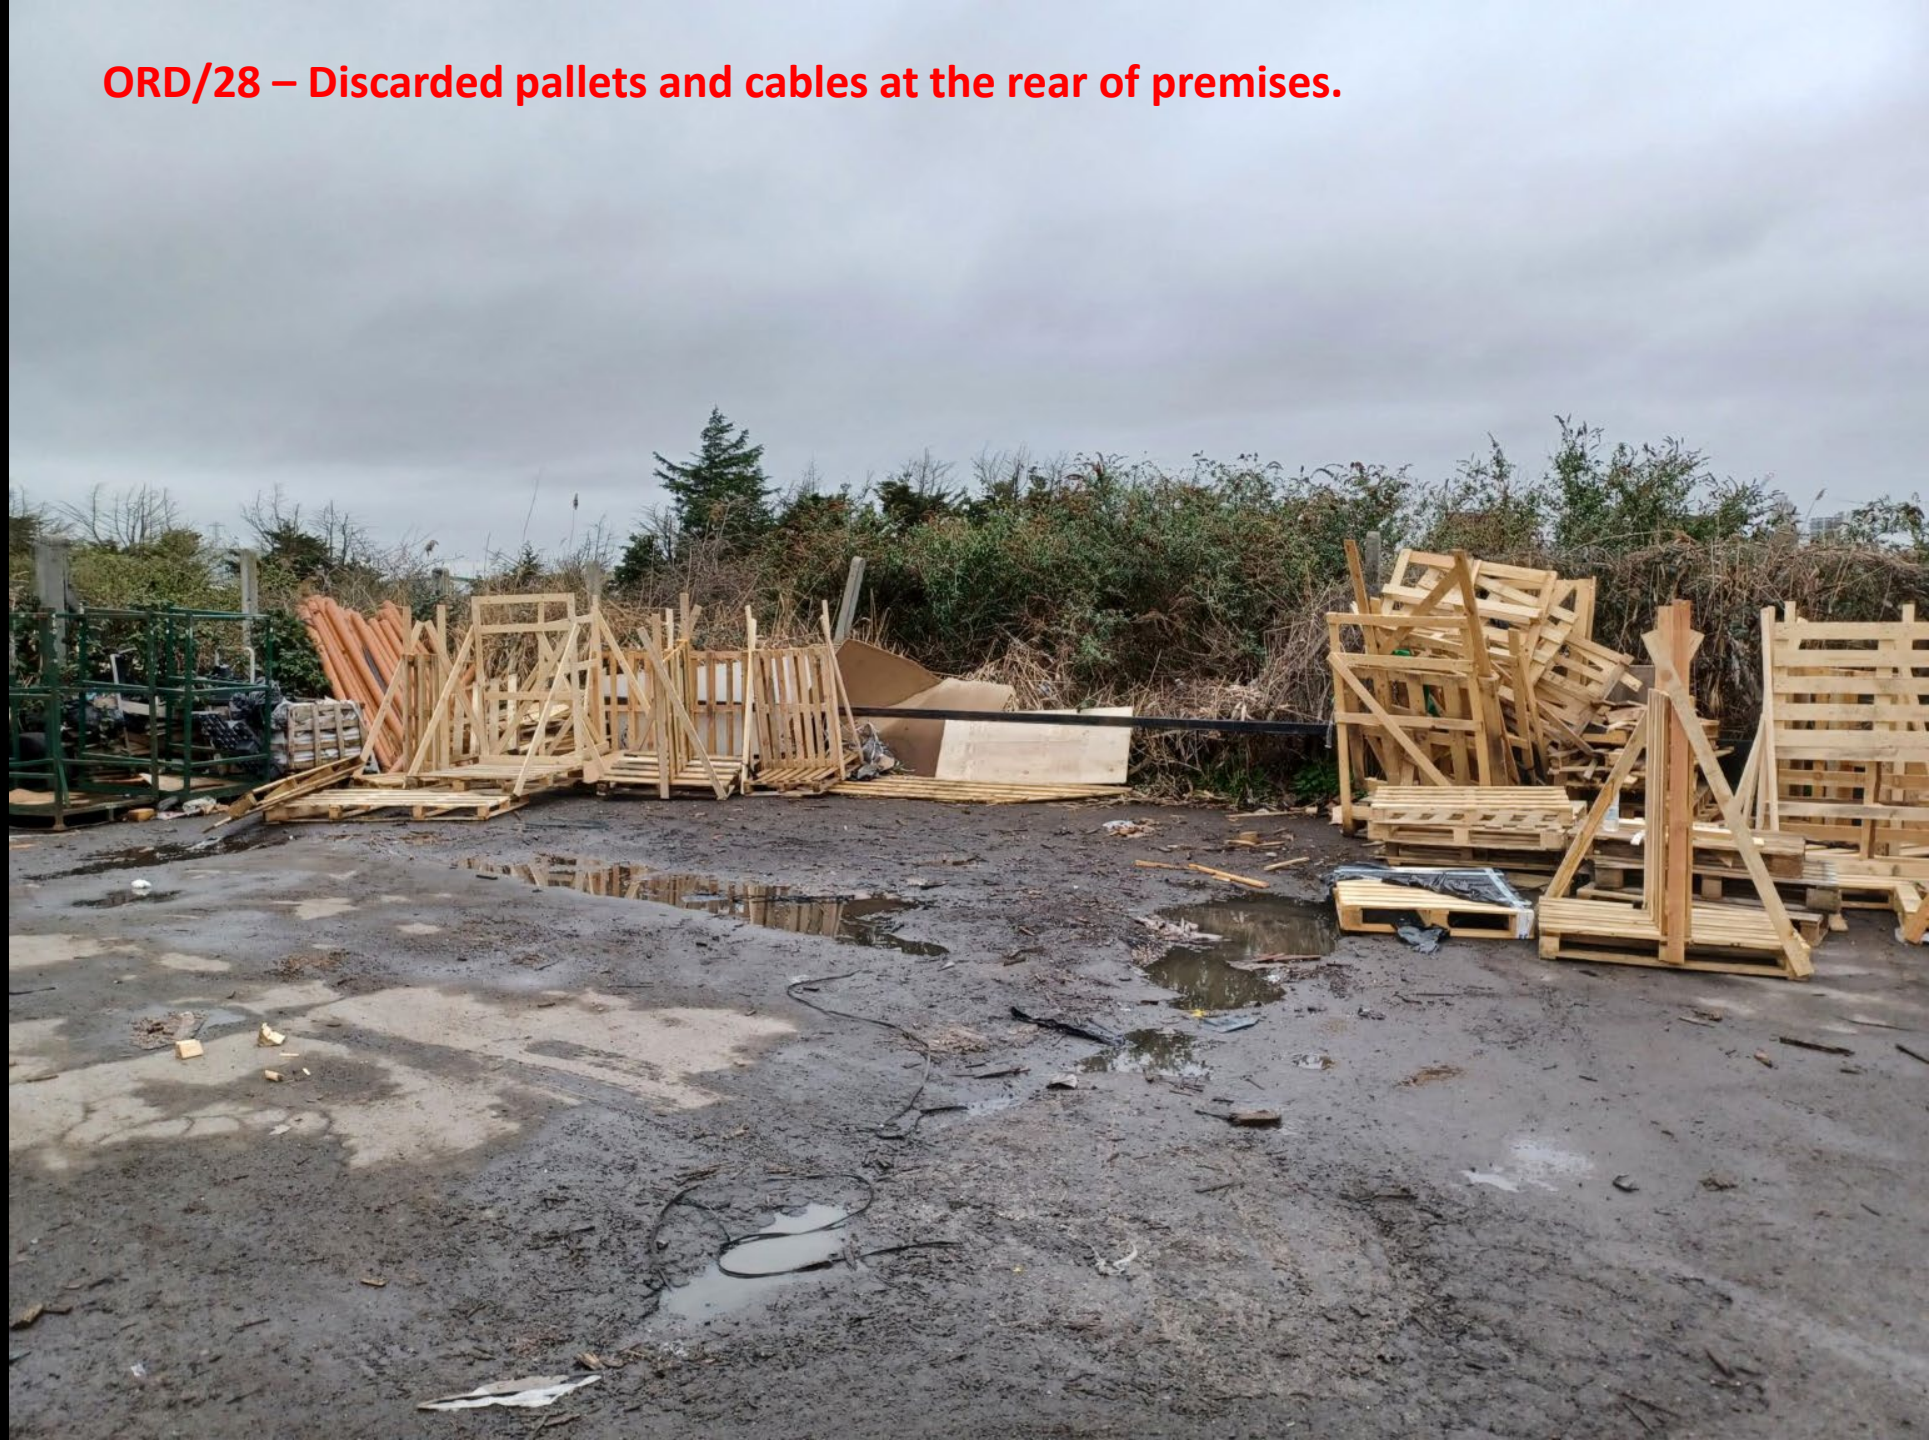
**ORD/28 – Discarded pallets and cables at the rear of premises.**
