# Photo Exhibits Album

by Dunn Owen R - EA-CU

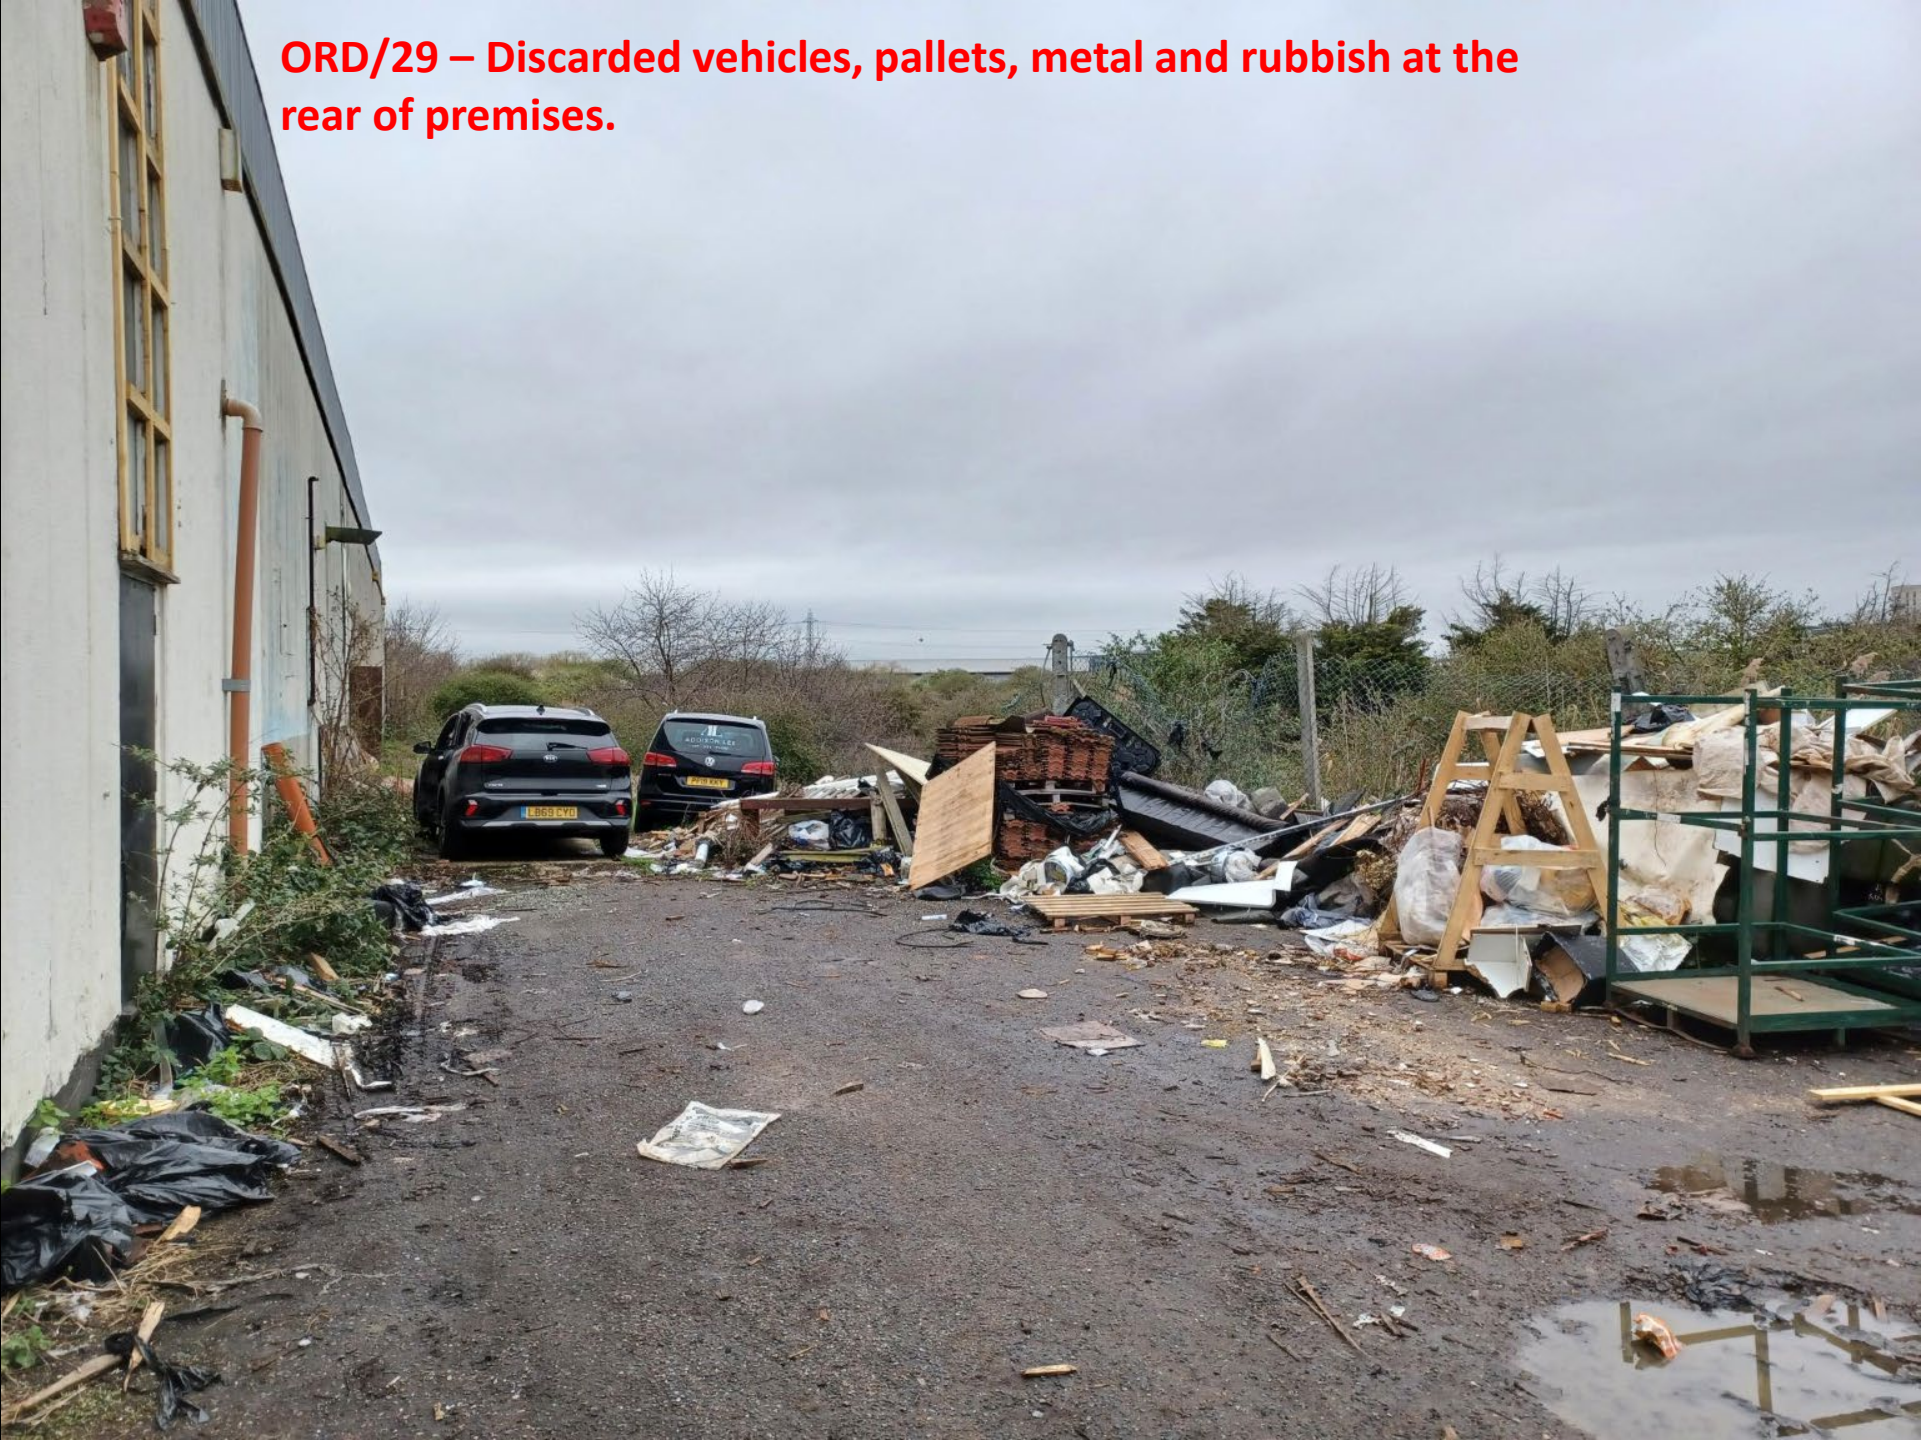
**ORD/29 – Discarded vehicles, pallets, metal and rubbish at the rear of premises.**

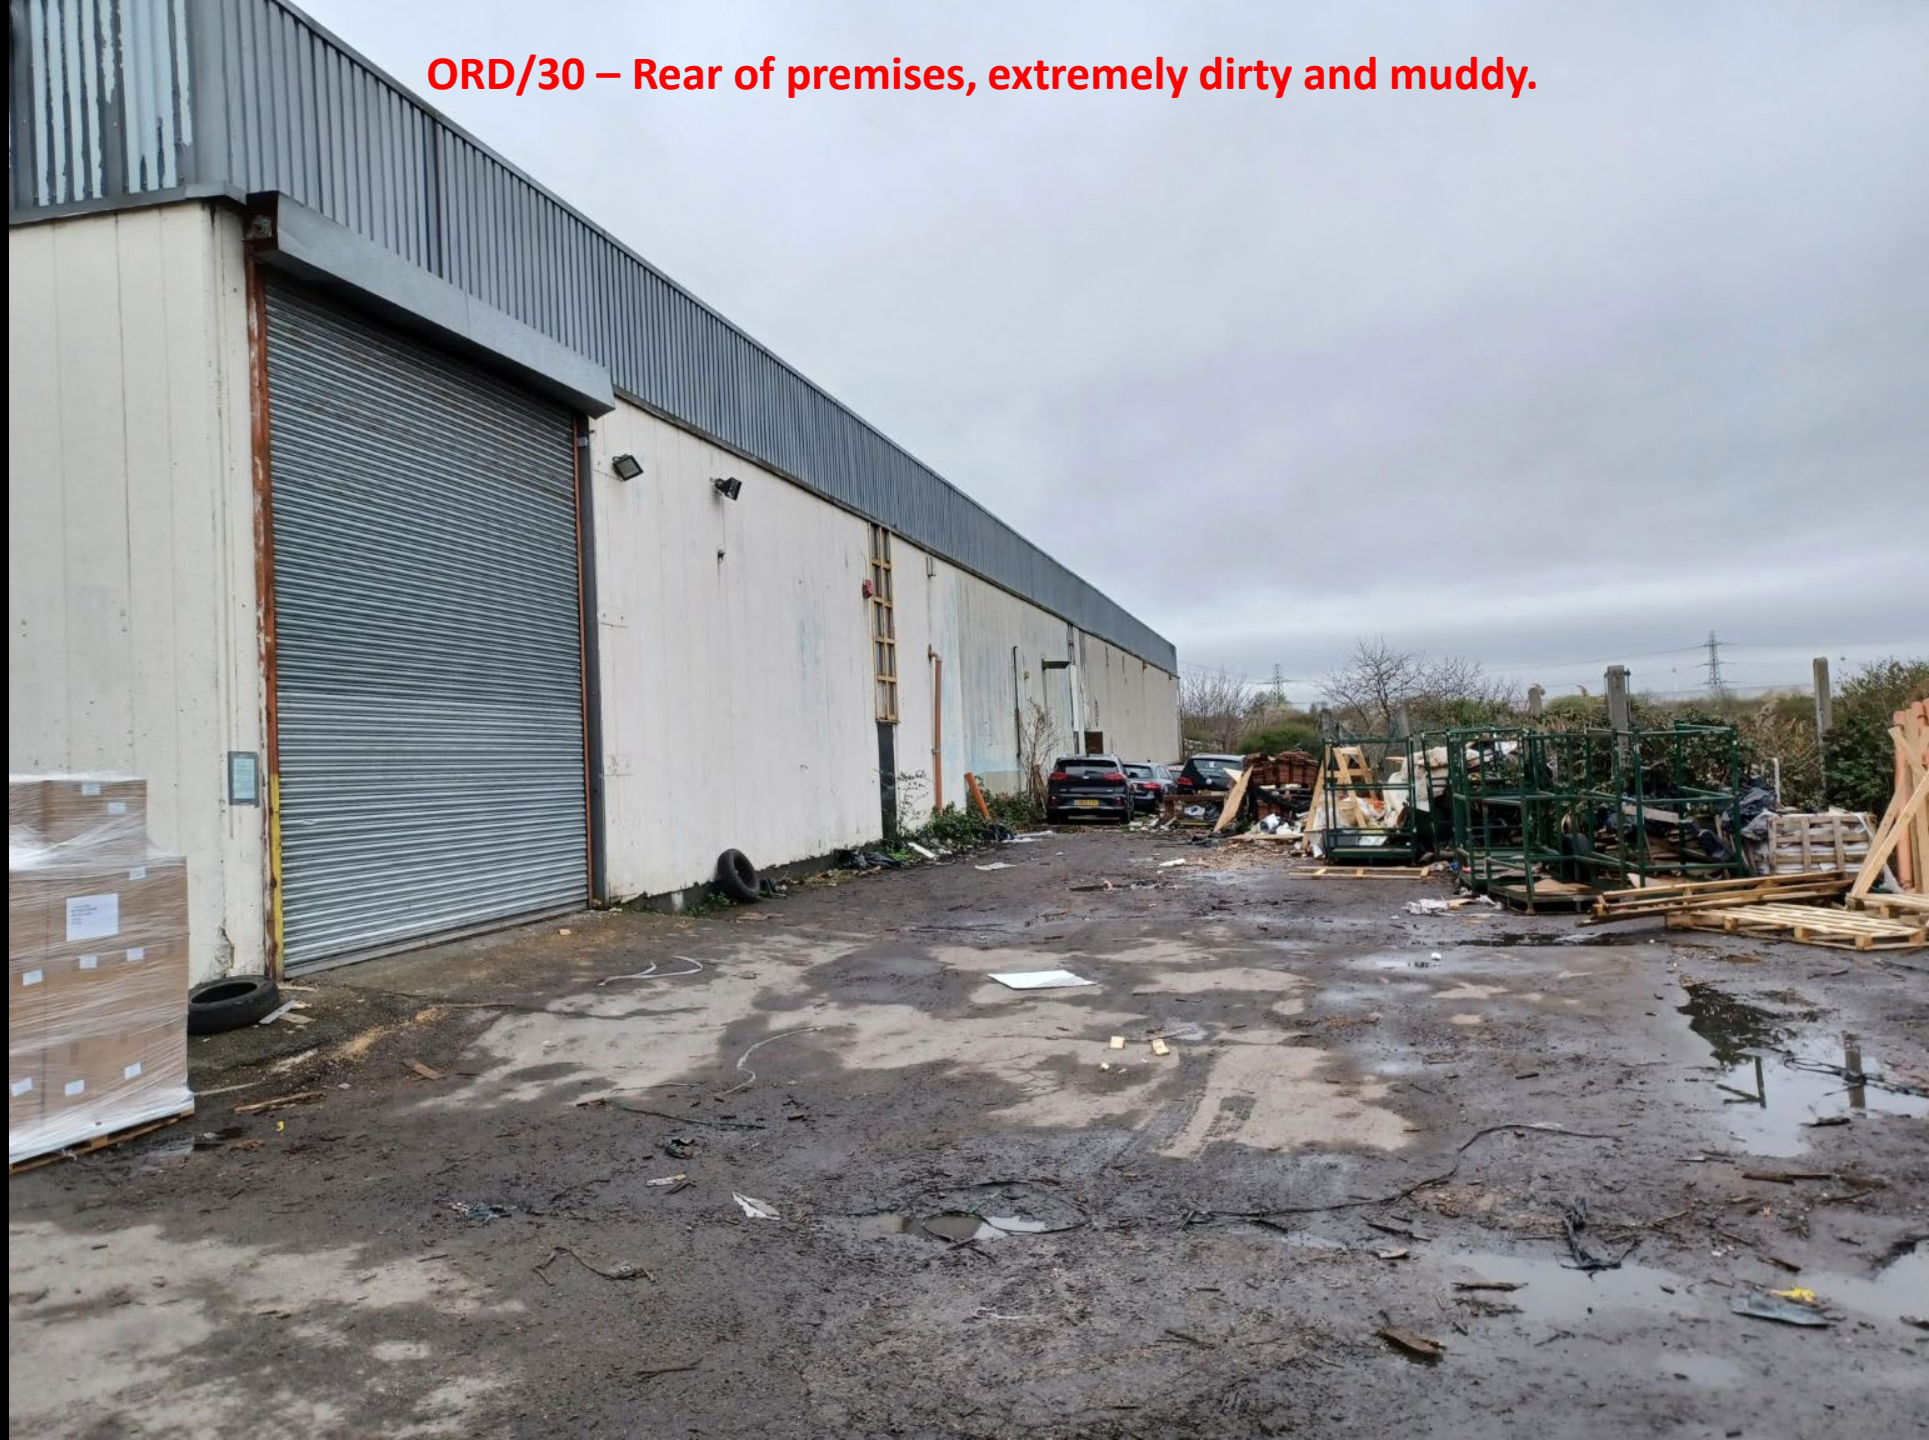
**ORD/30 – Rear of premises, extremely dirty and muddy.**

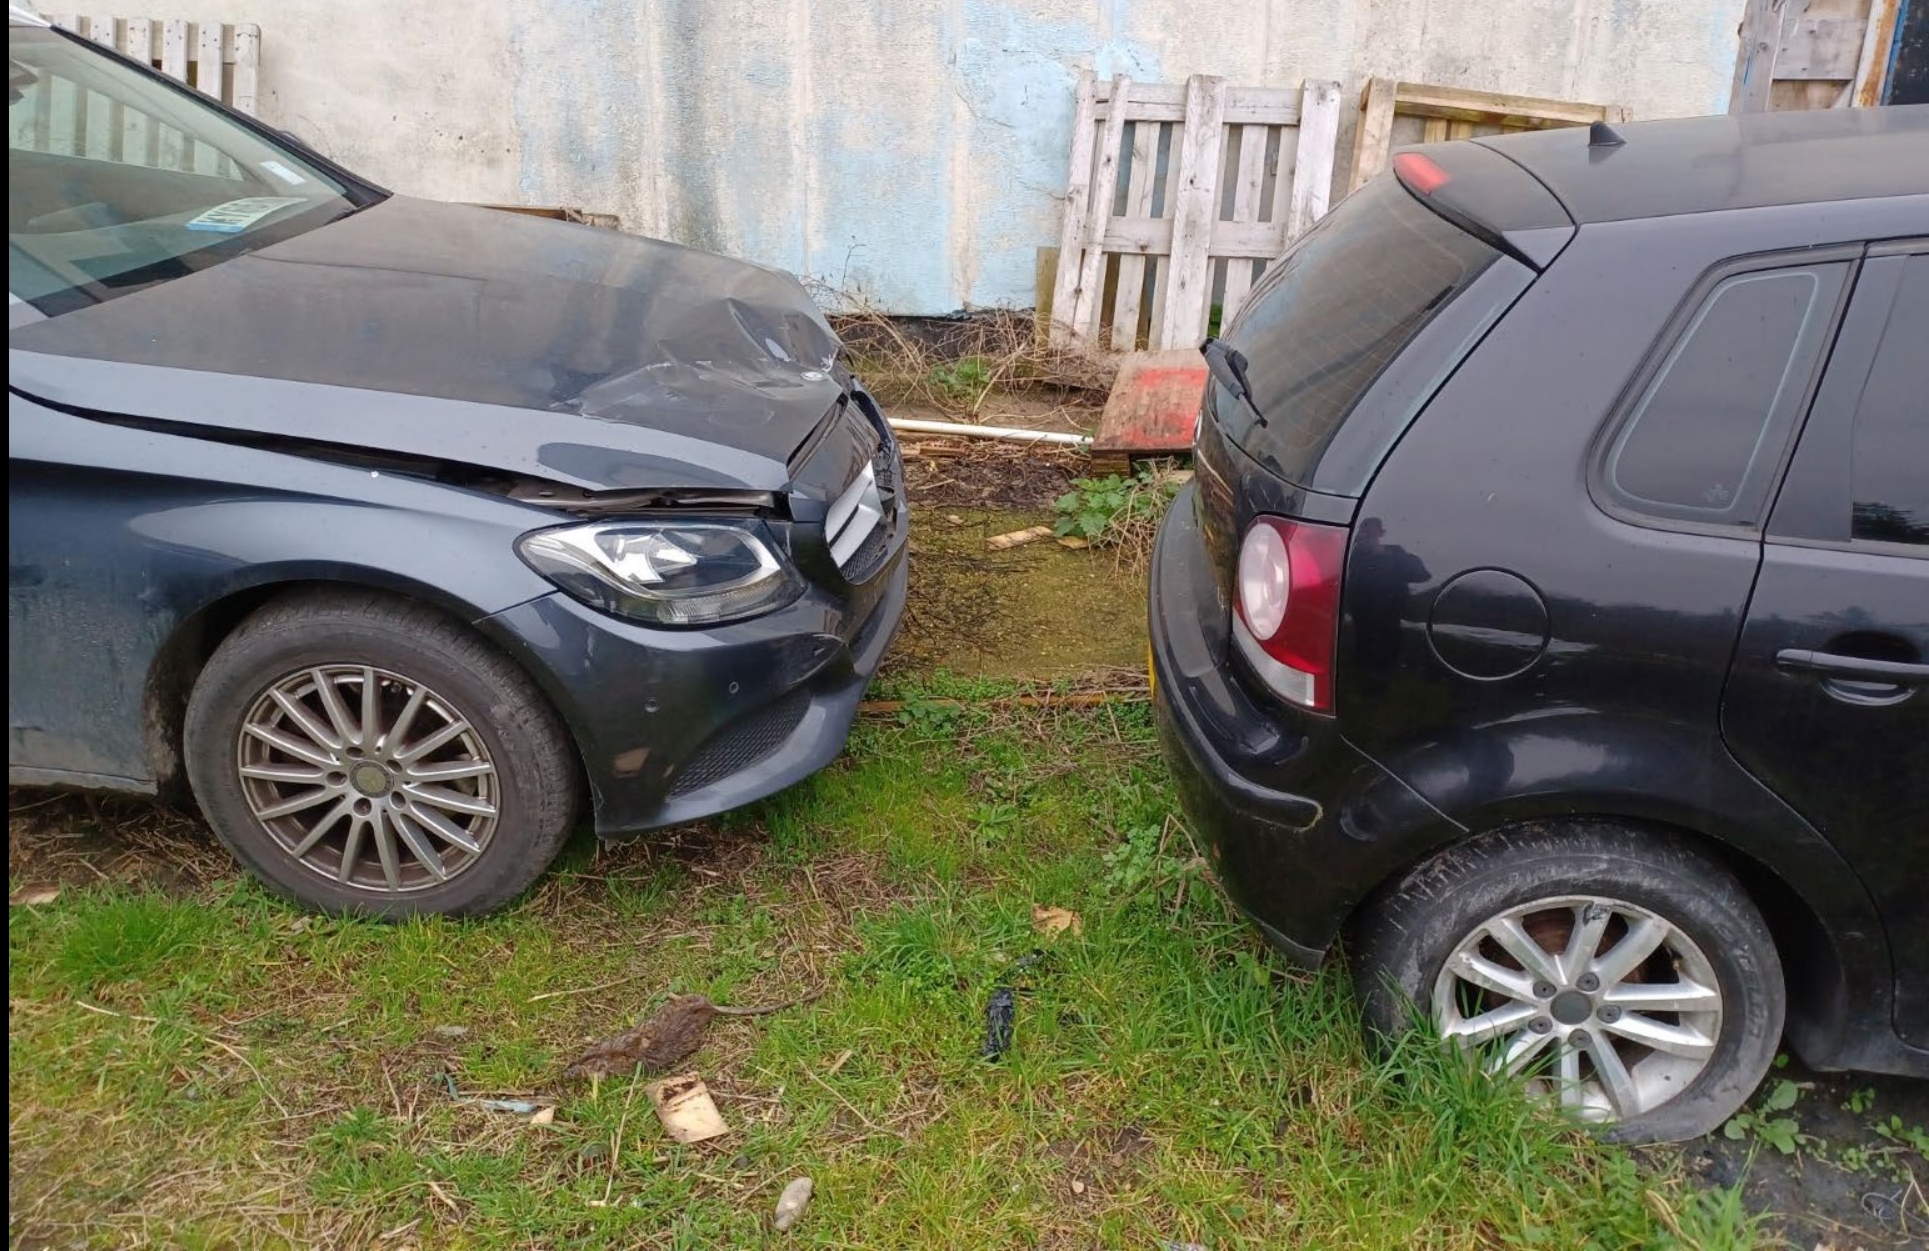
**ORD/31 – Damaged vehicles left at the rear of the premises  
and a dead rat.**

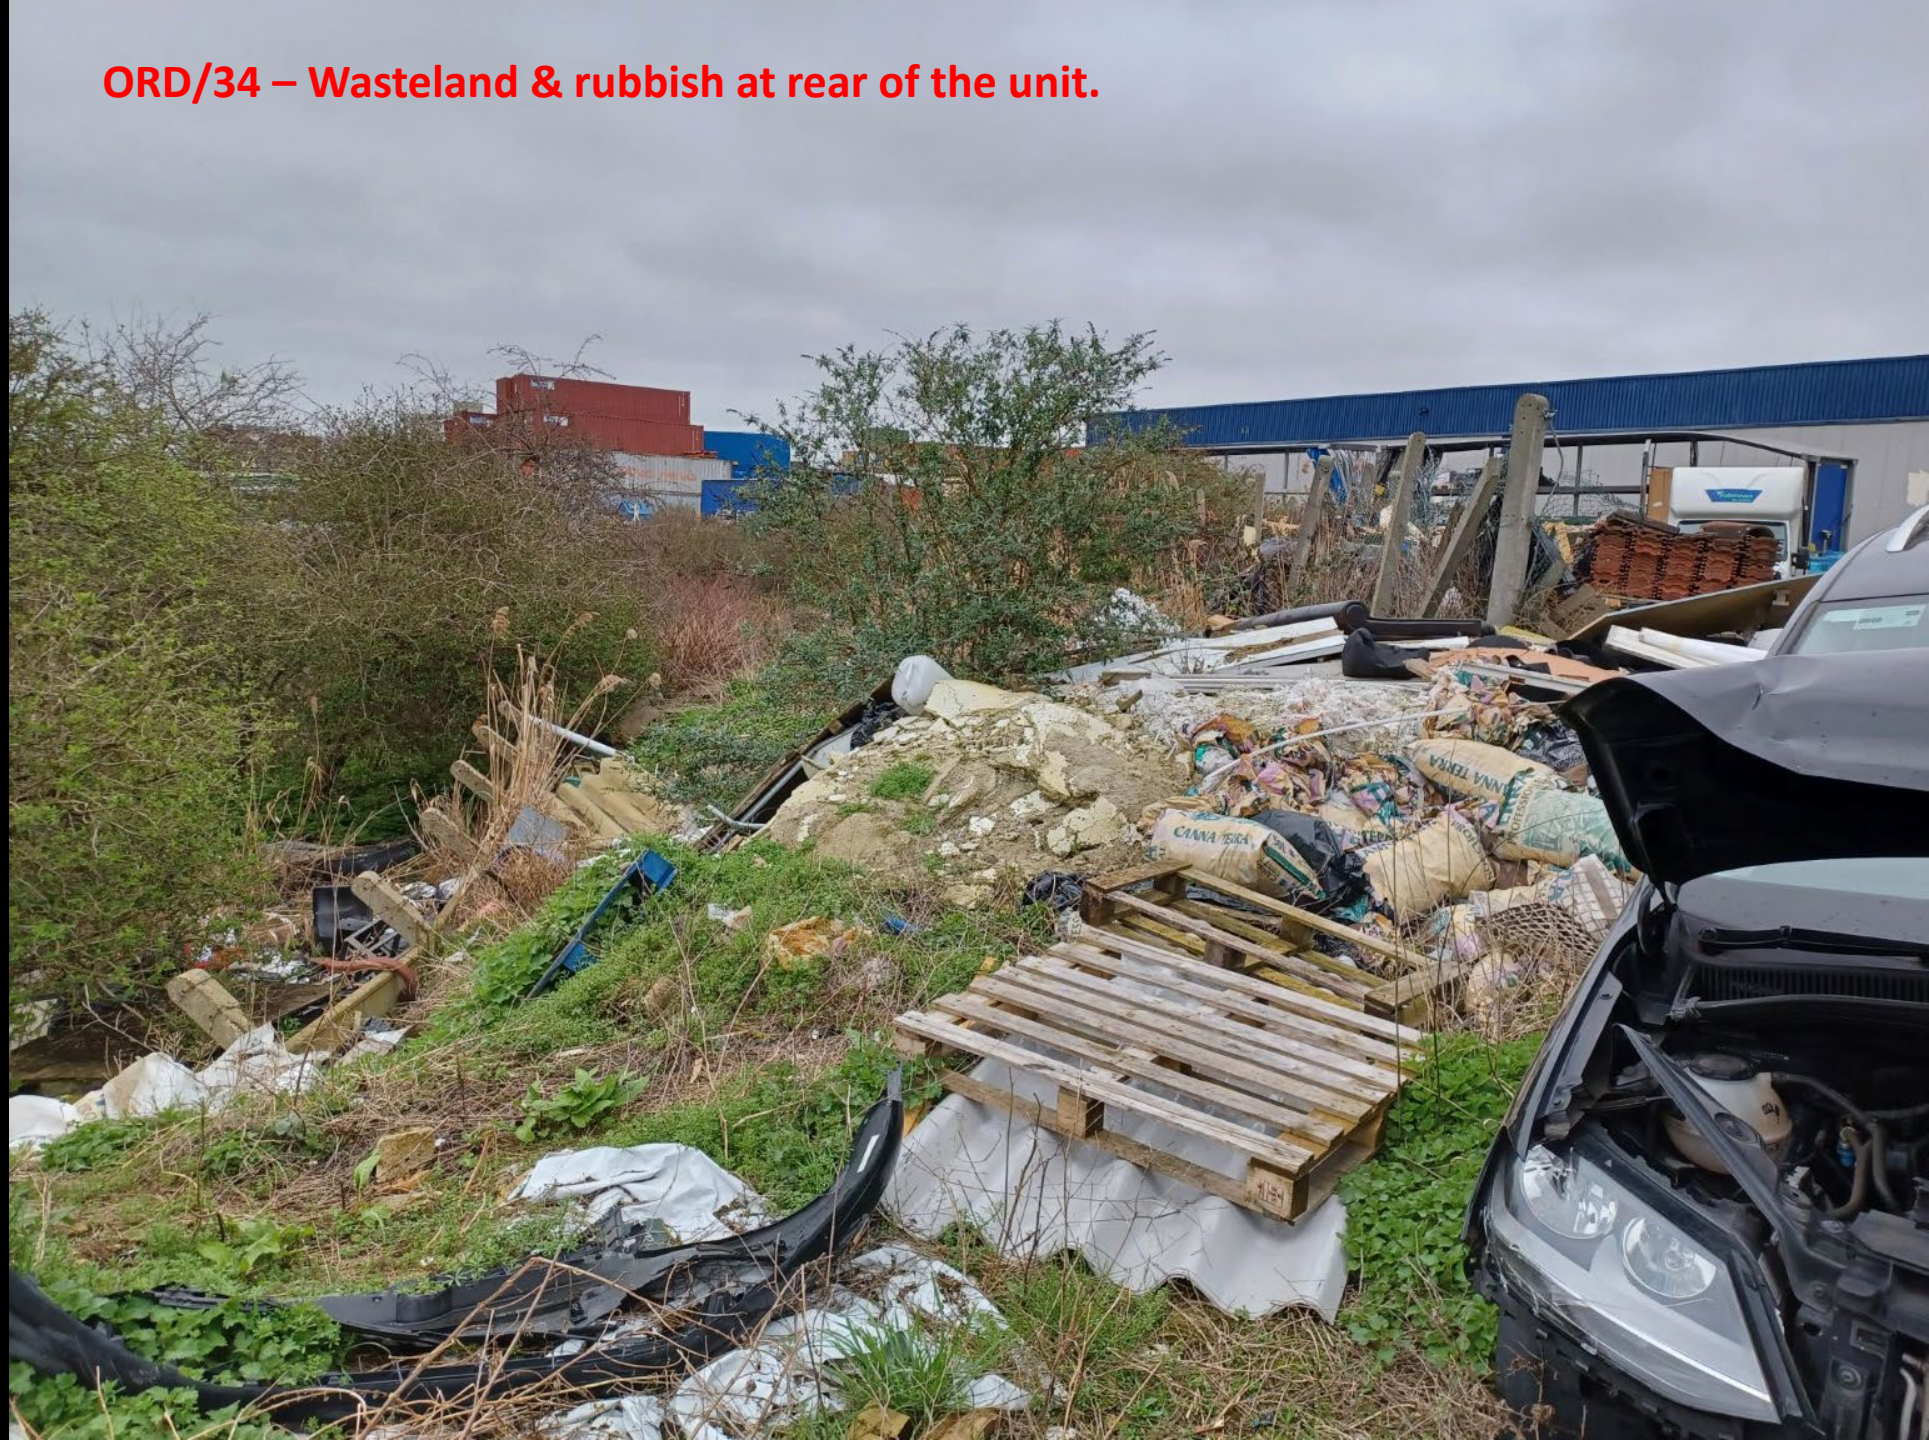
**ORD/34 – Wasteland & rubbish at rear of the unit.**

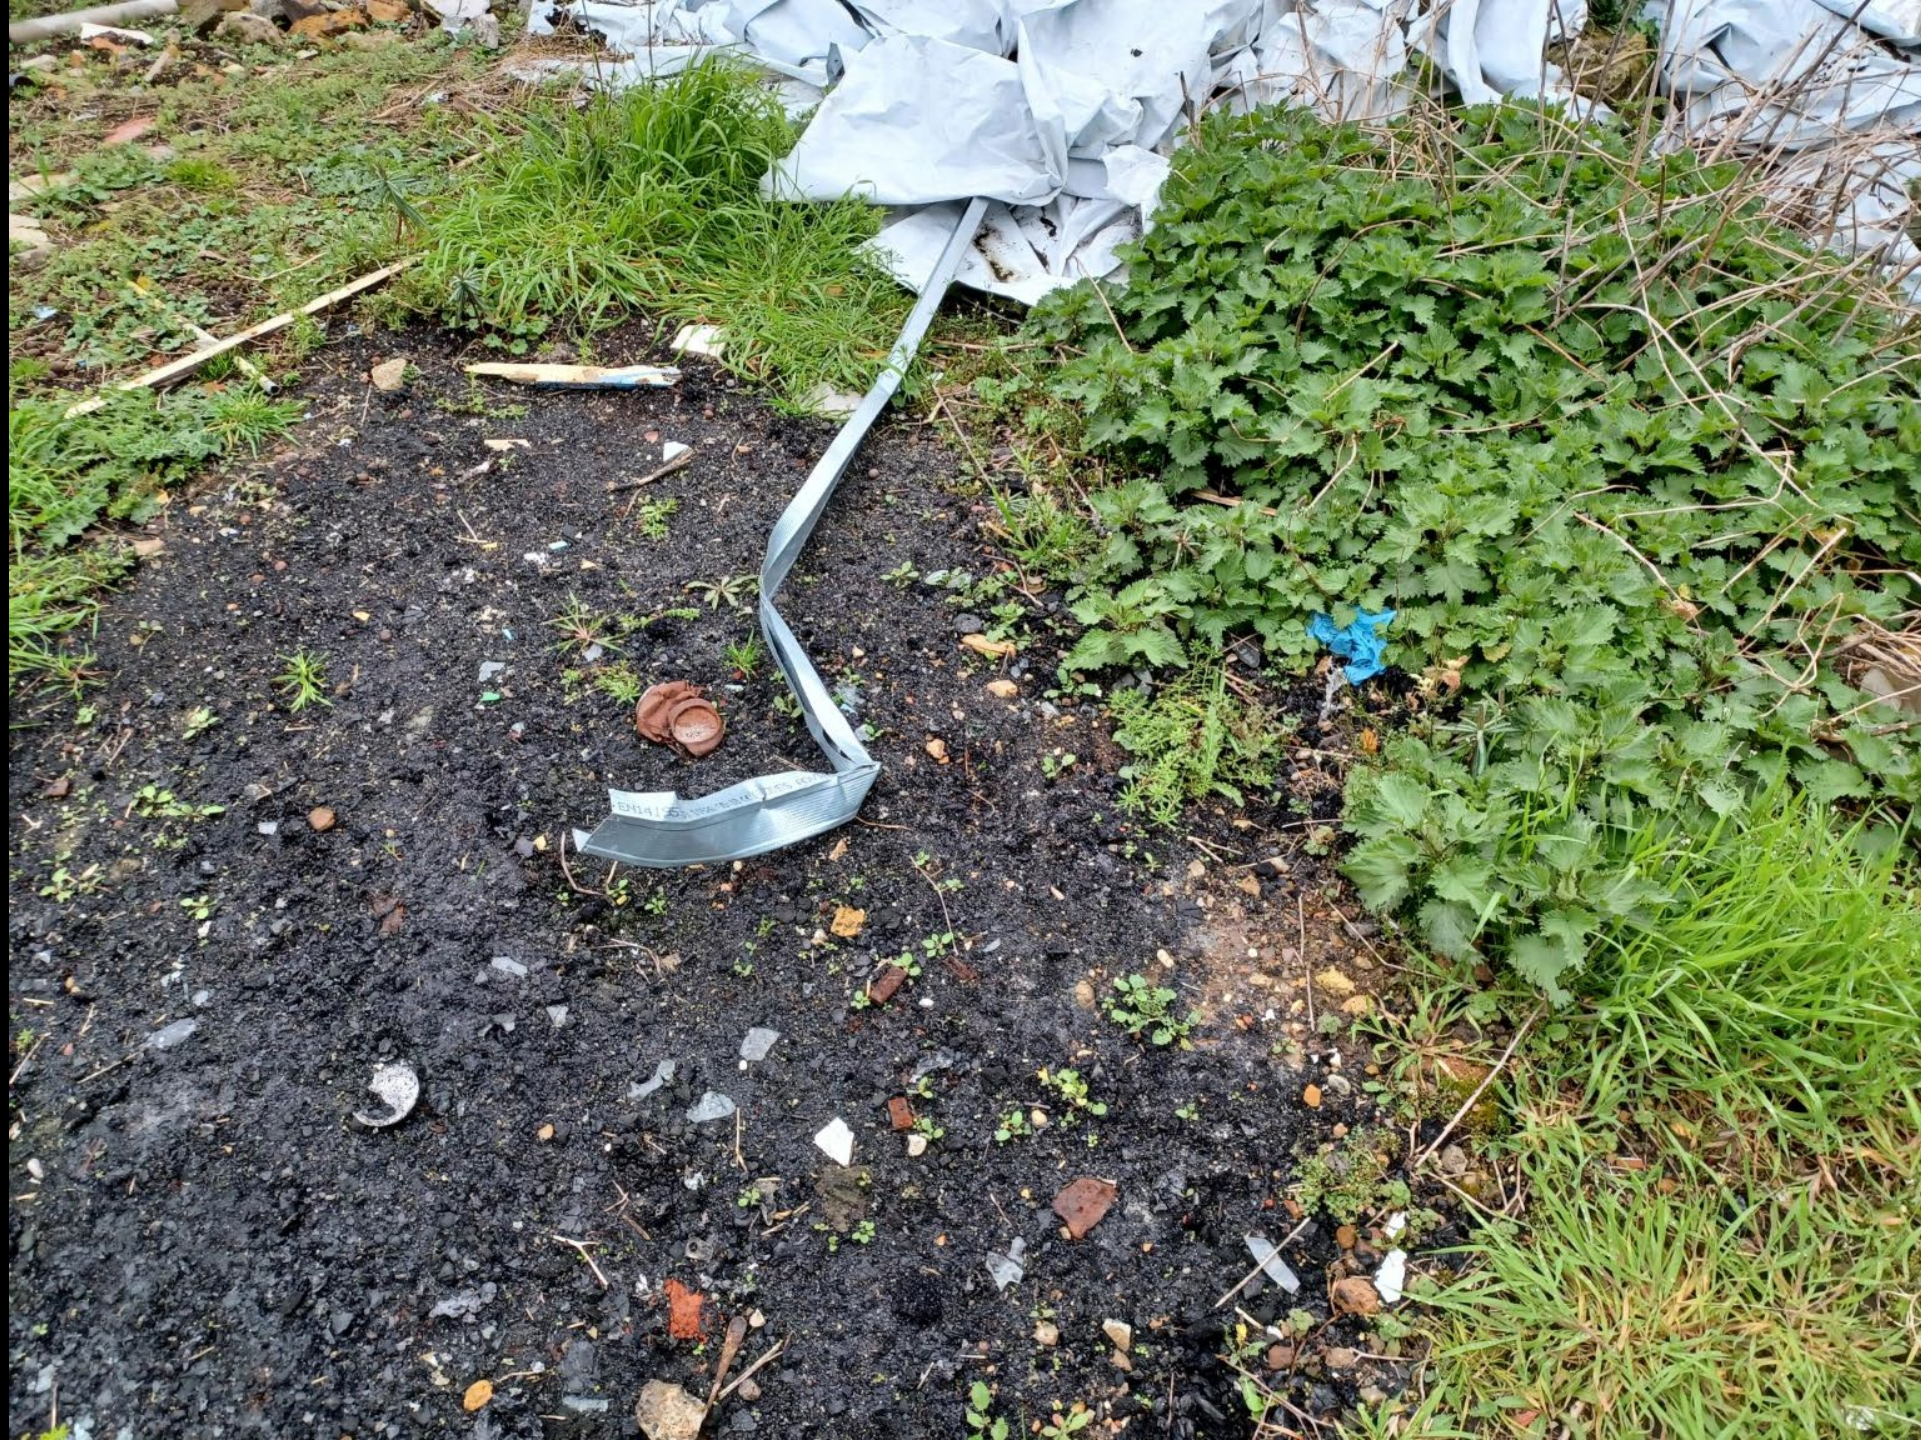
**ORD/35 – Sharp  
metal  
object sticking up  
from ground.**

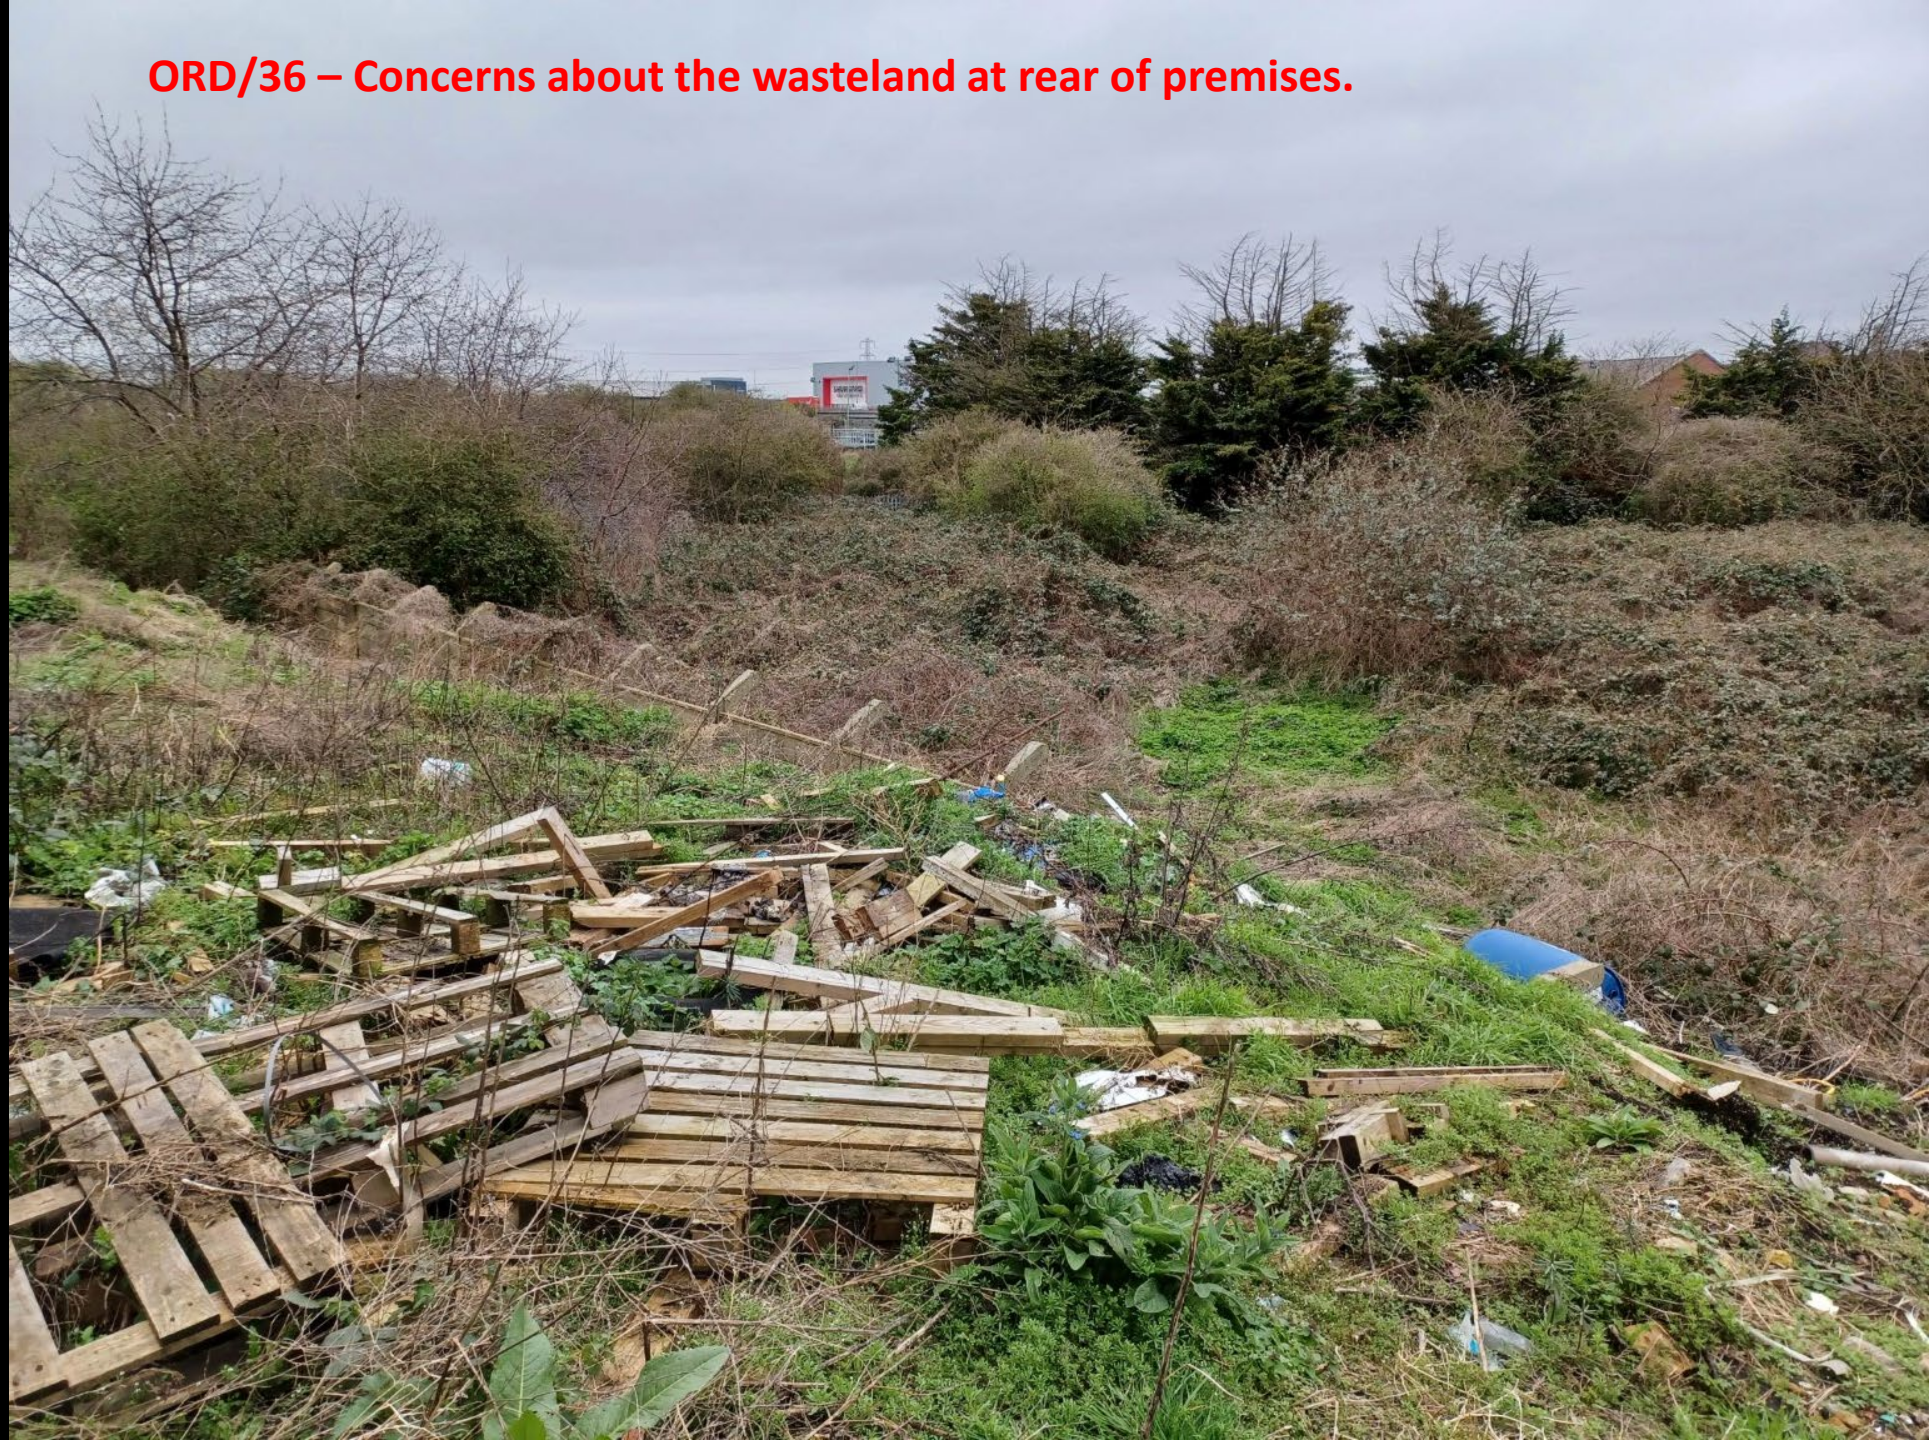
**ORD/36 – Concerns about the wasteland at rear of premises.**

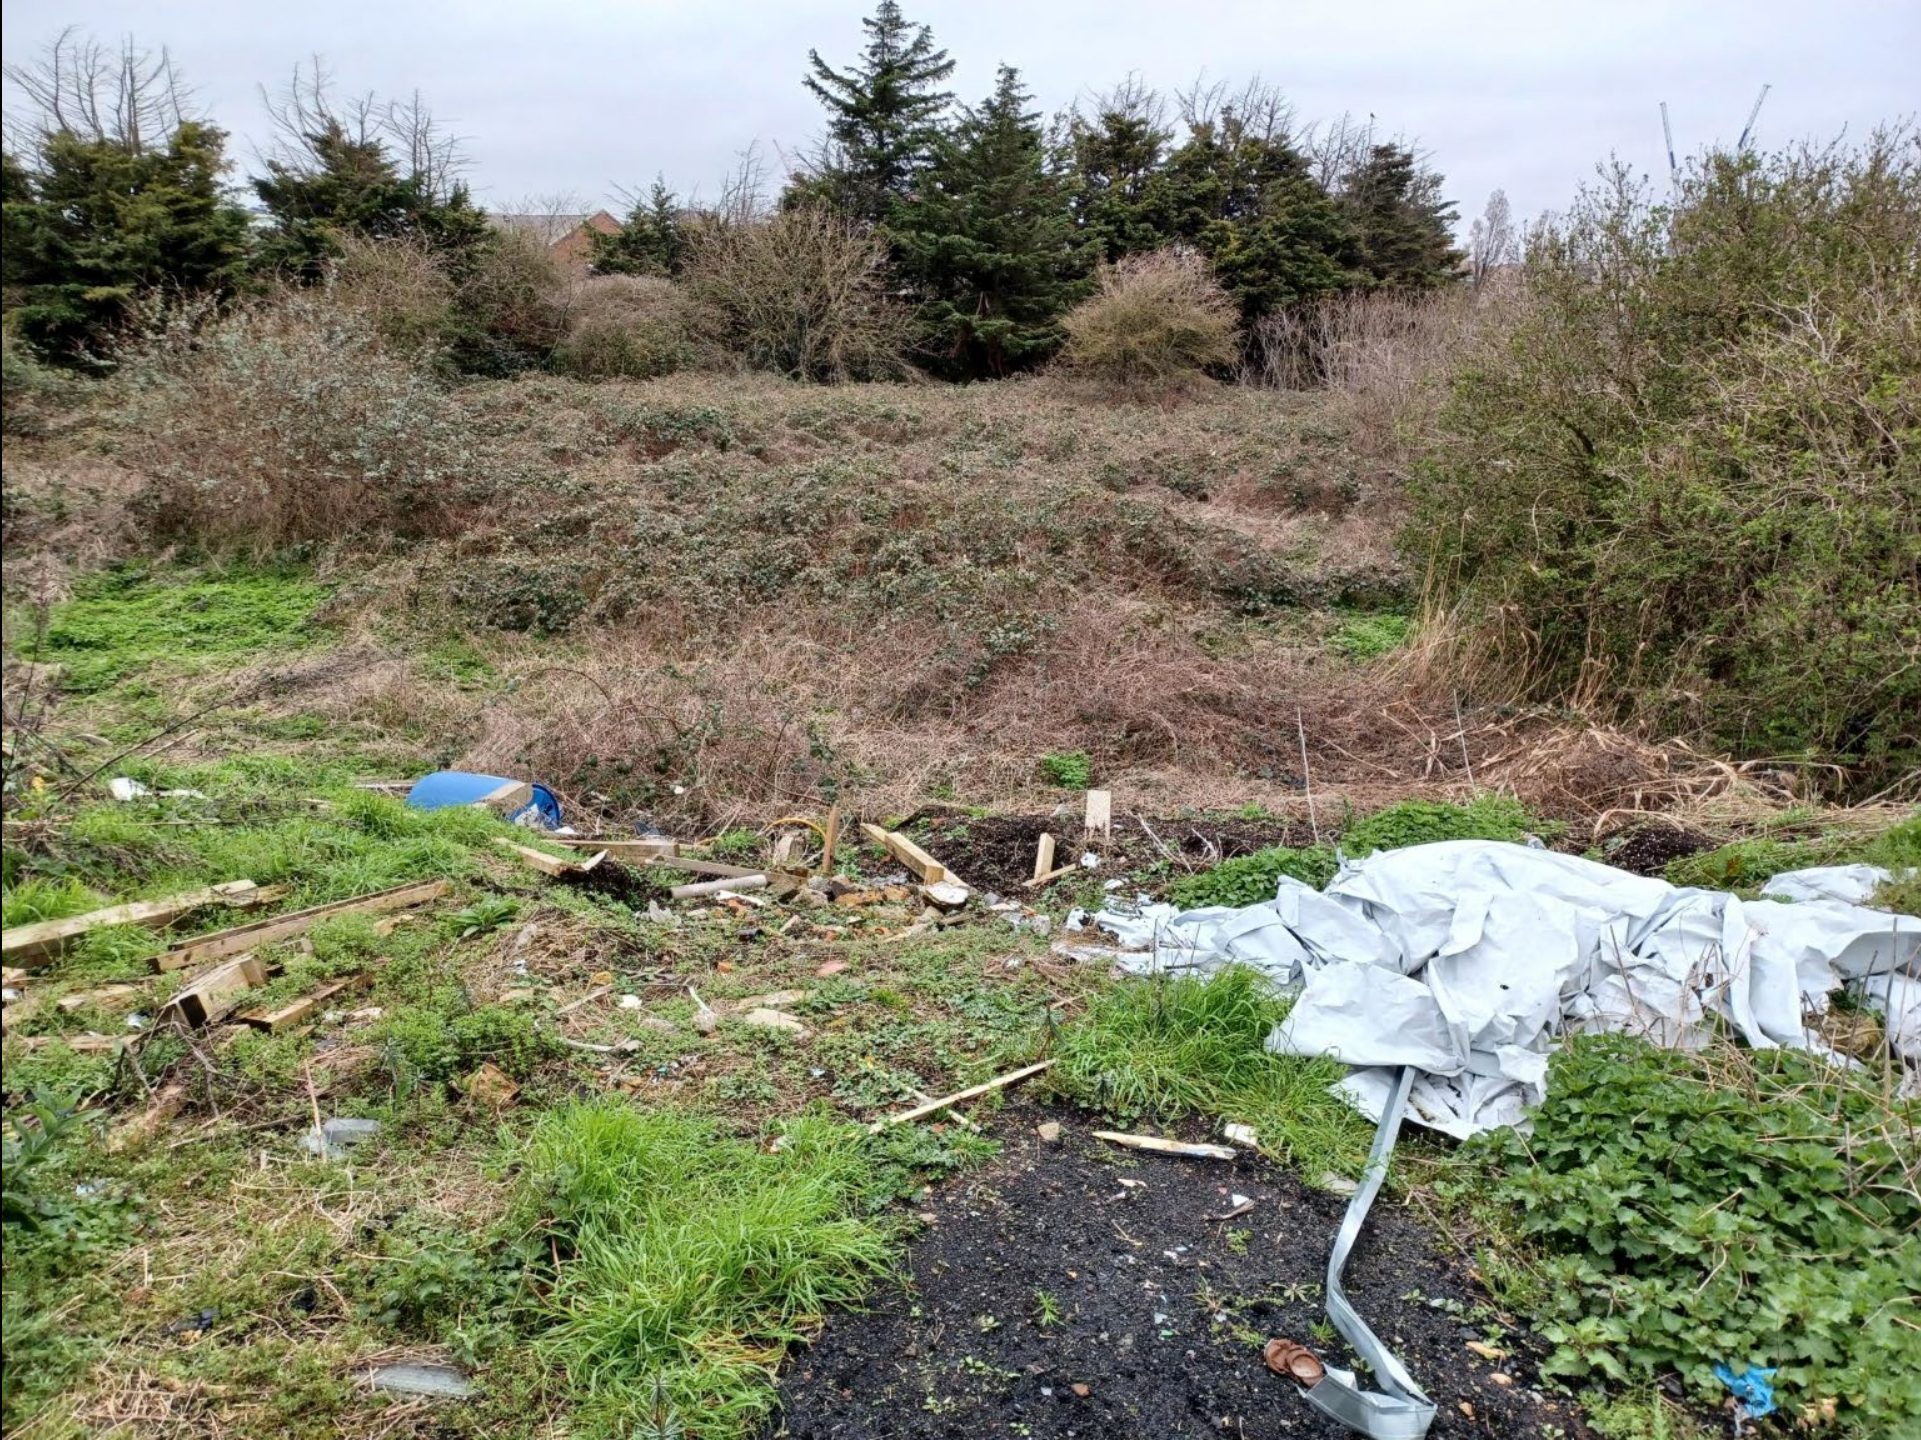
**ORD/37 – Concerns about the wasteland at the rear of the premises.**
