SUPPLEMENTARY AGENDA 3

121 Broad Street

Noise Impact Assessment

Report reference
2122252_NIA1 (DRAFT)

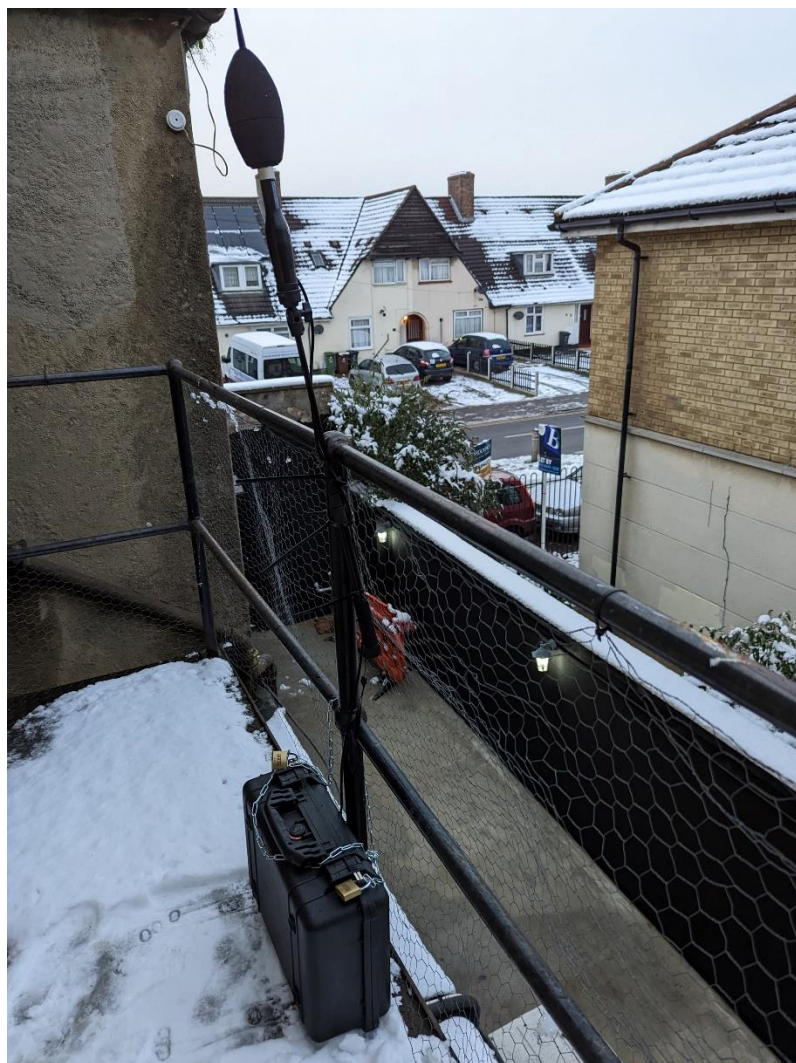
Photo 1 Unattended survey location UA1.

It should be noted that results at UA1 were affected by noise from condenser units located in the northern side alley serving 121 Broad Street during the day, until approximately 16:30 when workers left site and they were turned off. However, it could be argued that this forms a legitimate part of the existing noise climate around site.

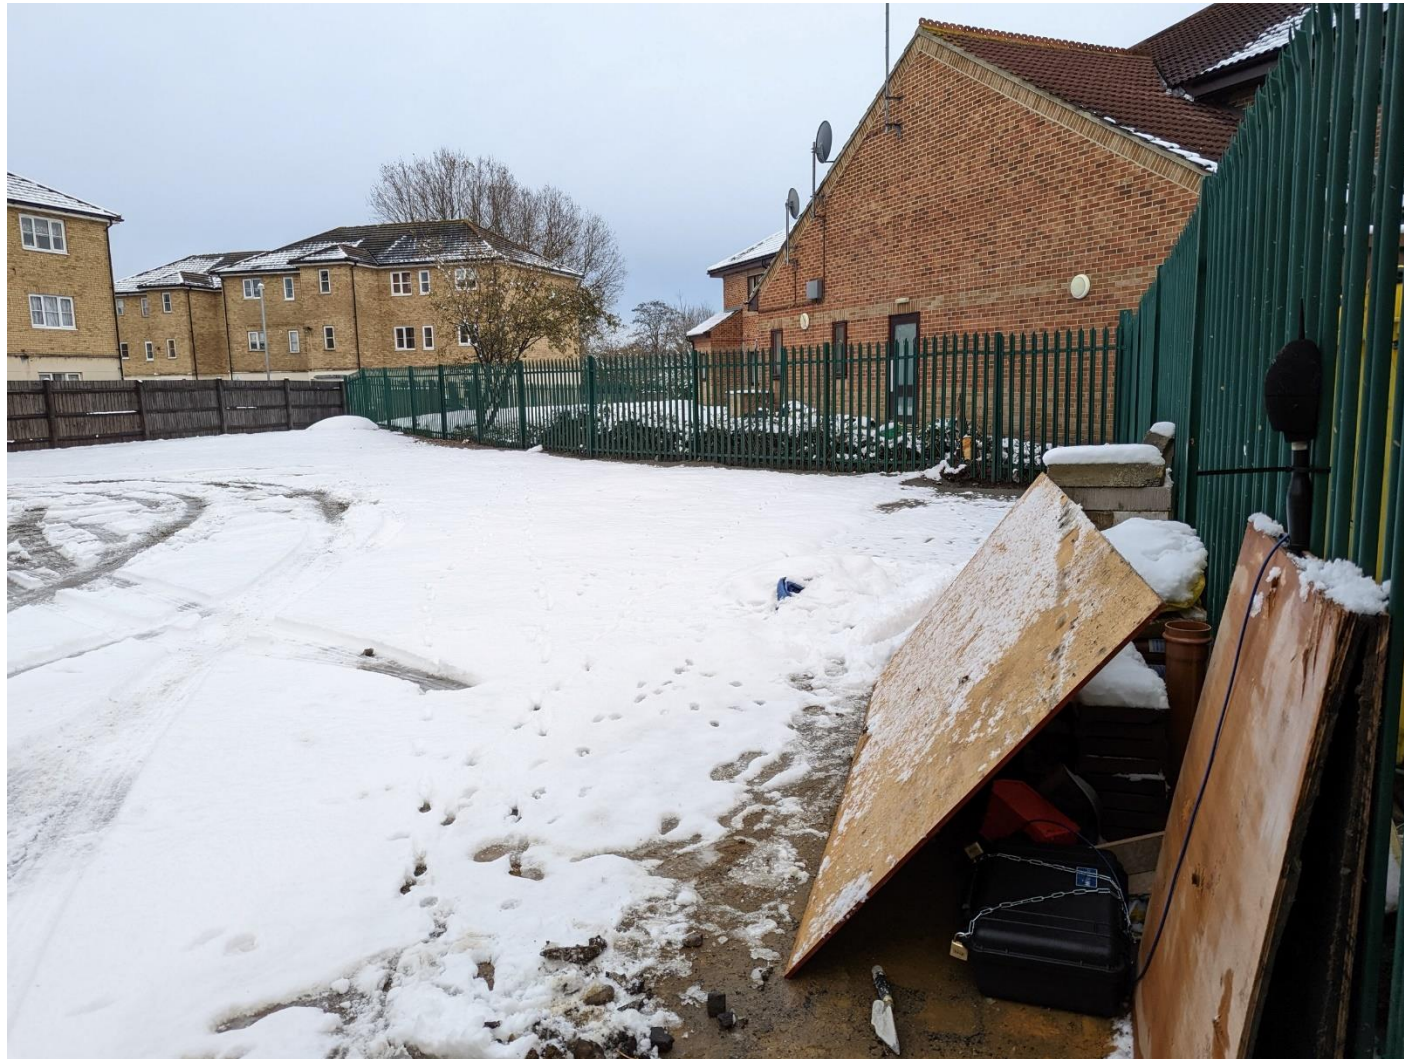
Photo 2 Unattended survey location UA2.

| Measurement position | Description |
|---|---|
| UA2 | The microphone was located at ground floor level in the rear car park to the east of site. This position is thought to be representative of NSR3 and NSR4. The microphone was secured flat against a fence rail, approximately 1.5m from ground level. See Photo 2. |

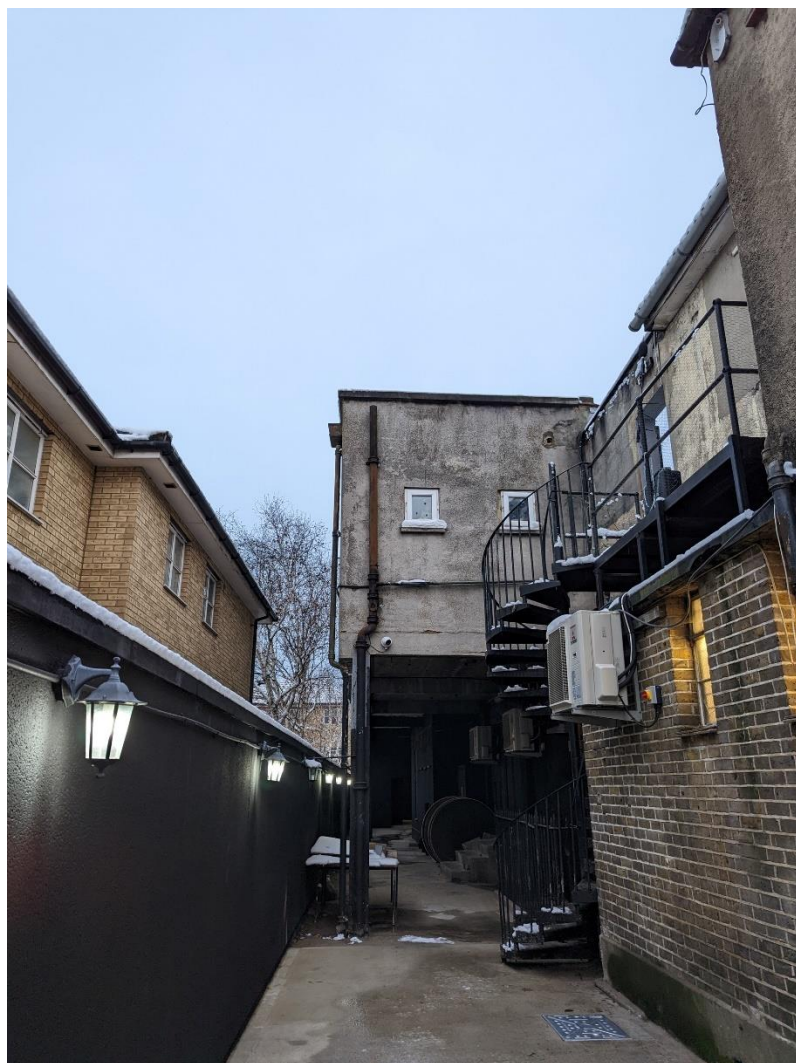
Photo 3 Northern side alley

The Client has suggested enclosing the area underneath the cantilever to provide a sound lobby to the fire escape and façade. Enclosing this area of the façade with a suitably-specified independent stud construction and acoustic doorset would provide a substantial uplift to the sound insulation of the façade. However, it should be noted that any remaining portions of the façade of the main hall which remain exposed would still be an acoustic weakpoint.

There are a number of considerations in closing off this area, including the existing wall-mounted condenser units, fire egress, drainage, access to the basement and interaction with existing fire escape staircase. **We would recommend investigating the potential to enclose the area underneath the cantilevered commercial units, and any additional exposed areas of main hall façade with a suitably-qualified architect.**

We recommend speaking to a suitably-qualified architect about enclosing the area underneath the cantilevered commercial premises in the northern alley, to uplift the sound insulation of the building envelope in this area.

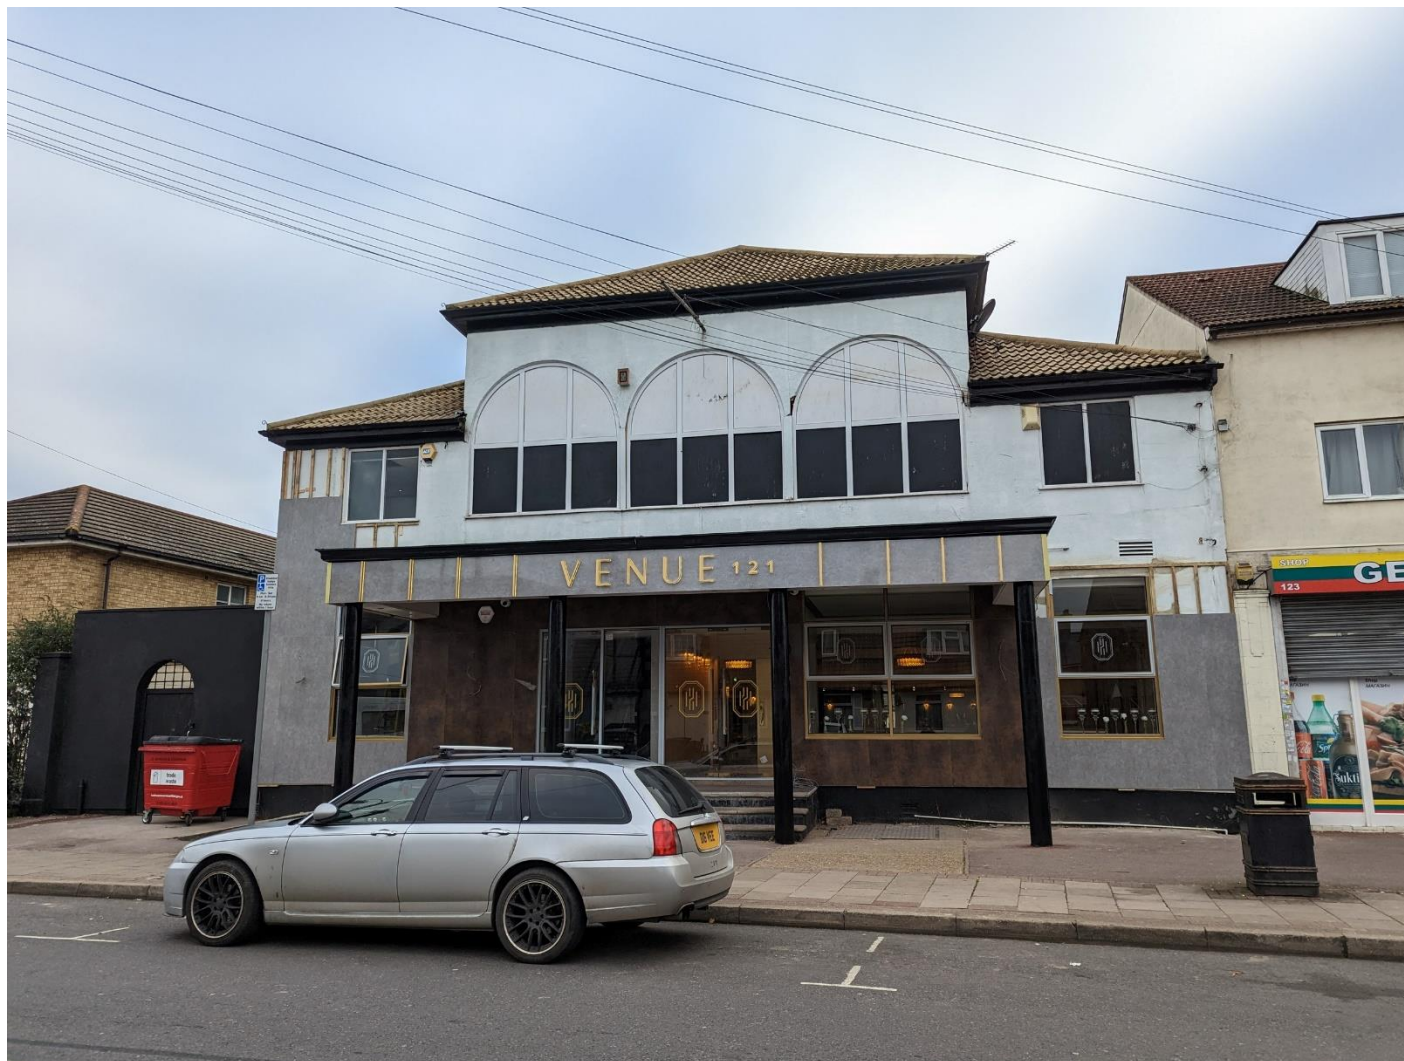
Photo 4 Front façade

We would recommend a similar room is constructed on the right hand side, so that the main hall does not have windows directly onto the façade overlooking Broad Street. The wall should comprise an independent double stud partition with a minimum laboratory rating of R_w+C_{tr} 52 dB, and an acoustic doorset with a minimum laboratory rating of R_w 30 dB. We are not aware of the acoustic performance of the wall and door to the left of the front door. We would suggest this is confirmed and updated, if necessary. The wall should span through the ceiling bulkhead into the soffit, so that the room is fully closed off from the main hall except for the door.

We recommend uprating the sound insulation of the front façade by improving the doors and creating a small, separate room on to the right of the main entrance, similar to the room to the left.

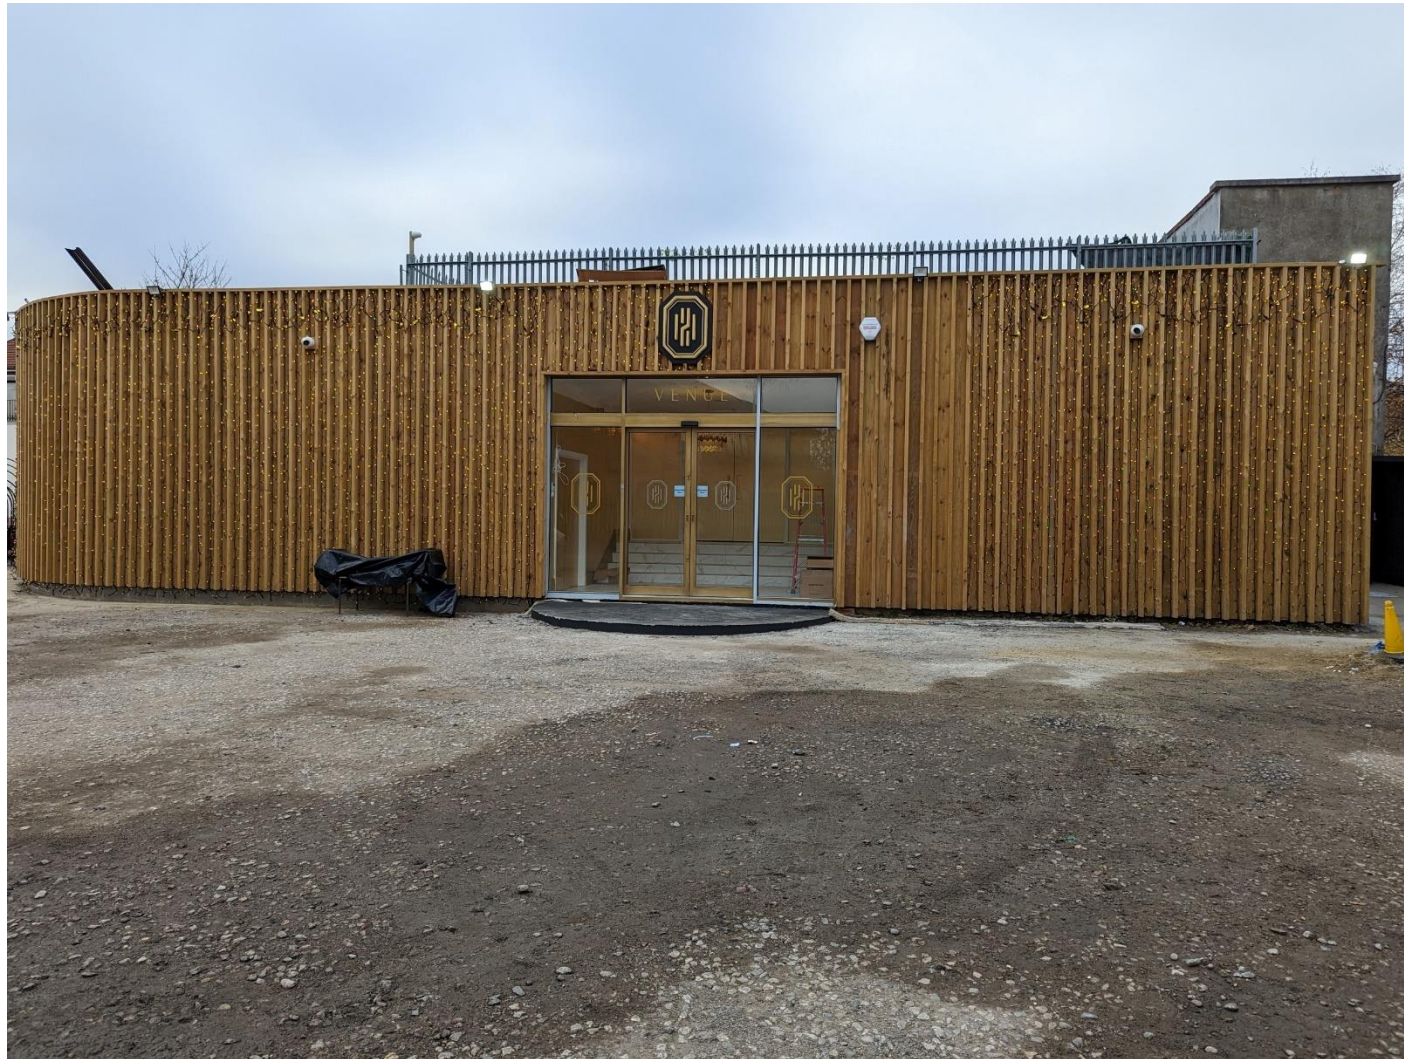
Photo 5 Rear facade and entrance (view from rear car park)

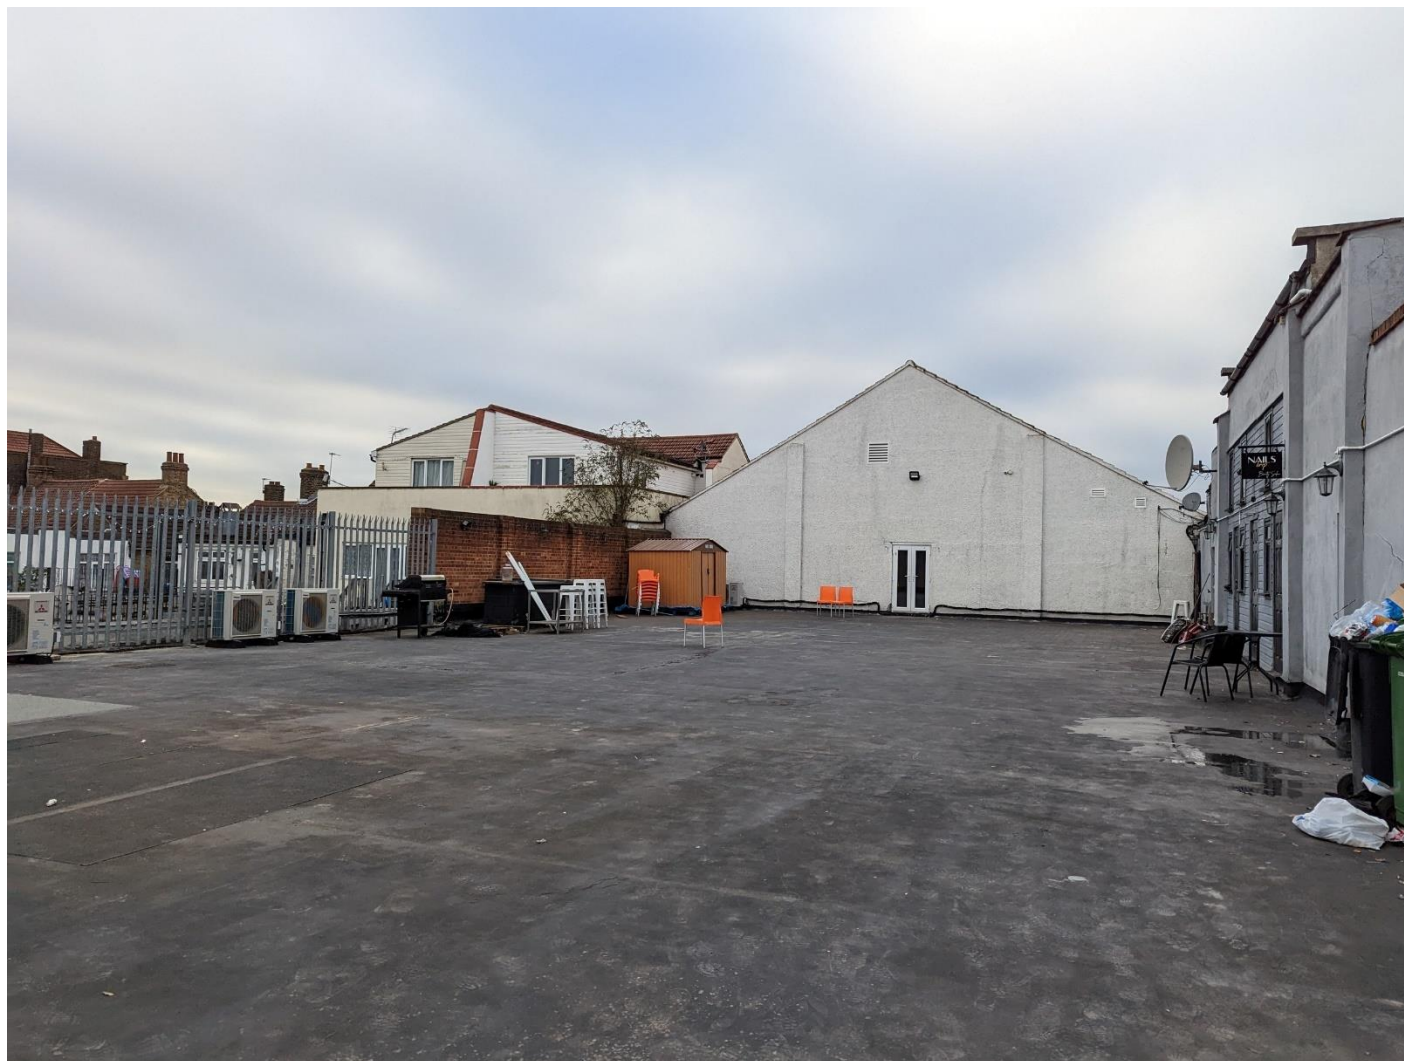
Photo 6 Flat roof (first floor level), facing west

| Reference | Description | Building element contributing most to noise emissions at NSR |
|---|--|--|
| NSR3 | Rear facades of properties on Broad Street. | Flat roof (first floor level). |

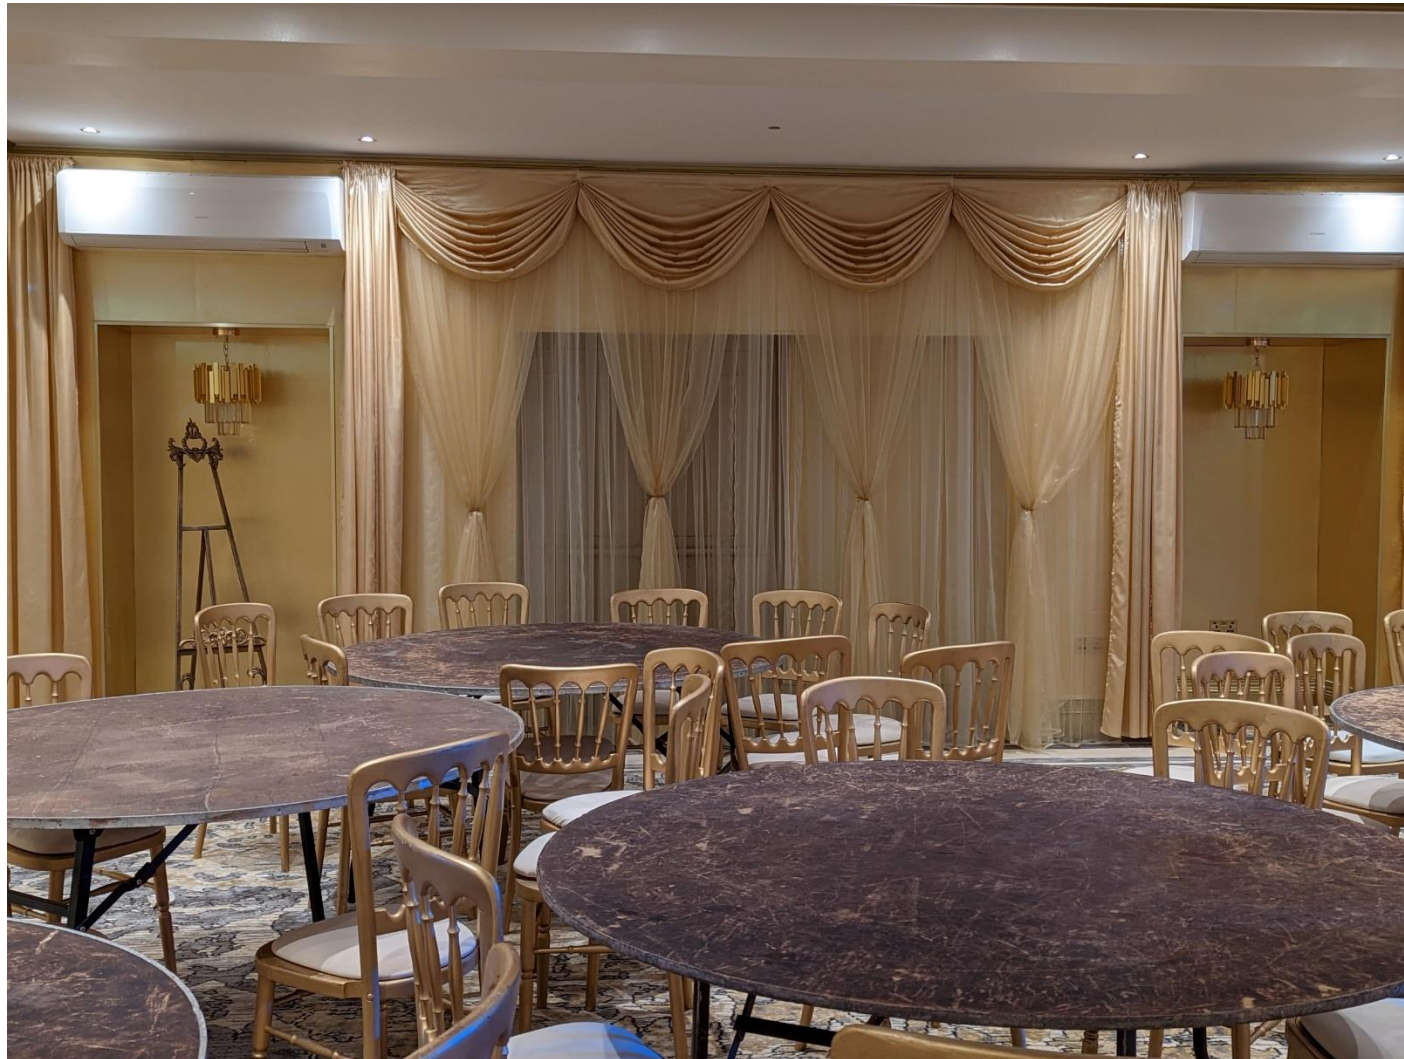
Photo 9 Internal photograph facing northern fire exit.

Internal photographs are presented in Photo 7 to Photo 9 in the Appendices.
