ABBEY AND BARKING TOWN CENTRE  
CONSERVATION AREA APPRAISAL  
AND MANAGEMENT PLAN  
OCTOBER 2020

# ABBEY AND BARKING TOWN CENTRE: CONSERVATION AREA APPRAISAL AND MANAGEMENT PLAN

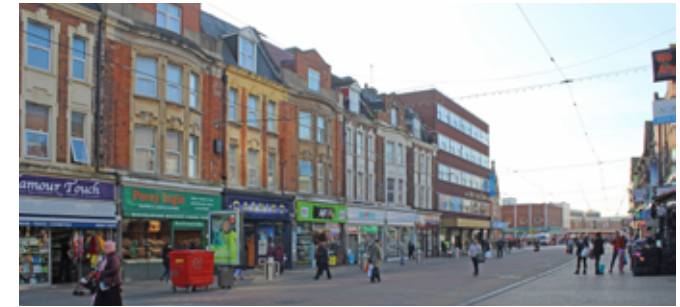
Character Area 1: East Street is home to Barking's market and is the principal retail street in the town centre

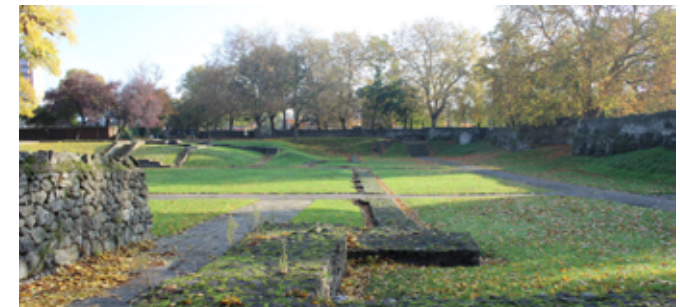
Character Area 2: The establishment of Barking Abbey was pivotal to the history of Barking. The remains of the Abbey Church and cloister are demarcated by low stone walls.

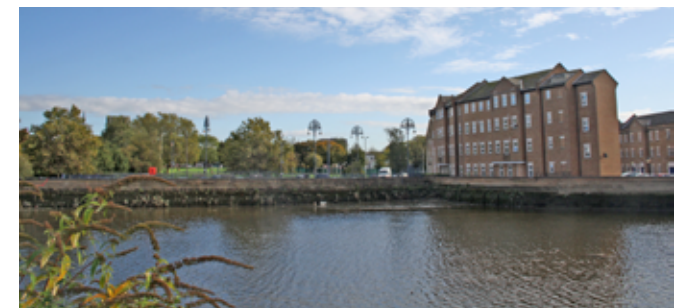
Character Area 3: The Town Quay on the River Roding was originally significant for being the location for receiving goods for the Abbey and was then the heart of Barking's fishing industry. Today it is a pleasant public space.

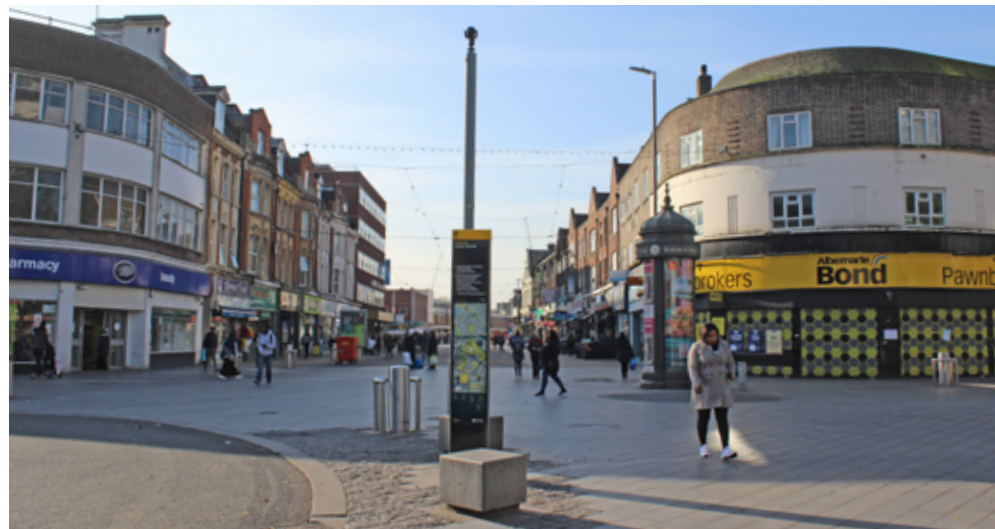
*One of the two principal junctions within the conservation area is at the junction of Ripple Road and East Street; it forms an important public space.*

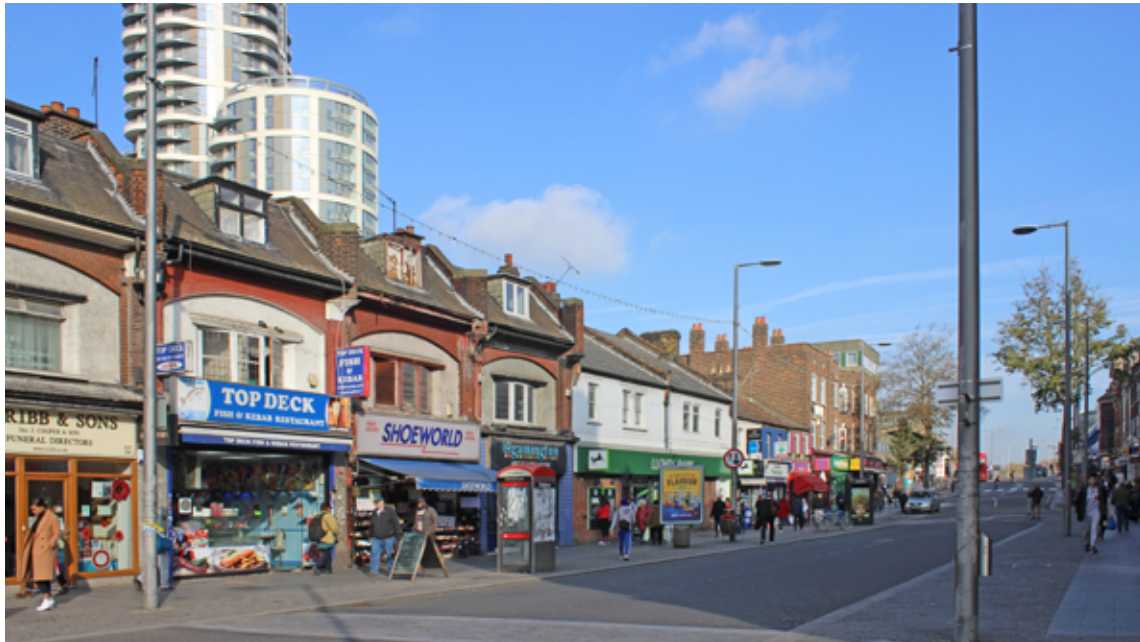
The fine-grain, narrow fronted plots which characterise Station Parade.

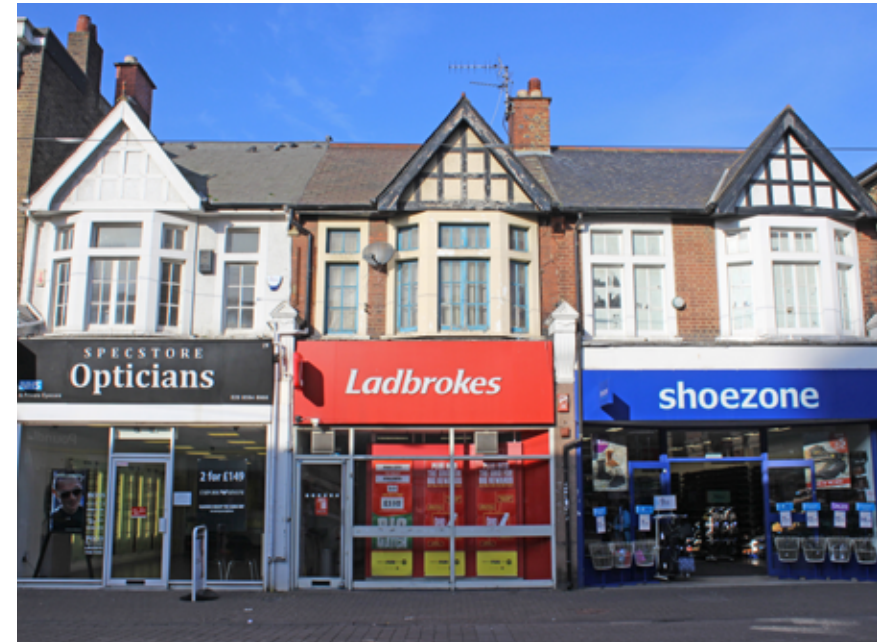
Narrow fronted plots along East Street.

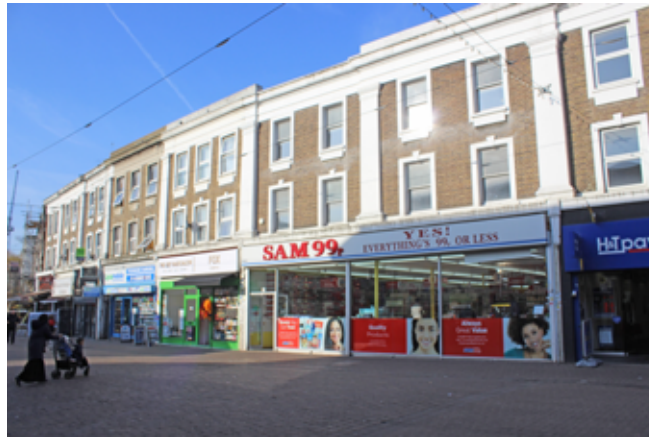
Three storeys terraced buildings on the north side of East Street.

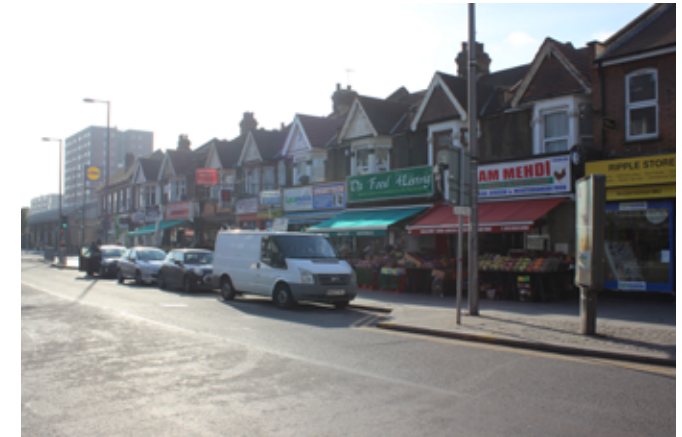
Two storey terraced buildings in Ripple Road.

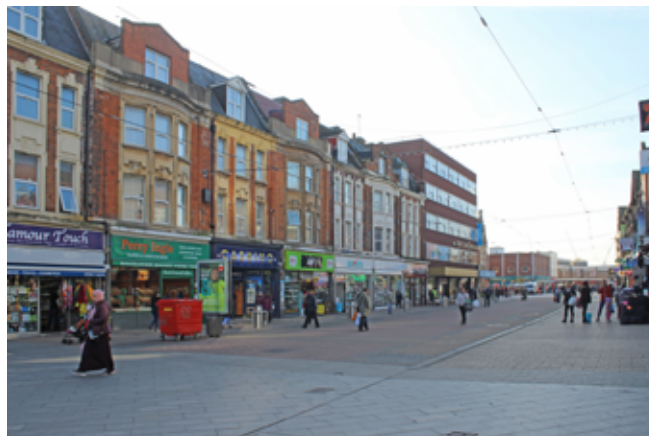
Three storeys terraced buildings on the south side of East Street with attics in the pitch roofs and a five storey office building beyond.

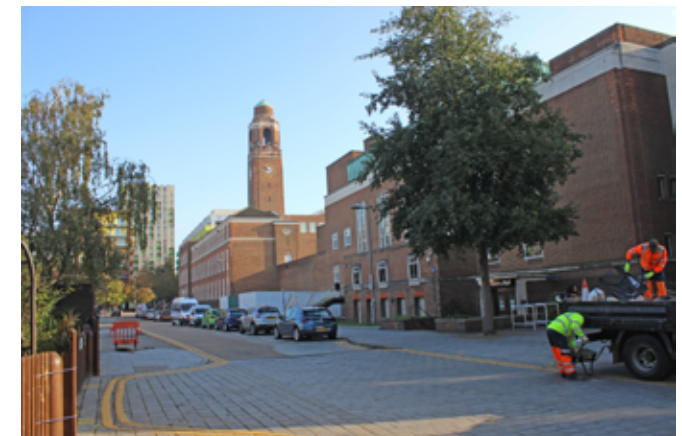
The clocktower of the three storey Town Hall is visible from across the conservation area.

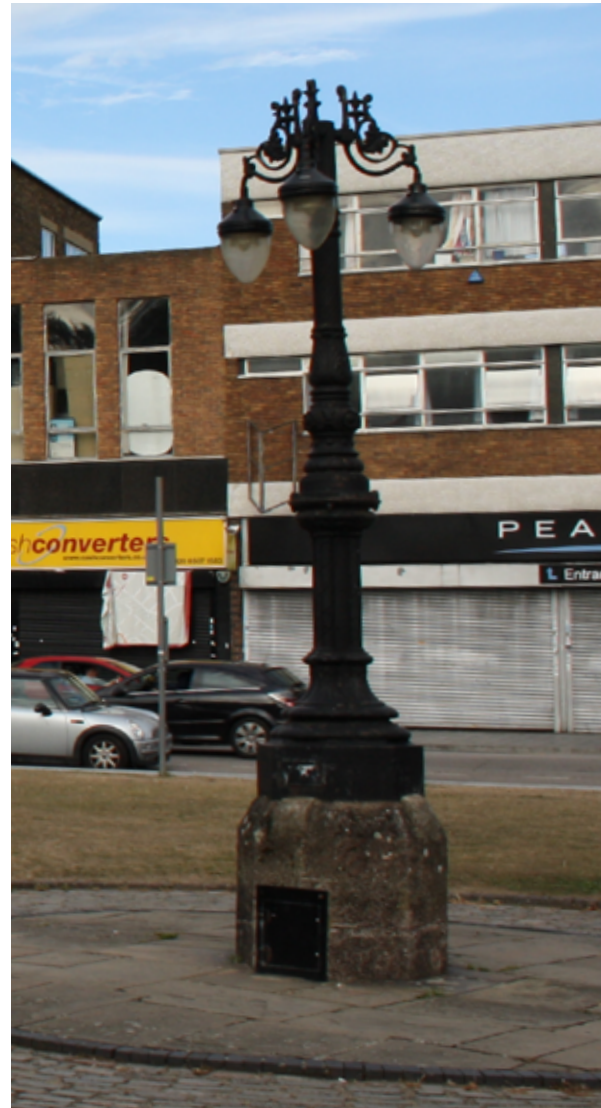
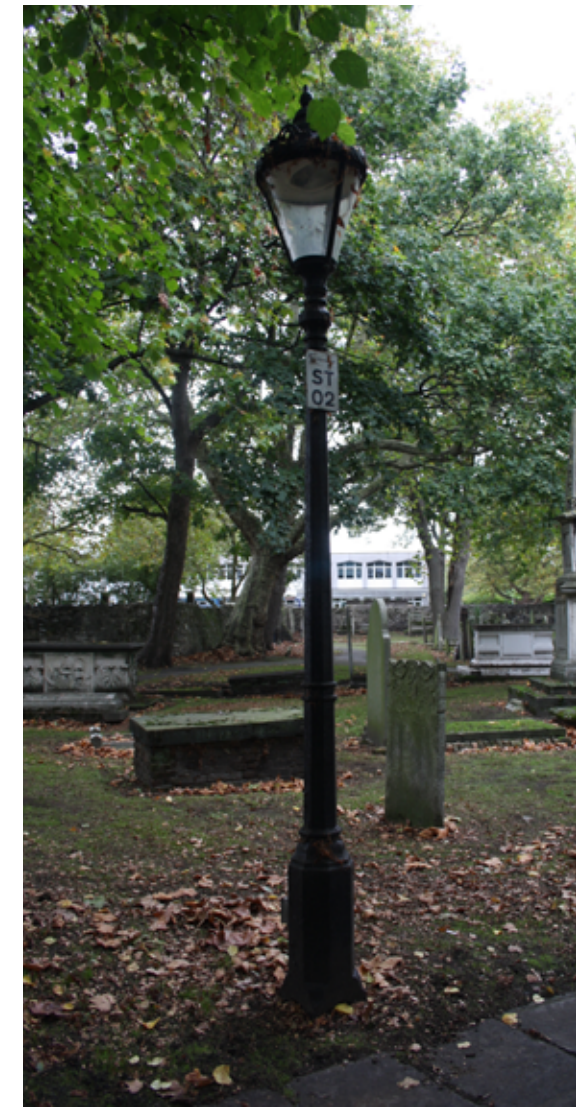
Examples of historic lamp standards in the conservation area

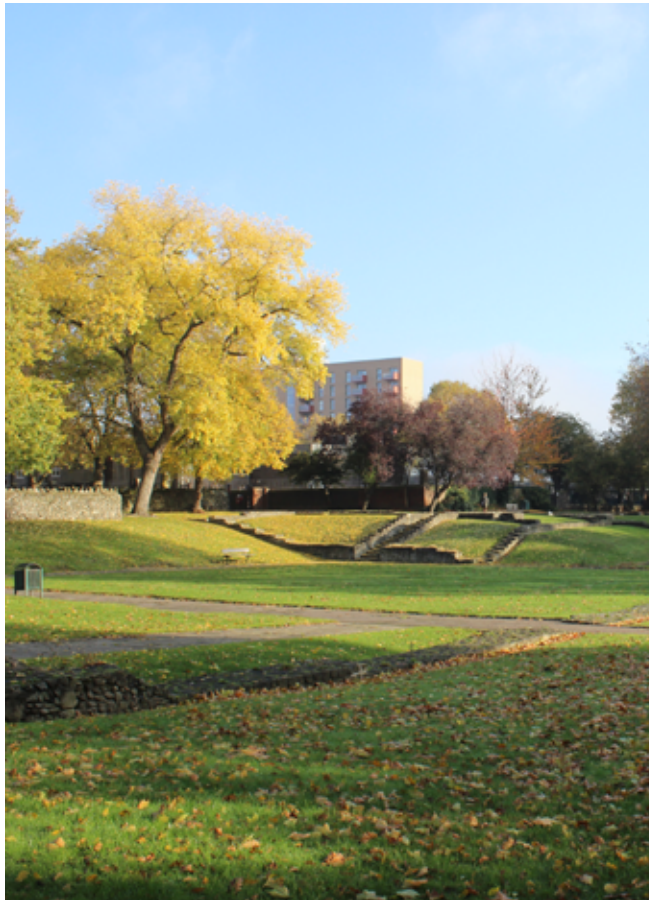
The remains of Barking Abbey are in a sunken but more open public space.

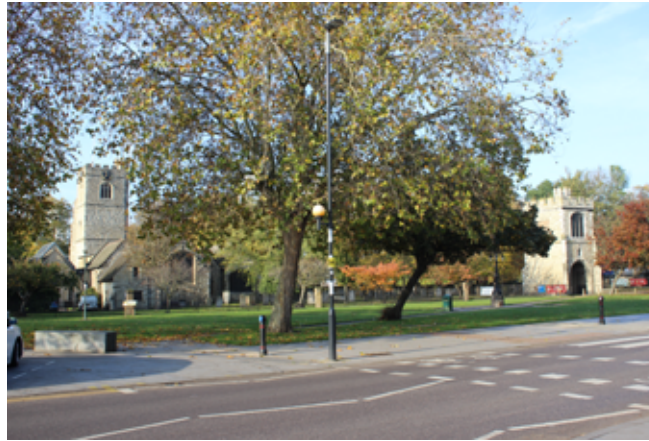
**View 2: View from the junction of Broadway and Clockhouse Avenue looking north-west**

The view takes in two of the most historic buildings in the conservation area, St Margaret's Church, to the left and the Curfew Tower to the right. The Church is listed at Grade II\* and dates back to the late 15th (with 12th century fabric) and the Tower is Grade I and dates to the 13th century. The historic buildings are set within mature trees and the lawns of Abbey Green which add to the character of this view.

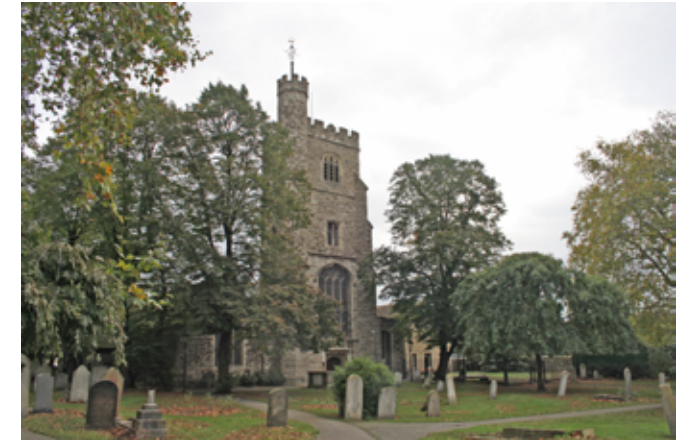
**View 3: St Margaret's Church from the churchyard**

This is one of the best views of the Grade II\* listed St Margaret's Church, looking from the west towards its tower. The church, the oldest parts of which date to the 12th century, is a landmark building within the conservation area with the tower prominent from the southern half of Abbey Green.

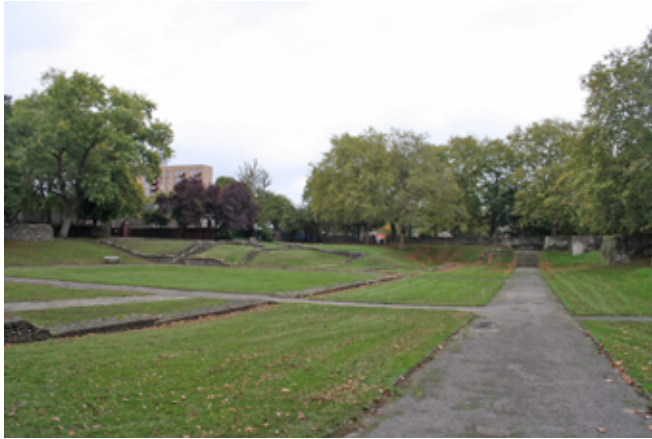
#### View 4: View of Barking Abbey

This view encompasses the open space formerly occupied by Barking Abbey. The abbey is perhaps the most important aspect of Barking's history as without it the town would not have developed and flourished. Only below ground remains survive of the Abbey and these are protected through a Scheduled Monument designation. The layout of the Abbey building and other attached structures is interpreted through the low level walls, themselves Grade II listed.

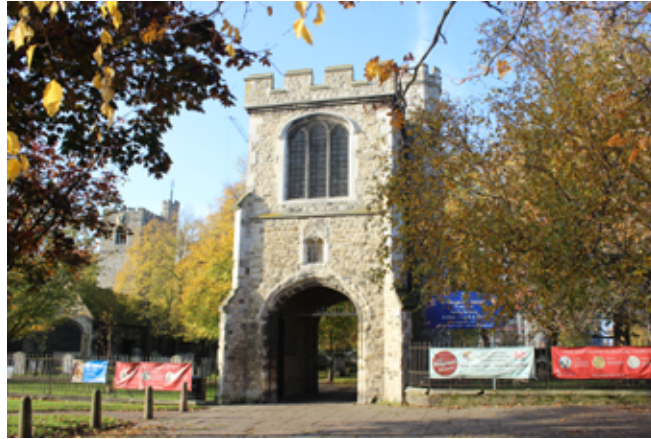
#### View 5: View of the Curfew Tower

This close view of the Curfew Tower is taken from the area of public realm which forms a forecourt to it. The Tower is Grade I listed, recognising its importance as the only surviving building of the Barking Abbey complex.

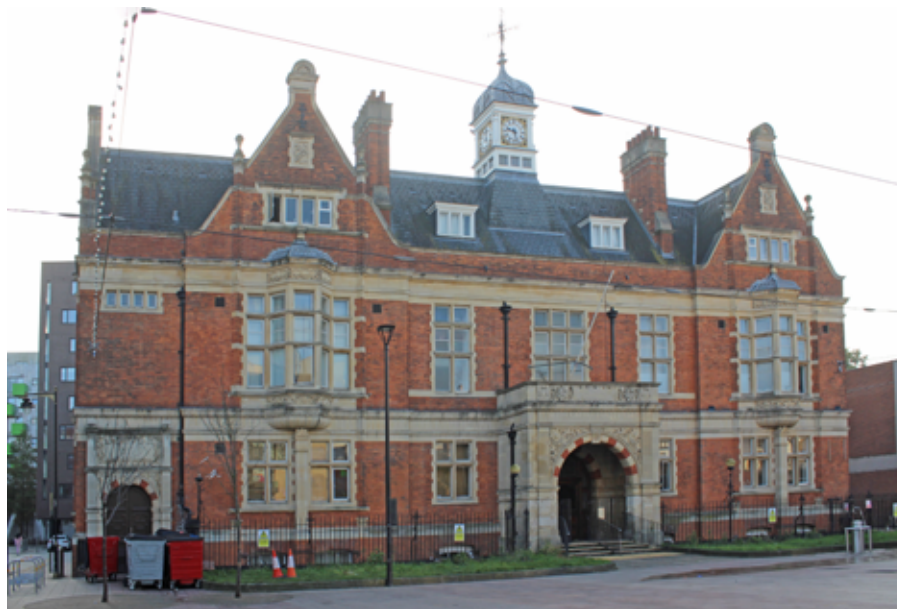
*Barking Magistrates' Court is a landmark building for its highly decorative appearance and position at the heart of East Street.*

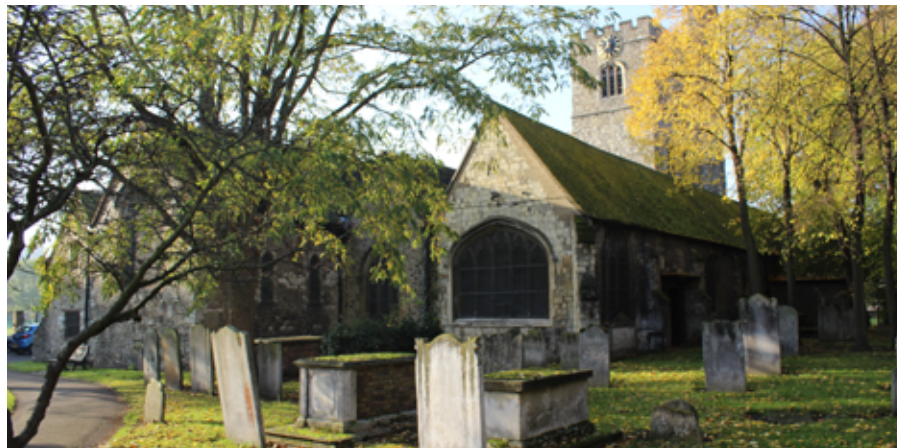
*St Margaret's Church is a landmark building, its tower in particular is visible from across Abbey Green.*

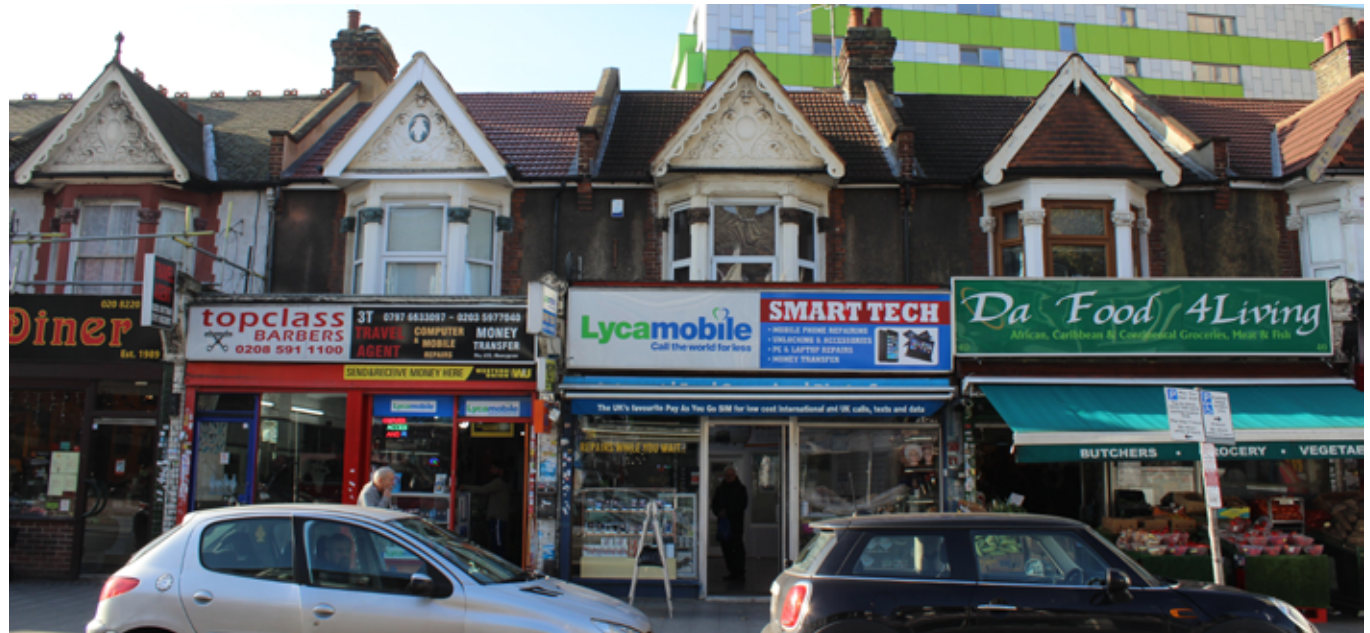
Nos. 40-46 Ripple Road are positive buildings, despite later insensitive modern shop fronts and signage

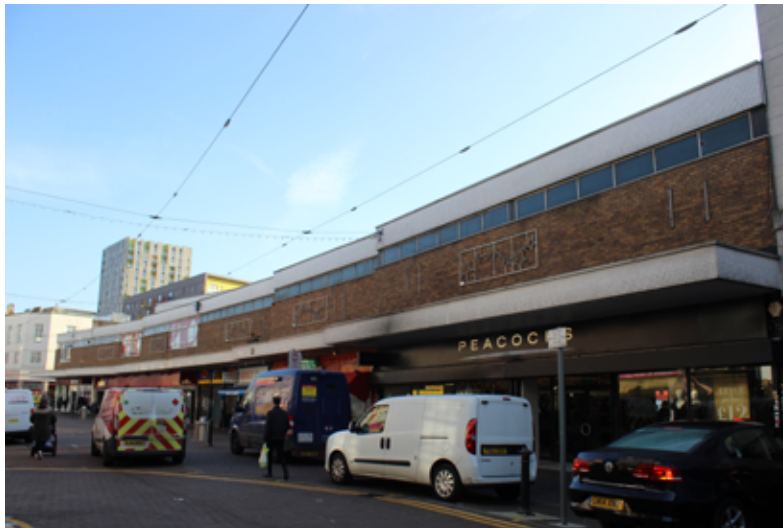
*10-30 East Street is a detracting building.*

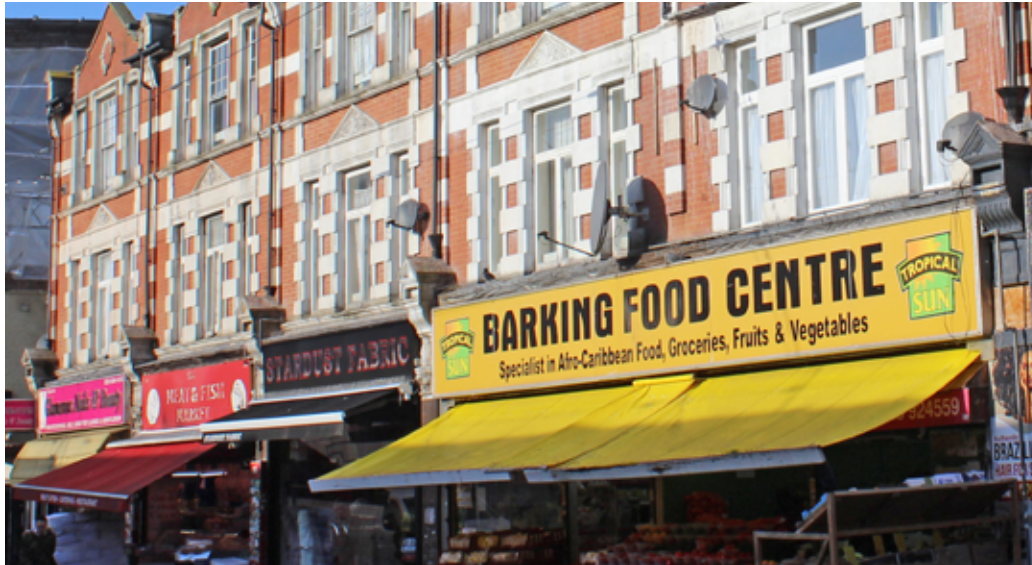
Satellite dishes attached to principal elevations of buildings in the conservation area.

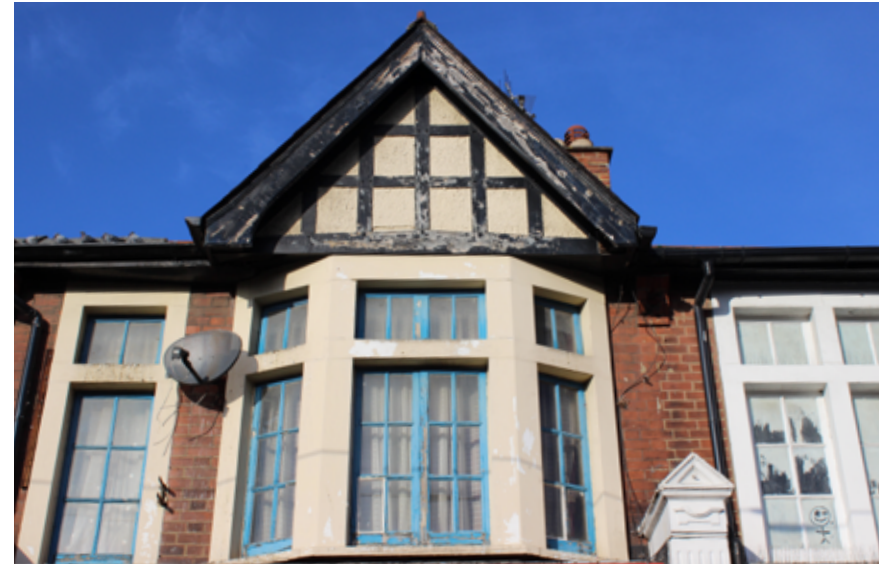
This building has peeling paintwork to both the gable and windows, exposed wiring and a satellite dish, all of which detract from the appearance of the conservation area.

Overall, there are opportunities to improve the awareness amongst local owners and occupiers of the importance of building maintenance and, where necessary, sensitive like-for-like repairs to prevent degradation and also increase awareness of what alterations are appropriate.

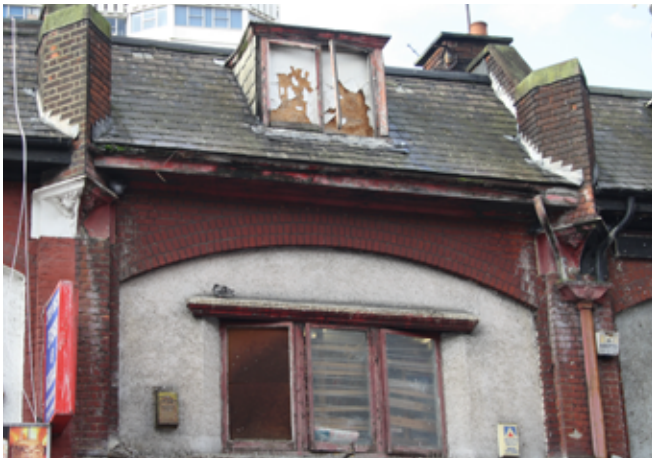
This building is in an extremely dilapidated condition due to lack of maintenance.

Many buildings are in need of maintenance and repair to reverse the prevalent issues in the conservation area such as foliage and shrubbery growth, slipped tiles, guano build up, blocked drainage goods, discolouration / dirt build up on render and stonework, peeling paintwork, and rotting timber windows. Appropriate and regular building maintenance will not only improve the appearance of the conservation area it will also be of considerable benefit to the buildings themselves, ensuring that they function effectively and will survive for future generations to enjoy.

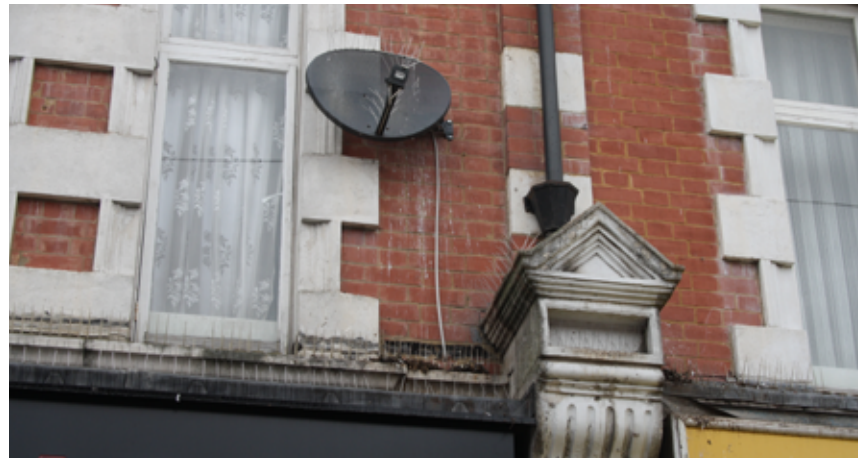
Pigeon spikes are used extensively in the conservation area, they detract from the conservation area and are also appear to be ineffective.

Pigeons are a significant issue in the conservation area. Many projecting architectural features possess pigeon deterrent spikes, which are often damaged and have an accumulation of guano and dirt. Guano has collected on other areas of buildings which further detracts from the appearance of the area.

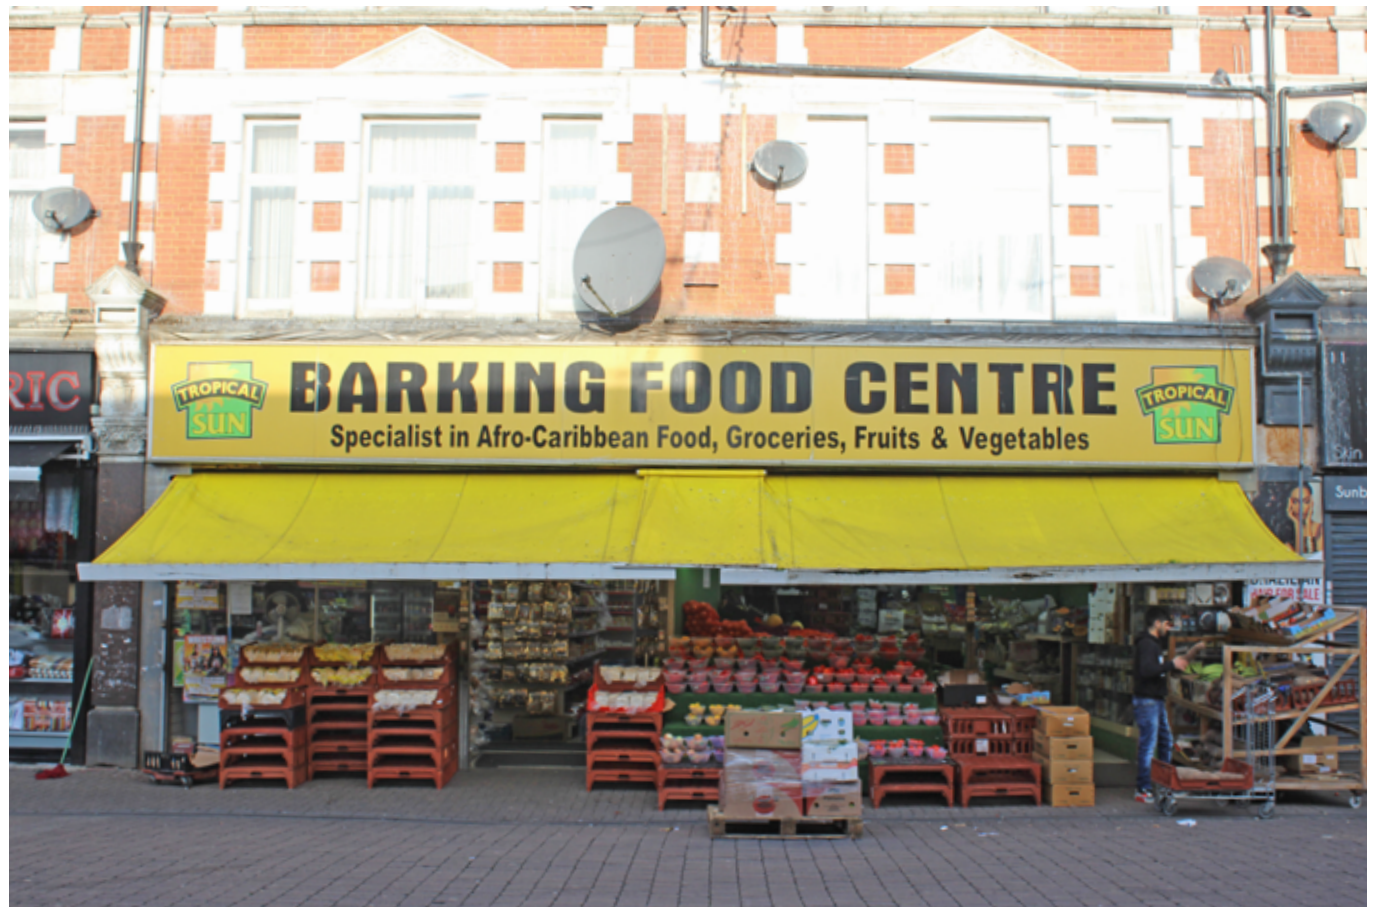
*This shopfront has been extended across two historic units with the pilaster and corbel which would have separated them lost. The frontage also has inappropriate internally lit fascia signage and a poorly positioned and dilapidated canopy.*

There are considerable opportunities to improve the appearance and character of the conservation area through improvements to the shops. Inappropriate shopfront alteration and replacement is one of the main elements which detracts from the appearance of the conservation area. It could be greatly improved through the restoration of more traditional shopfront designs, by reinstating historic features or installation of sensitively-designed, new shopfronts. See section 7.4.4 for details of appropriate traditional shop front forms.

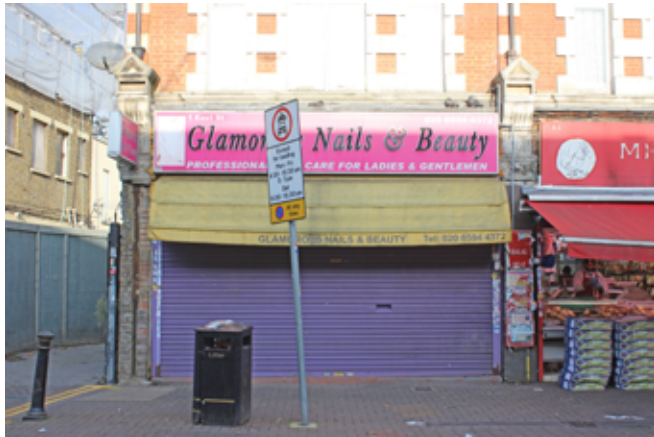
The scale, material and internally lit nature of this shop signage, both projecting and fascia, is inappropriate within the conservation area. Dutch-style canopy is inappropriate as it remains visible when retracted. The canopy is poorly positioned below the signage and is dilapidated. This shop front also has a roller shutter which also detracts.

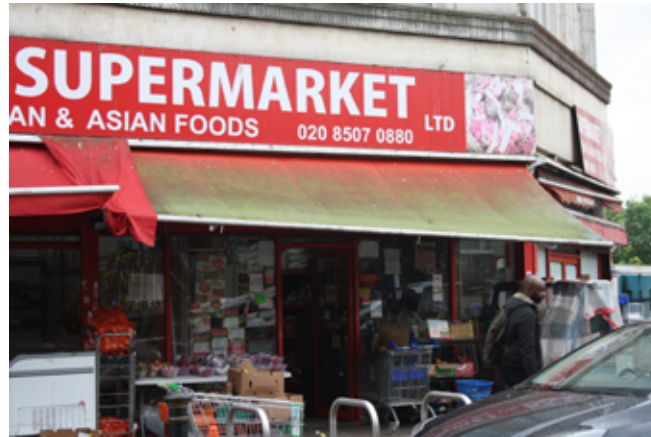
The inappropriate signage and canopy above modern metal shop frontage detracts from the appearance of the building and the conservation area more widely.

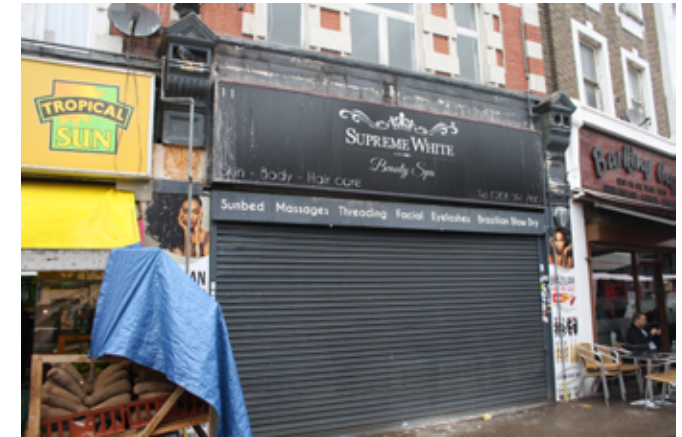
A shop in a dilapidated condition and with inappropriate fascia sign and metal roller shutter.

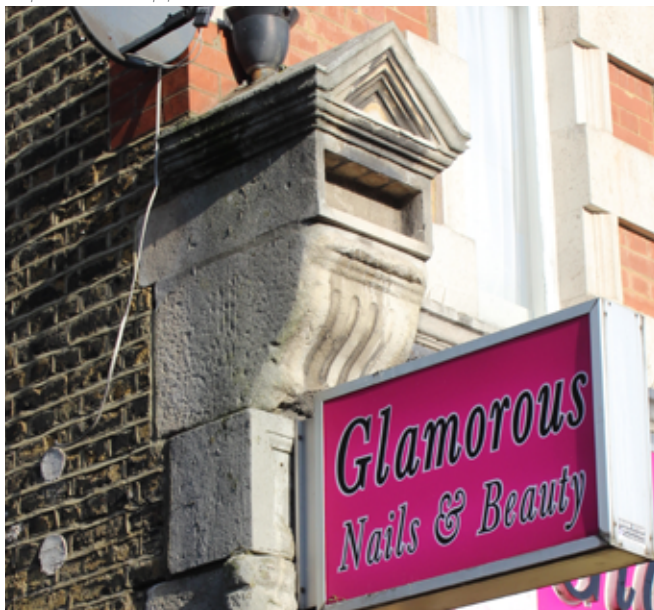
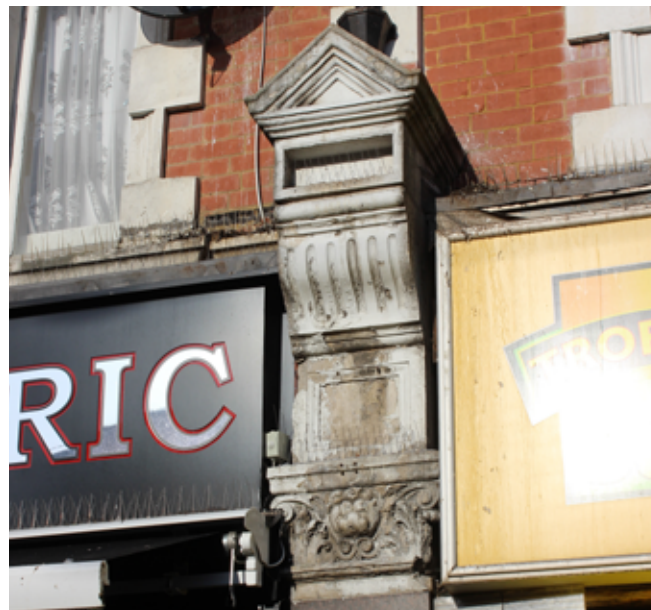
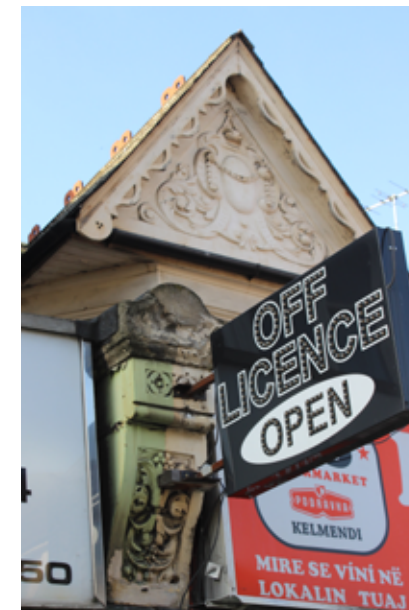
Surviving but damaged historic shopfront corbels often with inappropriately attached projecting signs and pigeon spikes.

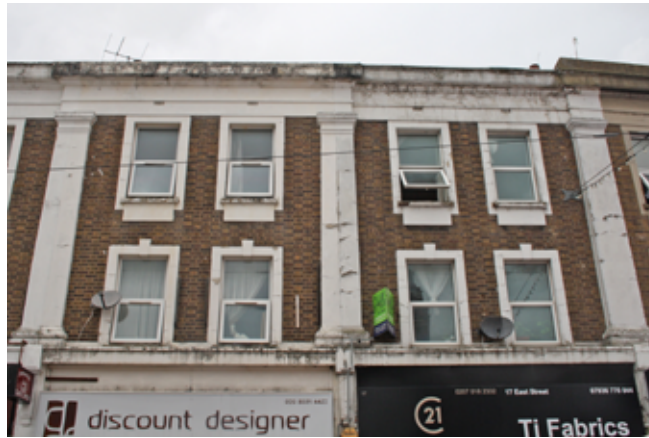
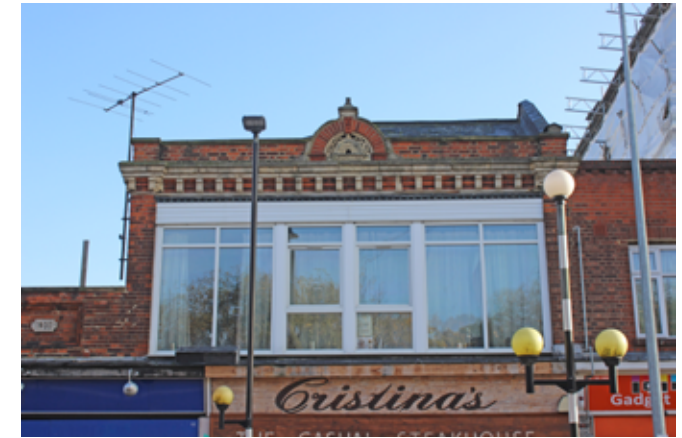
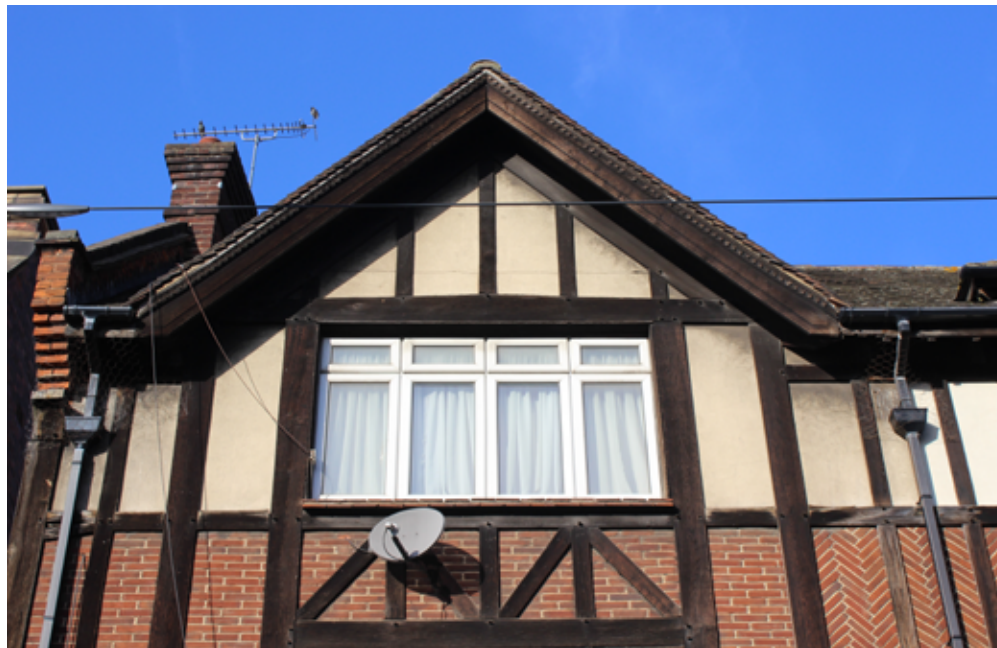
*In insensitive replacement of traditional windows with uPVC units is harming the appearance of the conservation area.*

There are opportunities to improve the appearance and the condition of the built fabric of the conservation area by returning uPVC windows and doors back to traditional timber units. Future change of traditional timber windows to uPVC would be resisted.

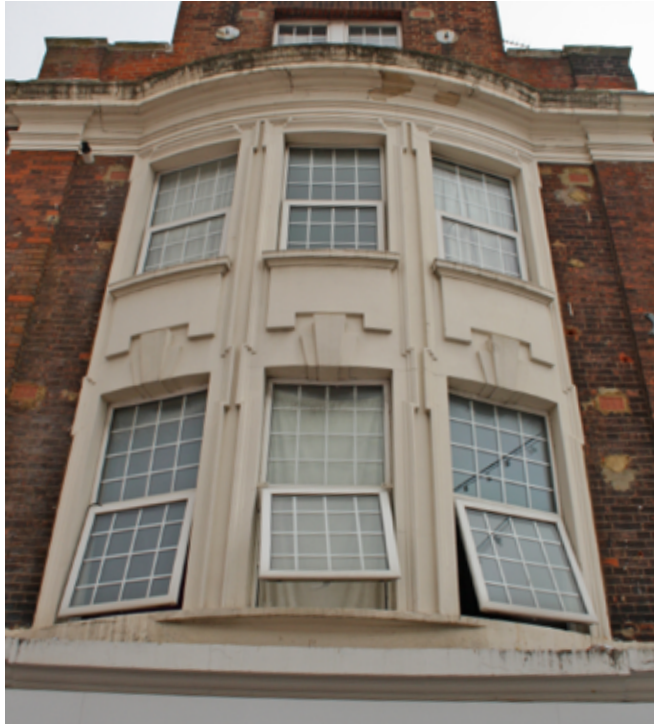
*Insensitive replacement of traditional windows with uPVC units is harming the appearance of the conservation area.*

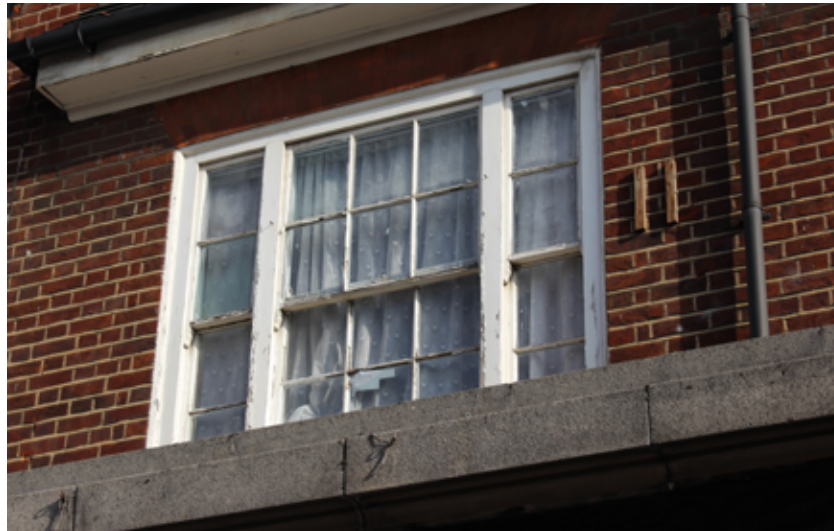
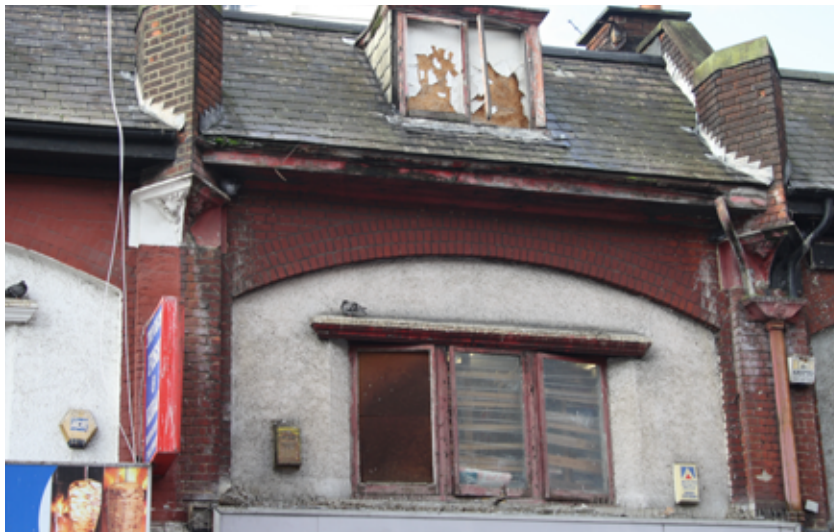
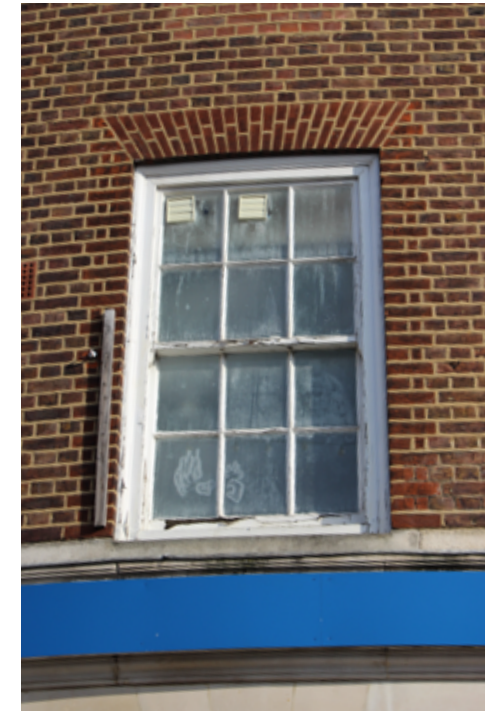
Some of the windows in historic buildings have not been replaced. However, almost all cases the windows have been neglected and are poorly maintained. They are therefore degraded to varying degrees. Regular maintenance and, where necessary repair, of these historic windows would both improve the appearance of the conservation area and also allow the historic fabric to survive longer.

*Many of the surviving timber windows are in a poor condition from neglect and lack of maintenance*

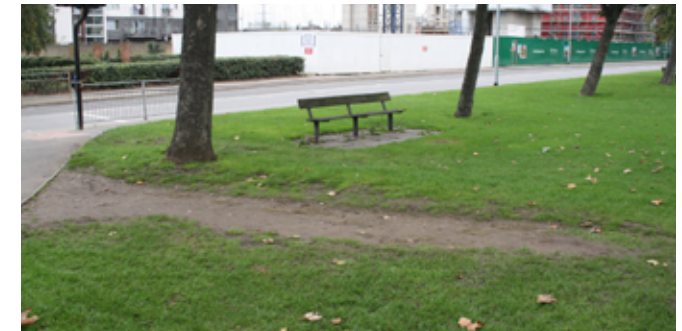
Within Abbey Green the pathways are also in need of maintenance in places due to damage from tree roots and pooling of water. There are also some issues

*Erosion to the grass at the edge of the park, the footpaths should be reviewed to ensure their alignment is correct.*

with erosion of the grassed areas where people use alternative route to the hard-surfaced paths. There is an opportunities to review the path layout within Abbey Green to ensure it is still fit for purpose. Within the area containing the Abbey remains, there are some maintenance issues including damaged steps and surface treatments, any works in this area would need to consider and take account of the highly significant and Scheduled remains and may require Scheduled Monument Consent to undertake.

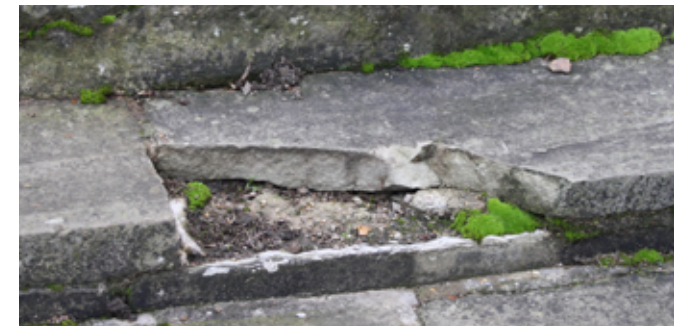
*Damage to steps in the Abbey remains; the steps are made from former gravestones.*

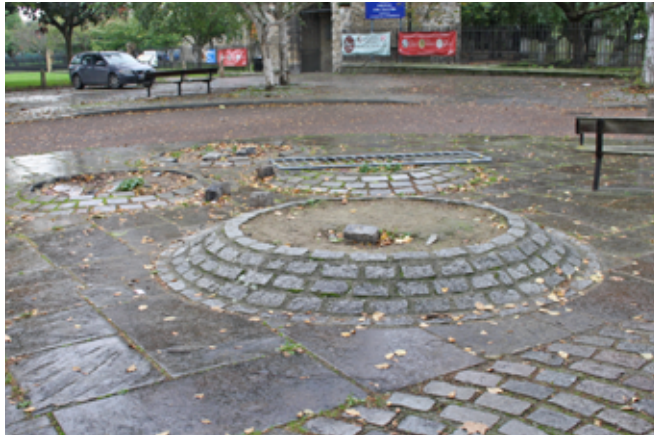
Damage to the granite setts in front of the Curfew Tower and loss of the feature trees.

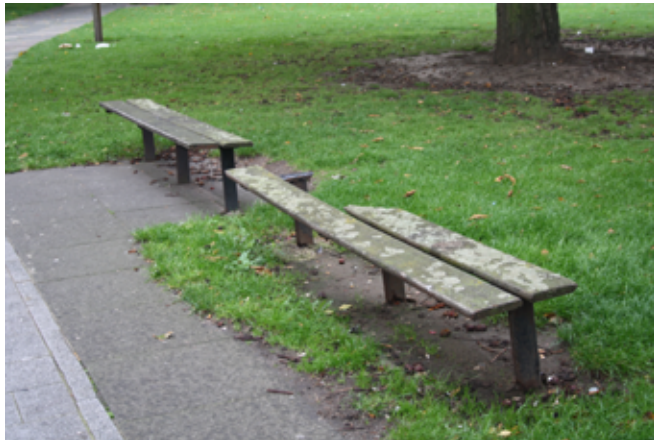
Dilapidated seating in Abbey Green.

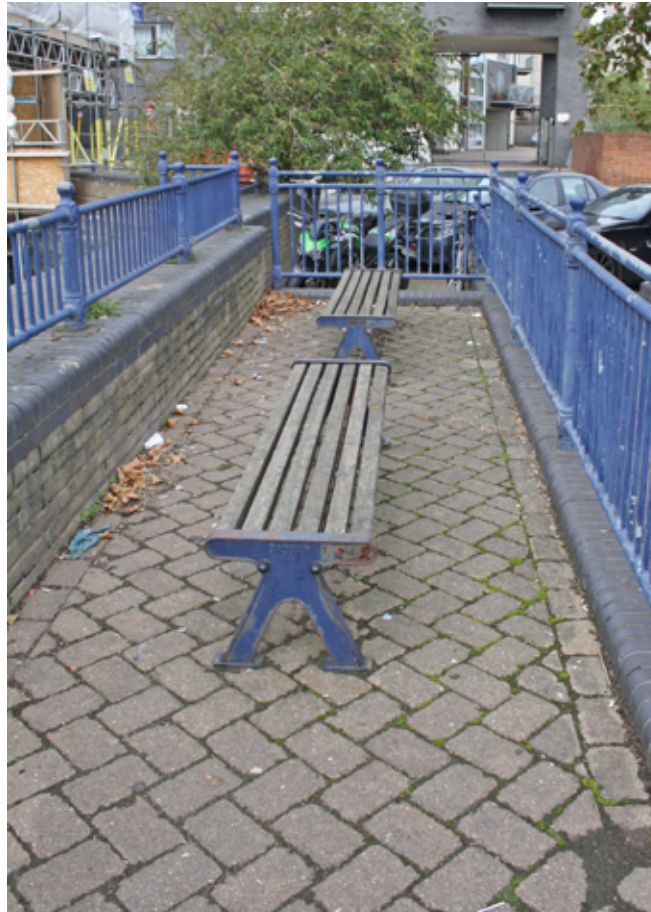
Outdated and neglected public realm around the Town Quay.

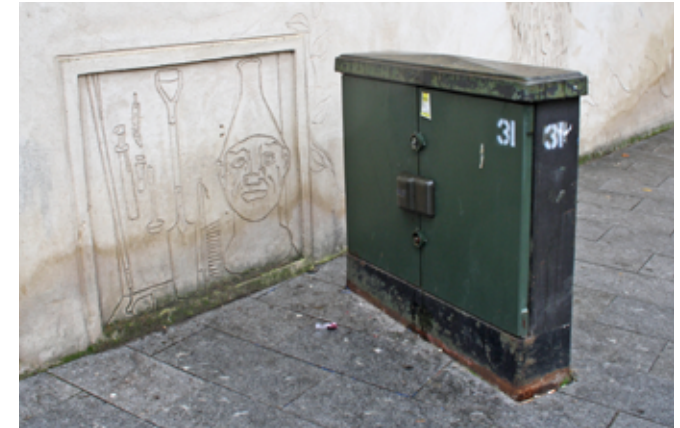
A very poorly positioned broadband cabinet.

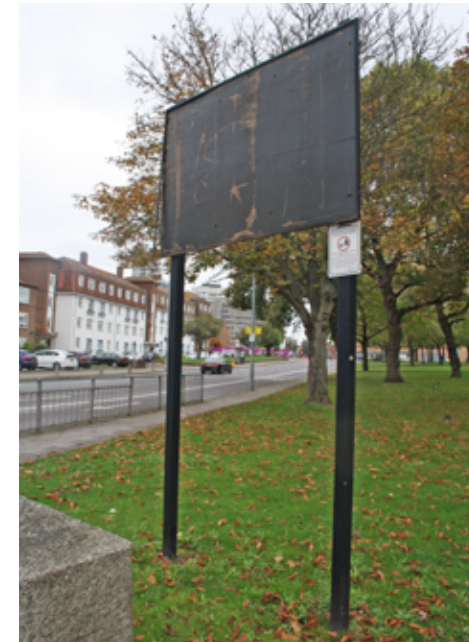
Redundant signage in Abbey Green.

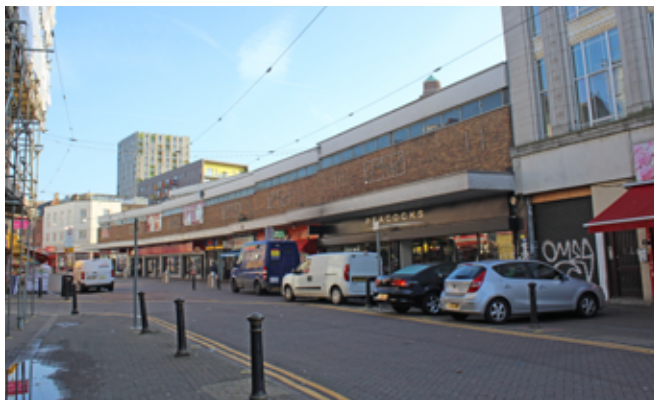
*East Street detracts from the conservation area primarily due to the building's horizontal appearance and lack of an active frontage on the upper floors.*

As identified in section 5.0, there are a number of buildings in the conservation area which detract from its special interest. These are frequently post-war period buildings which are insensitive in terms of their scale, massing or materiality or detailing to the historic character of the conservation area. These include for example 10-30 East Street and Glebe House on Vicarage Drive. The inclusion of these buildings in the conservation area, whether or not they are fit for purpose, dilutes its special interest. Detracting buildings therefore offer great potential for enhancement of the conservation area either through refurbishment but more likely through their replacement with sensitively-designed buildings which respond better to the character and appearance of the conservation area.

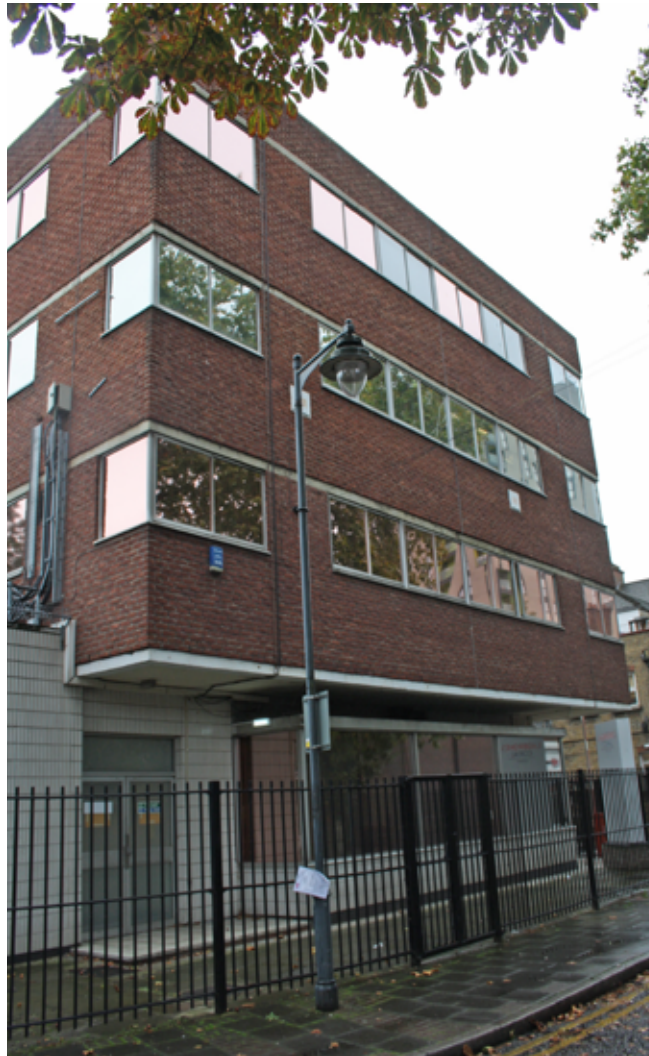
*Glebe House on Vicarage Drive detracts from the conservation area due to its insensitive massing and appearance.*
