ABBEY AND BARKING TOWN CENTRE  
CONSERVATION AREA APPRAISAL  
AND MANAGEMENT PLAN  
OCTOBER 2020

# ABBEY AND BARKING TOWN CENTRE: CONSERVATION AREA APPRAISAL AND MANAGEMENT PLAN

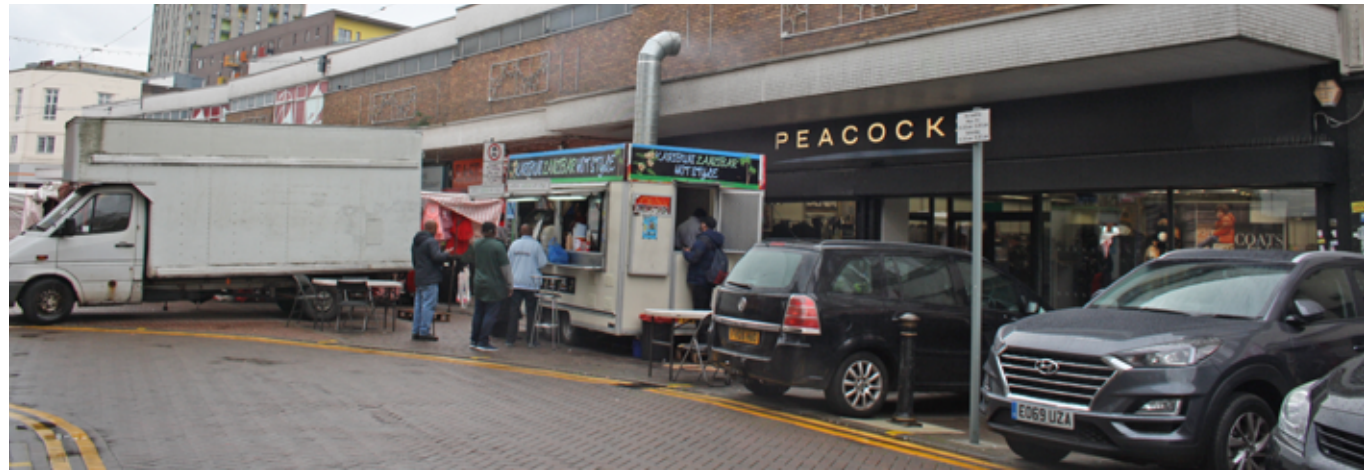
*Cars parked illegally along the pedestrianised East Street.*

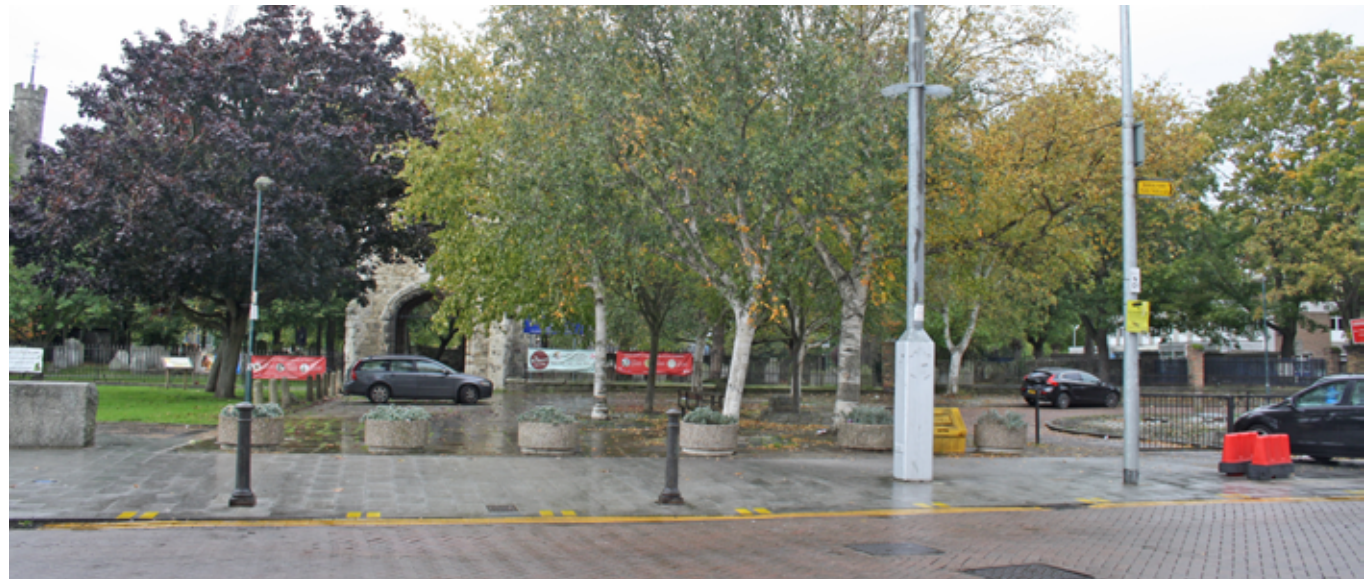
*Cars parked on the public realm in front of the Curfew Tower.*

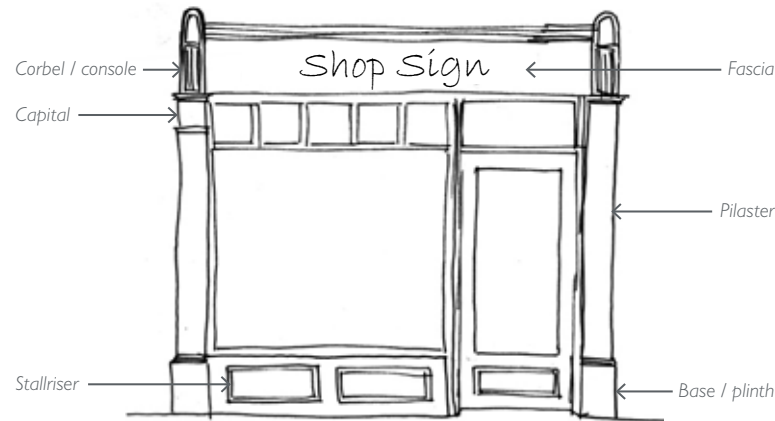
### Components of a Traditional Shopfront

The components of a traditional shopfront are identified on the drawings below. Pilasters, corbels, cornice, fascia and stallrisers are all important elements in traditional shopfronts which create its visual proportions. Fascias are of notable importance and should be in proportion to the rest of the shopfront and not overly large. Furthermore, fascias should not extend above or below cornice level (or, where there is no such feature, should be well below the cill of the window above), or beyond the corbels on either side. Full height glazing is a modern feature and does not reflect the character of historic buildings. Smaller windows with stallrisers (a plinth under the window), transoms and mullions are typical traditional features and more appropriate in historic contexts. Traditional and characteristic materials, such as painted timber, will best enhance the historic character of the buildings.

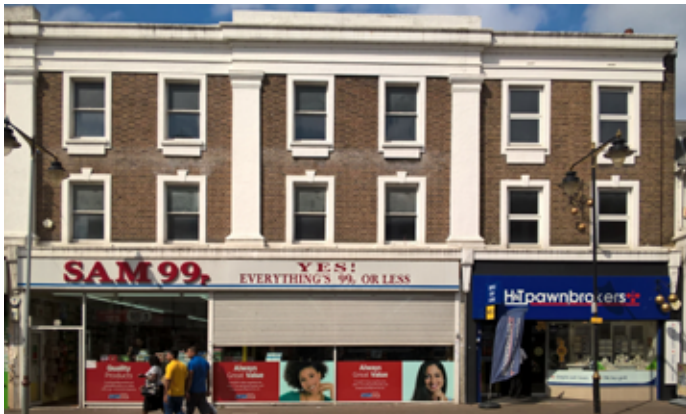
## EAST STREET NO. 23 - 27

**Contribution to Conservation Area:** Positive to Neutral  
Contributor to CA (group w/ Nos. 1-11 and 13 - 21)

**Positive Aspects:** Consistent appearance to upper facade

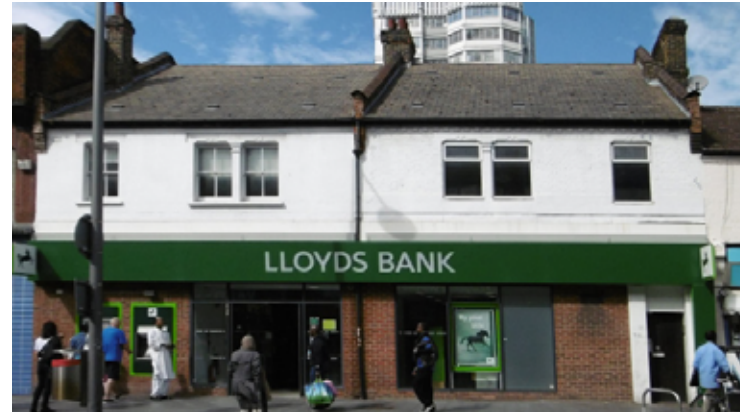
## STATION PARADE NO. 11 - 13

**Contribution to Conservation Area:** Positive to Neutral  
Contributor to CA (group w/ Nos. 1-9 & 21-27)

**Positive Aspects:** Shop frontage and upper facade in good condition.

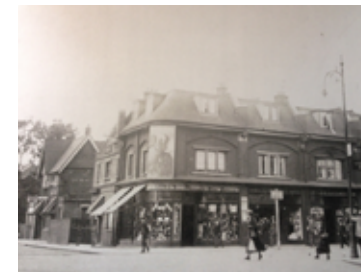
East Street/Ripple Road junction showing 1a Station Parade with an active frontage and windows on the upper floors, which are covered today by an unnecessary superficial render (see photo on p.26)

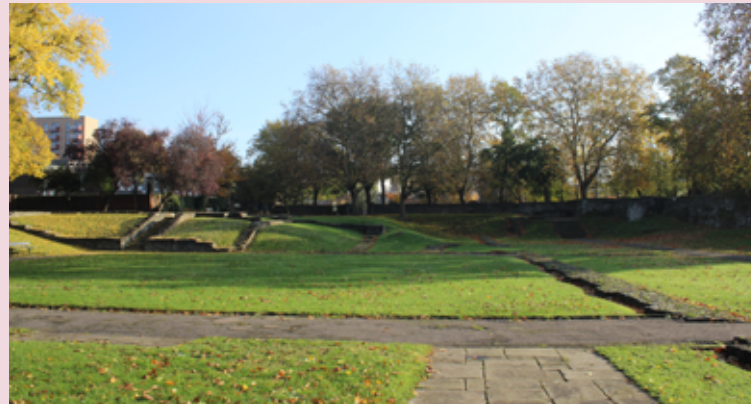
Little survives of the former Barking Abbey, which lies to the north of St Margaret's Church. It was established in c.666 by St Erkenwald, Bishop of London. First functioning as a double house of monks and nuns, it was sacked by the Danes in 870 and re-founded as a nunnery in the 10th century and eventually rebuilt in the 12th century. The Abbey was the most important nunnery in England; five of its pre-Conquest abbesses were canonised.<sup>02</sup> Throughout its life, the Abbey attracted recruits from prestigious families until its dissolution in 1539. The buildings were pulled down in 1541 and the stone was reused for other buildings such as the King's Palace at Dartford. The site was excavated in 1910 by A. W. Clapham and C. J. Dawson, who deduced the plan of the Abbey Church and memorialised it in stone above ground.

*The layout of Barking Abbey is represented in stone above ground.*

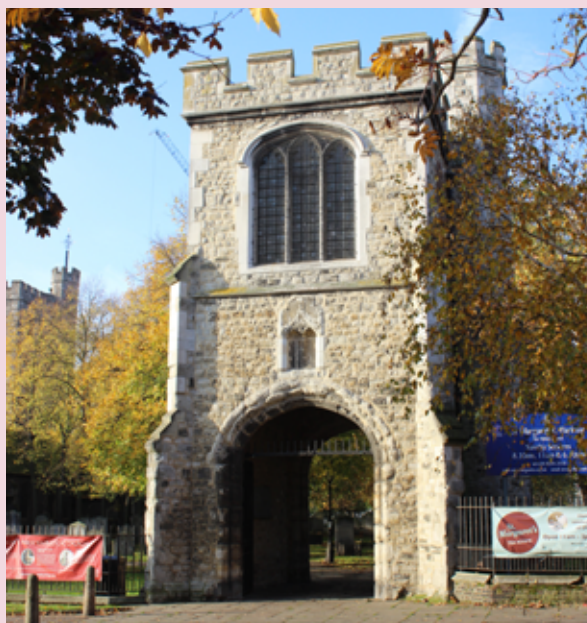
The tower dates to around c.1460 and is thought to be the principle (east) of two gateways into the Abbey precinct. It is two-storey coursed rubble building with stone dressings. It is the only remnant of the Abbey precincts still standing and today forms the entrance to the churchyard of St Margaret's parish church. The upper storey formed the Chapel of the Holy Rood; it houses the late 12th century stone Barking Rood, which is a representation of the crucifixion in stone. It is a rare example, as they are usually of wood, and it was an object of pilgrimage from the late medieval times.

*The Curfew Tower is the only surviving building of Barking Abbey.*

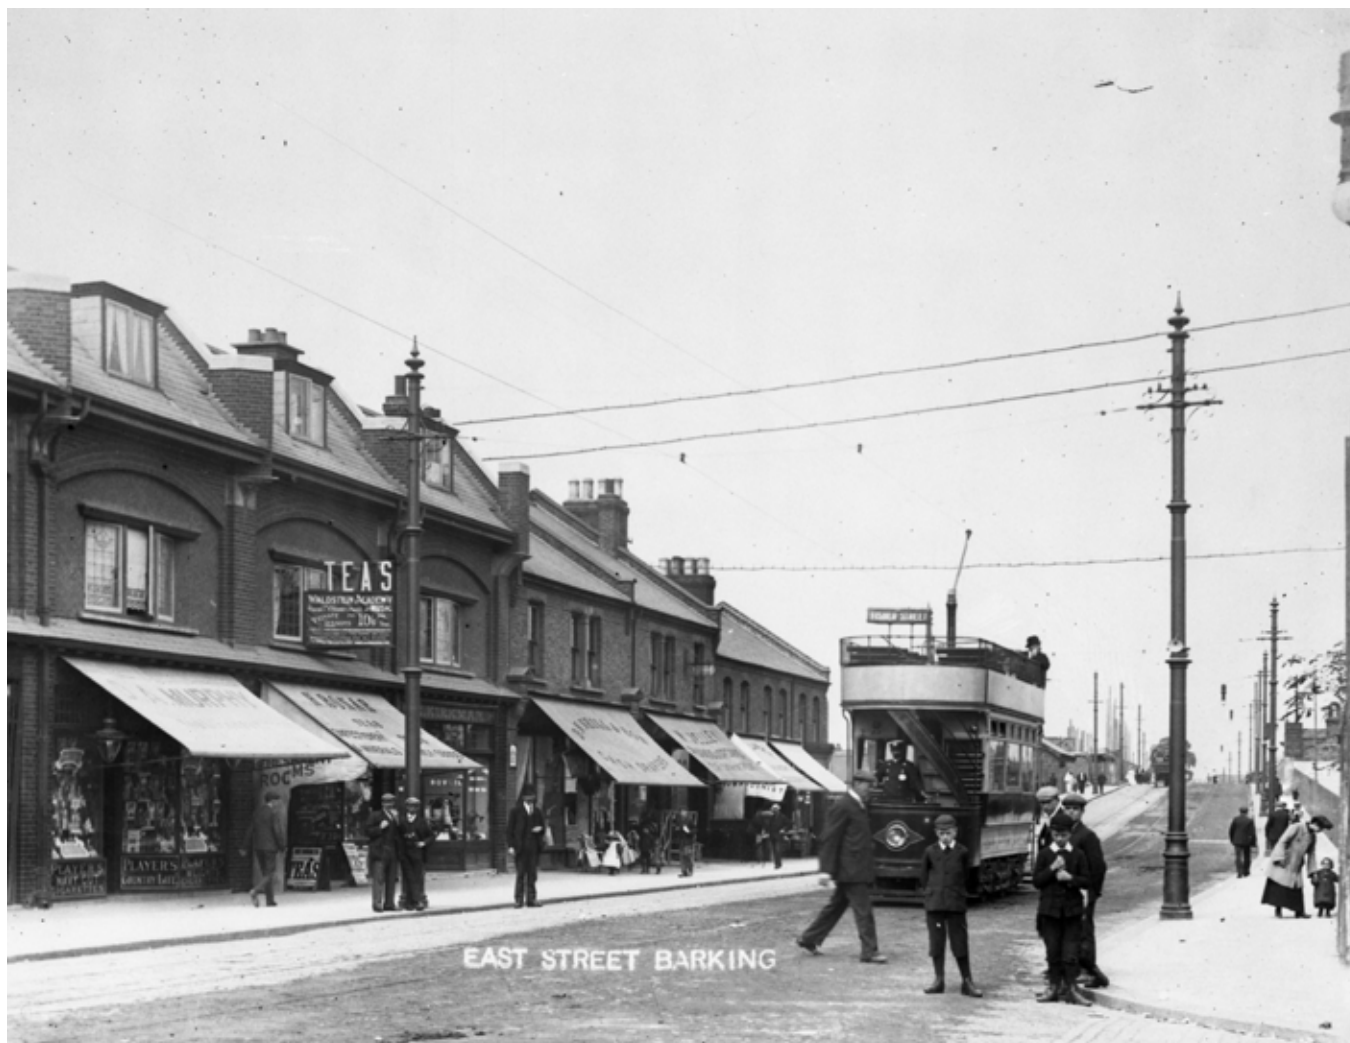
*This view of 'East Street' looking north-east shows what is now Station Parade; the street is characterised by the terraced shops with canopies and the tramlines. The shops on the north-west side of Station Parade have since lost their historic shopfronts at ground floor and the condition of the windows has deteriorated substantially. (Barking & Dagenham Archives and Local Studies, Valence House: DS347)*

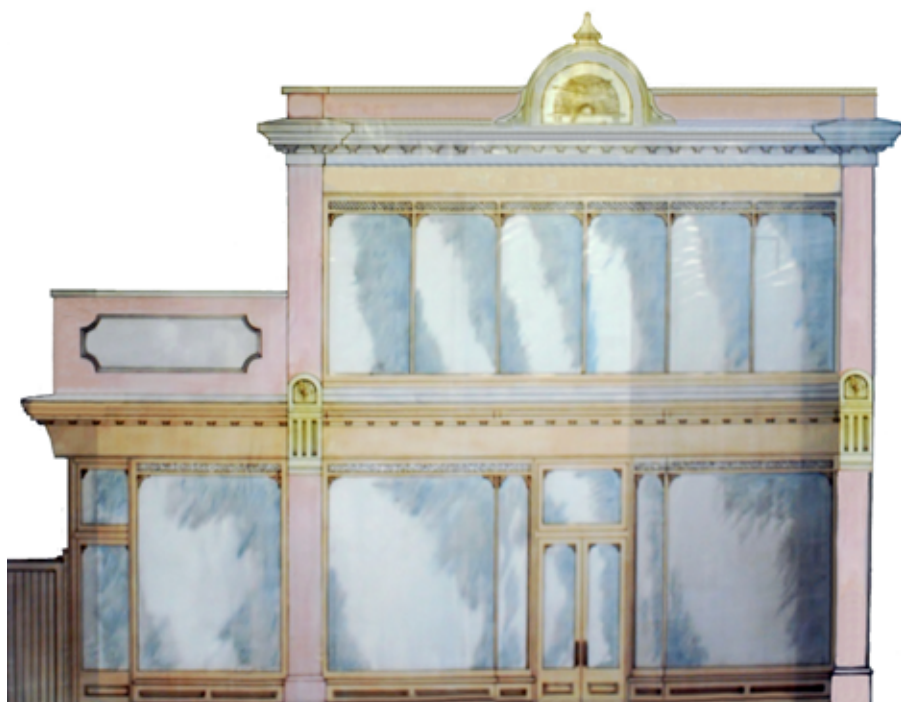
Front elevation of the Co Op Building on North Street, 28 Feb 1900. (Barking & Dagenham Archives and Local Studies, Valence House)

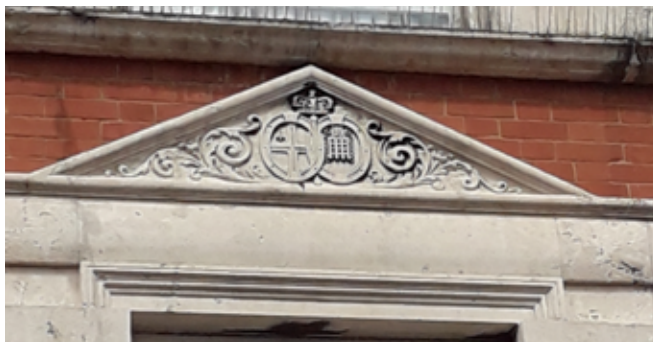
The crest of the United Westminster Charities Schools remains today in the pediment above each first-floor window.
